Rebekah Scott Hall

**Building Chronology
Exterior Conditions Assessment
Maintenance Recommendations**

**Agnes Scott College
Decatur, Georgia
September 2014**

Atlanta Preservation & Planning Services, LLC

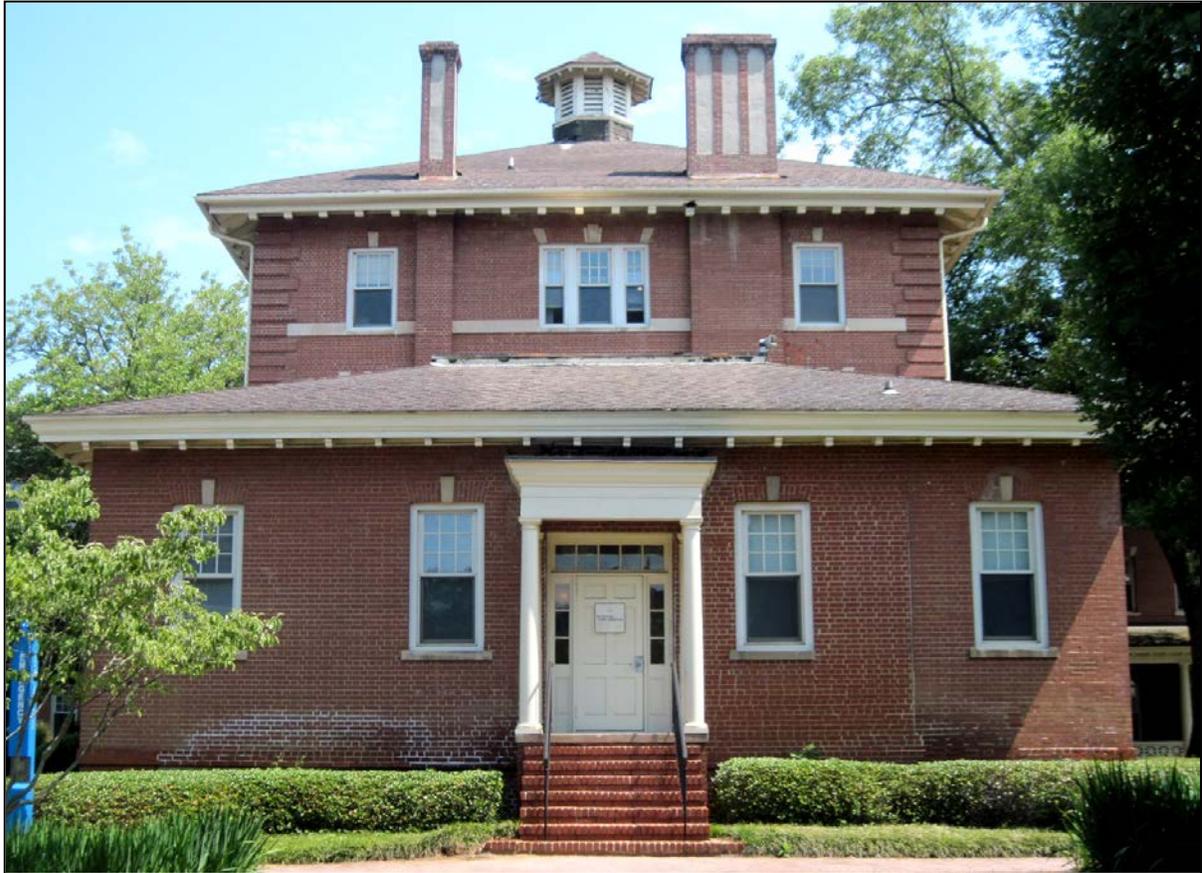
View of the original one-story kitchen/Annex south facade. The 1959 infill-brick area to the right of the present door is quite obvious. Inappropriate repairs to the brick are visible above the left shrubbery. These are discussed in the Load-bearing Brick section below.

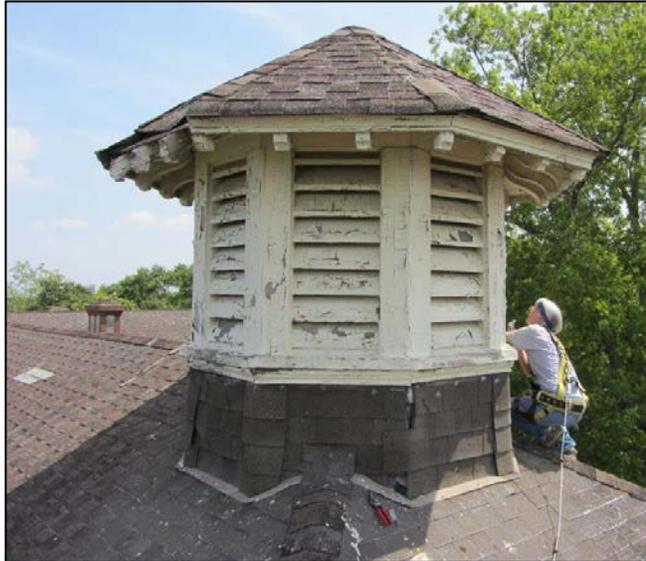
Southwest view of the south cupola with investigator on tether. Note worn roofing shingles and failed paint.

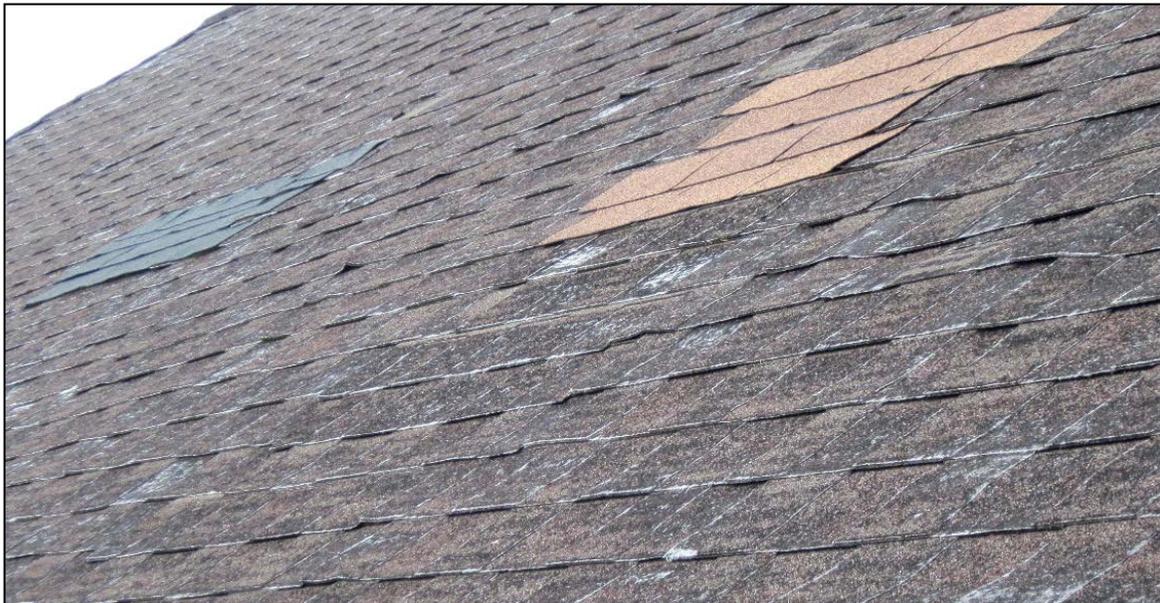
Composition asphalt-fiberglass roofing shingles show extreme wear and patched areas.

The current composition asphalt-fiberglass shingles were installed during the 1975-76 roofing project, and are only the second roof Rebekah has had in its 109 years. They are nearly 40 years old and are in extremely poor condition (see photo on preceding page). Many of the ceramic granules on top of the asphalt base have worn off; the remaining granules are loose and easily displaced when walked upon. The asphalt layer, which makes the shingles waterproof, has worn away, exposing the fiberglass strands beneath. The shingles are discolored, and sections have been patched with replacement shingles that do not match. Fortunately, the attic does not show any signs of ongoing water leakage, so for the moment the shingles are still keeping the weather out. However, it is strongly recommended that they be replaced as soon as possible.

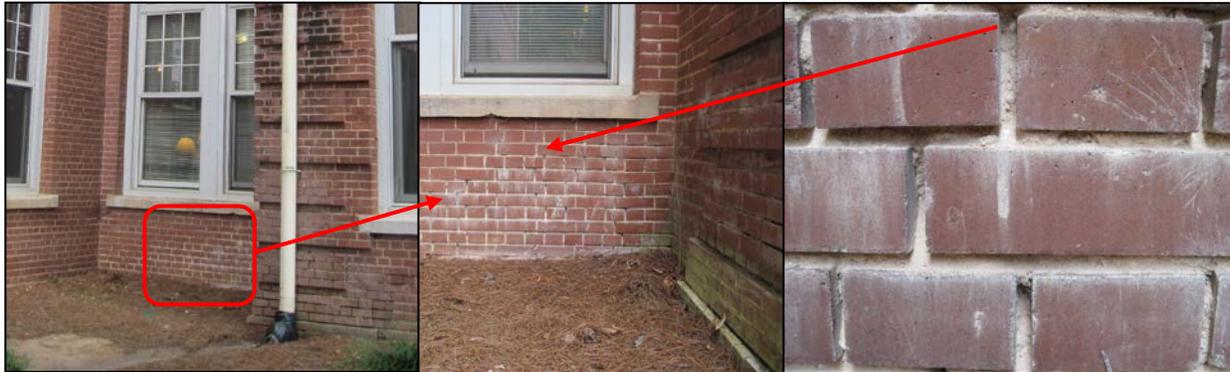
West façade at the recess where the south ell meets the northwest wing. At left, the general area of mortar loss beneath the windows; middle, a direct view under the south window; at right, close-up of the mortar, reduced to sand falling out of the joints onto the bricks and the ground.

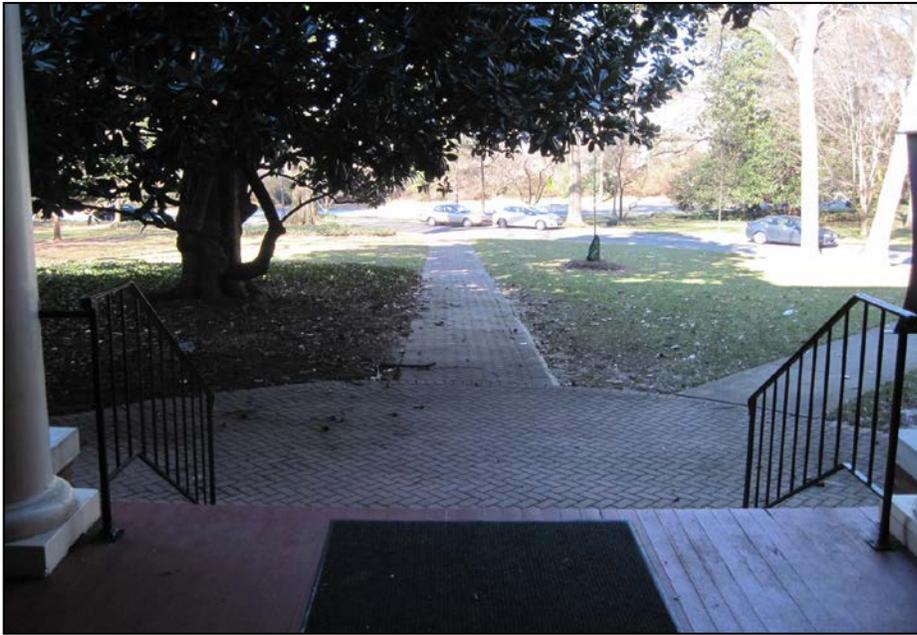
View from Rebekah's porch looking over the front stairs and walkway. This photo was taken January 20, 2014, a bright, crisp winter day with the leaves off the trees. Note how the evergreen magnolia prevents any sunlight from reaching the building. See photo on page 75 for a rainy day view with water pouring onto the front steps from the porch roof, which has no gutters.

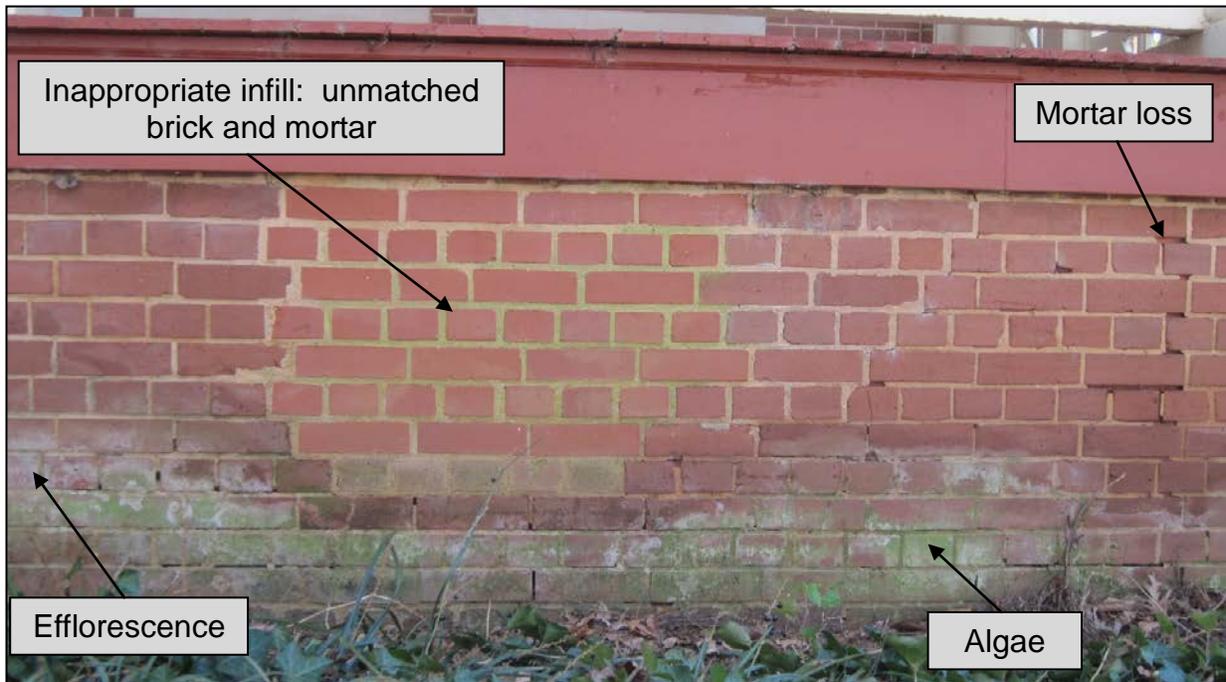
North façade of the porch foundation displays a variety of brick problems and types of decay.

The result of these unmitigated issues (moist environment and improper repairs) is the ruinous condition of the wall, which continues to crumble. Historic mortar has been lost. Some historic bricks are so deteriorated they must be replaced (see photo below and photos on the following page), and others have been displaced or soon will be. It is imperative first that the moist microclimate be eliminated. When that has been achieved, then correct repairs must be made, using custom mortar and bricks to make the repairs.

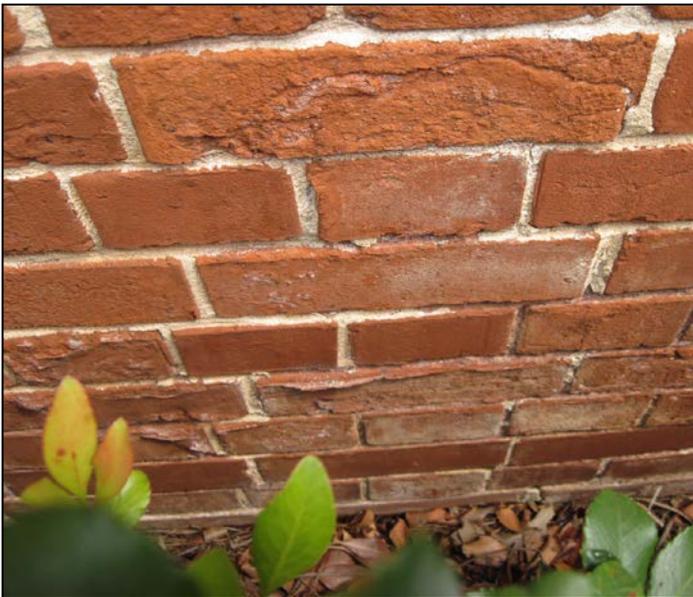
South foundation of the kitchen/Annex. Note some spalled bricks, and the surfaces of other bricks literally peeling away — the results of a moist microclimate and bad repairs using the wrong mortar.

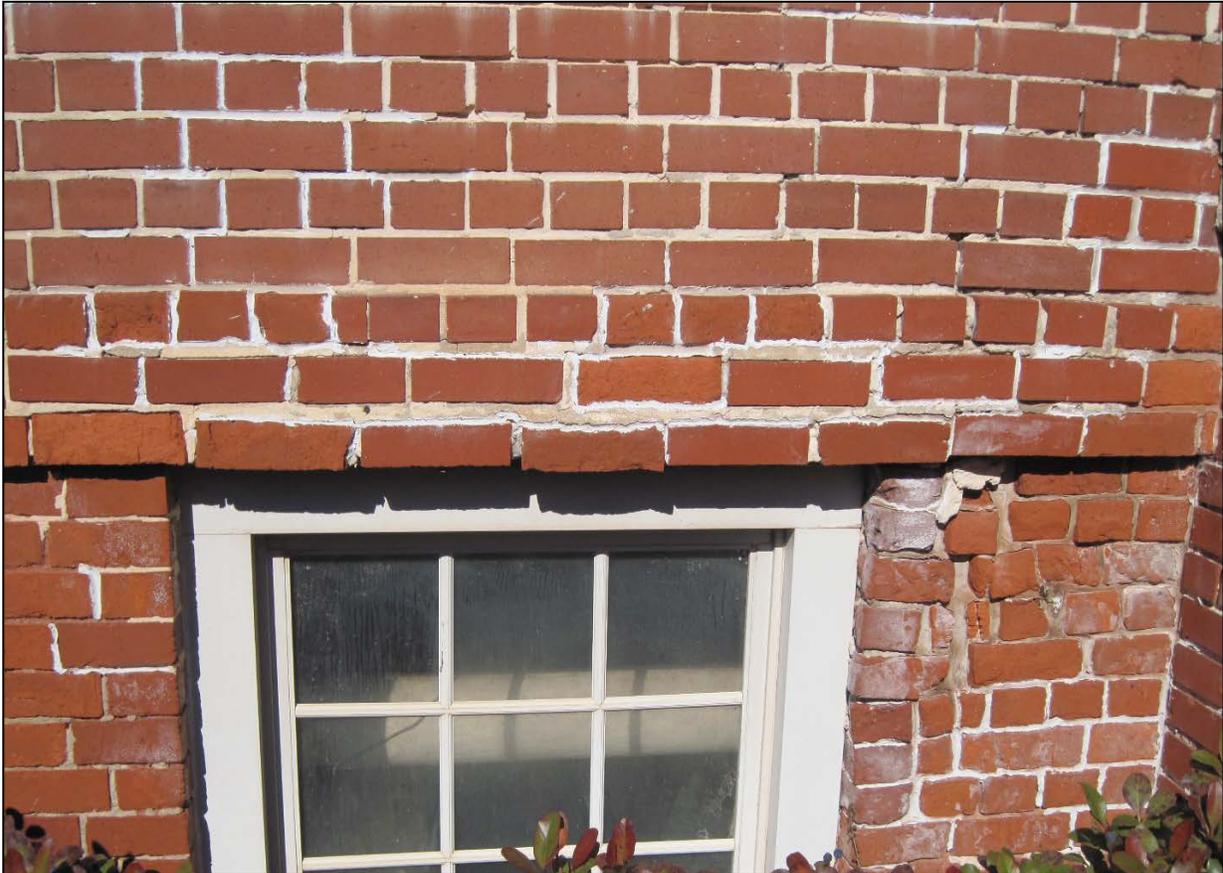
Original mortar failed due to continuously moist environment caused by lack of gutters and dense shrubbery. Incorrect repairs made with cement-based mortar. Use of caulk to "repair the repairs."

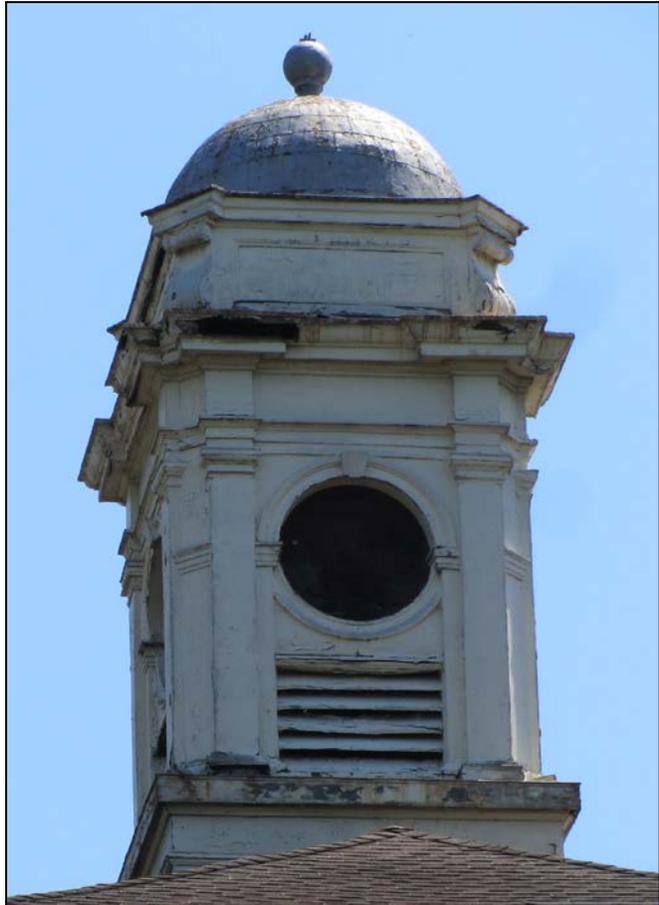
North cupola as viewed from the north, showing rotted and missing cornice sections, broken vertical spike, failed paint, and a rusted metal dome.

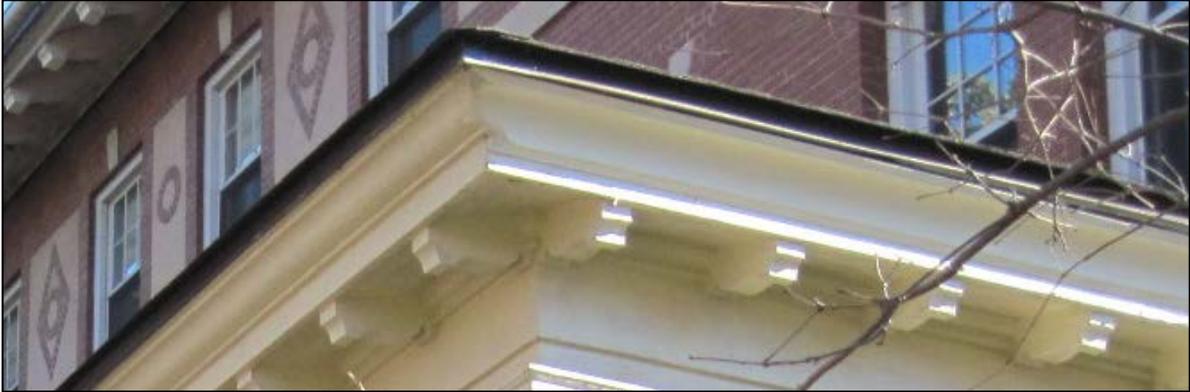
Molded cornice, fascia, and soffit supported by eave brackets. These elements on the porch are in better condition than those on the main building, but they need to be cleaned and then evaluated to determine if repainting is necessary.

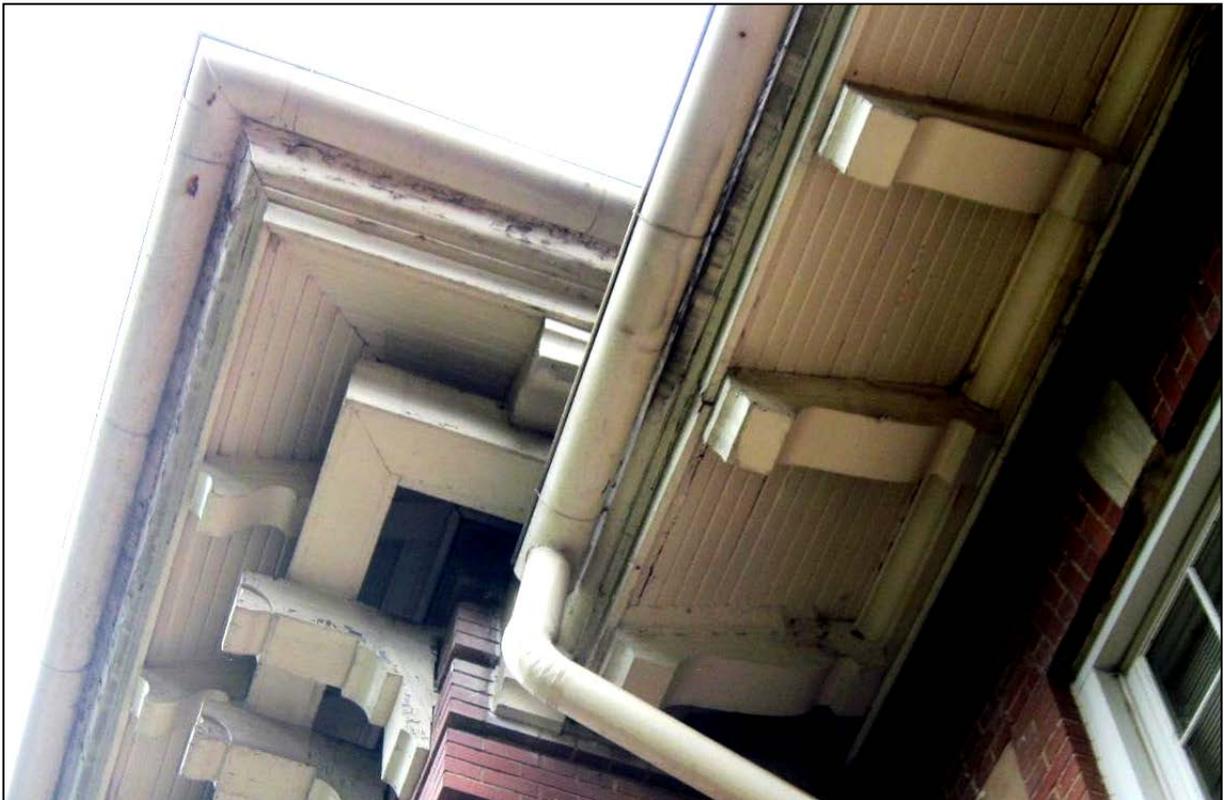
View where the west end of the front projection meets the recessed section of the main building. Note the two rows of eave brackets on the front project (at left), both of which differ from the regular eave brackets (at right) on the rest of the building. The cornices of both sections have extremely deteriorated paint and probably damage to the underlying wood. All of the wood elements need to be cleaned; most will need to be repainted.

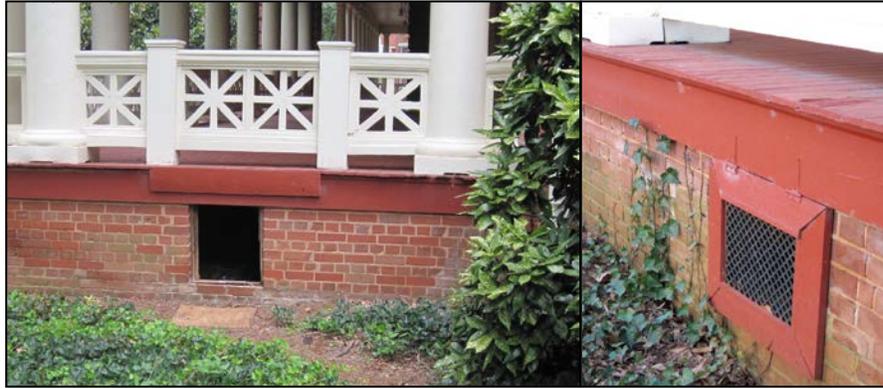
*Left: west crawlspace access with its plywood covering on the ground.
Right: the east crawlspace access has an appropriate door, except it is screwed shut.*

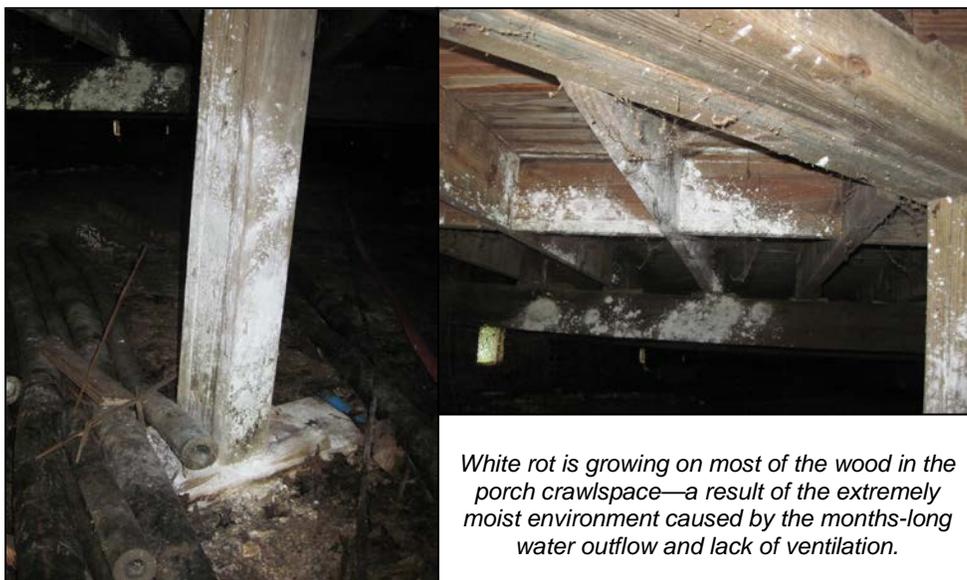
White rot is growing on most of the wood in the porch crawlspace—a result of the extremely moist environment caused by the months-long water outflow and lack of ventilation.

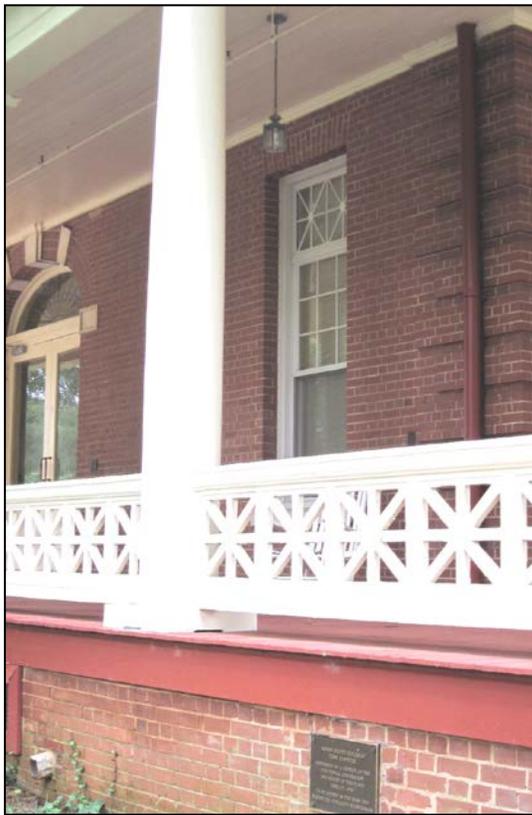
Note dark red downspout (top right) that leads from a gutter on the roof of the main building. Its shoe exits through the porch foundation (bottom left).

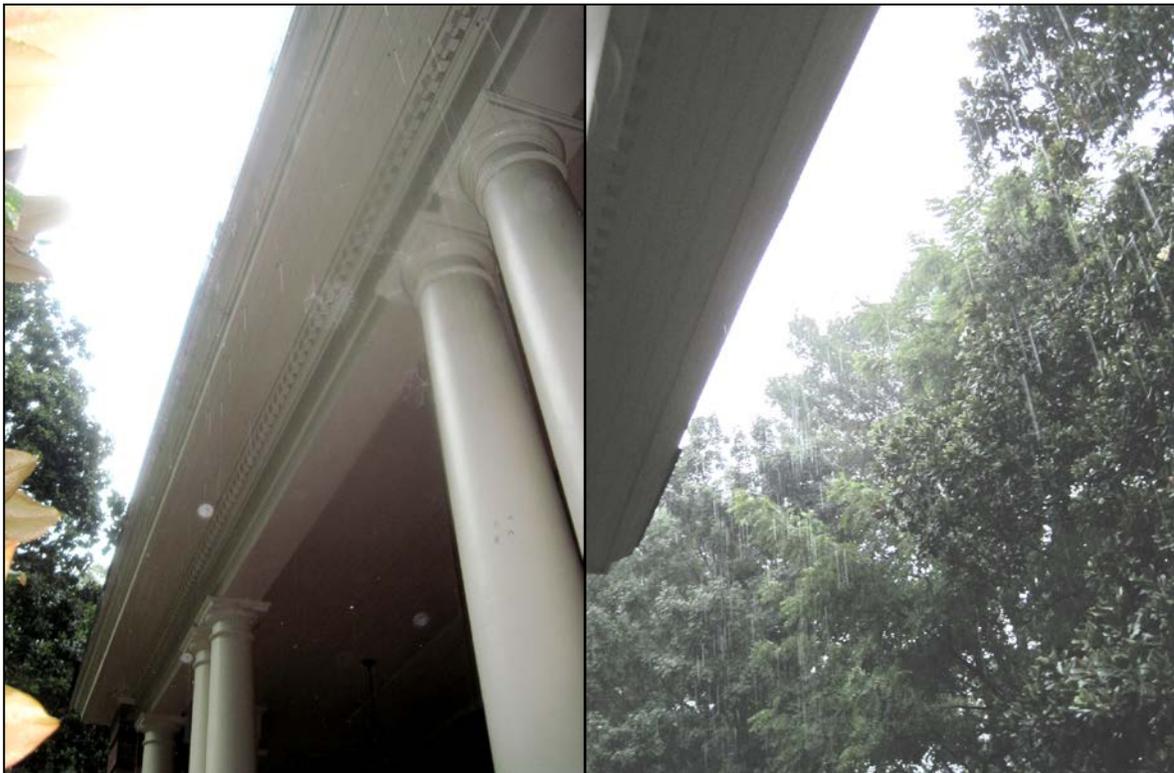
Rain water pouring over the front porch roof. At left, above the front steps onto the heads of visitors entering the building. At right, west of the stairs, creating a moist environment hazardous to all the building elements.

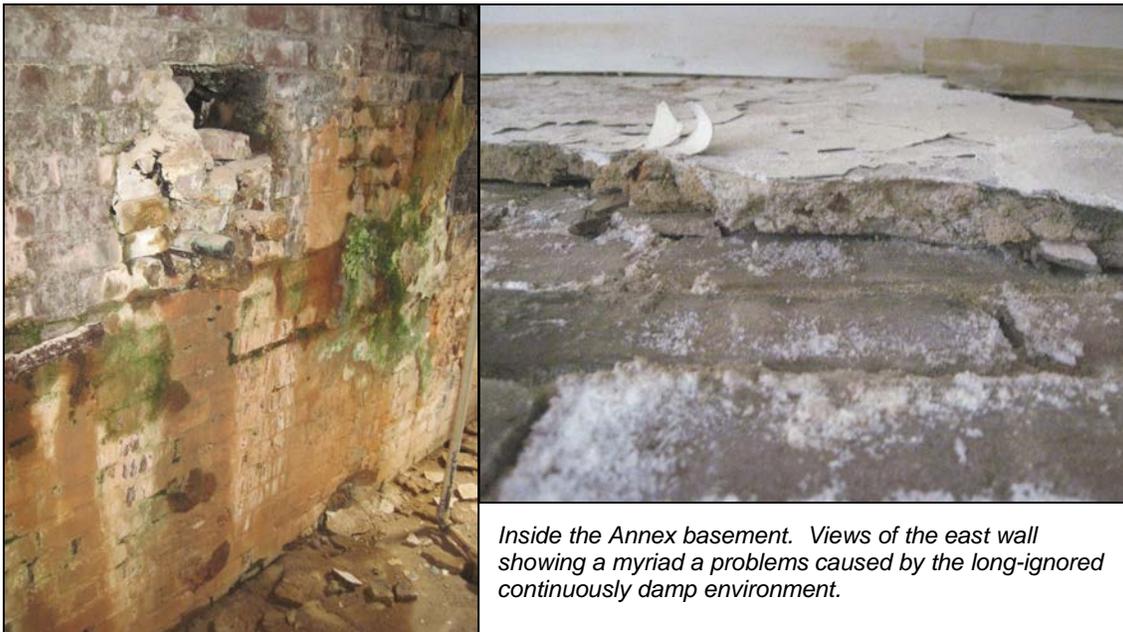
Inside the Annex basement. Views of the east wall showing a myriad of problems caused by the long-ignored continuously damp environment.

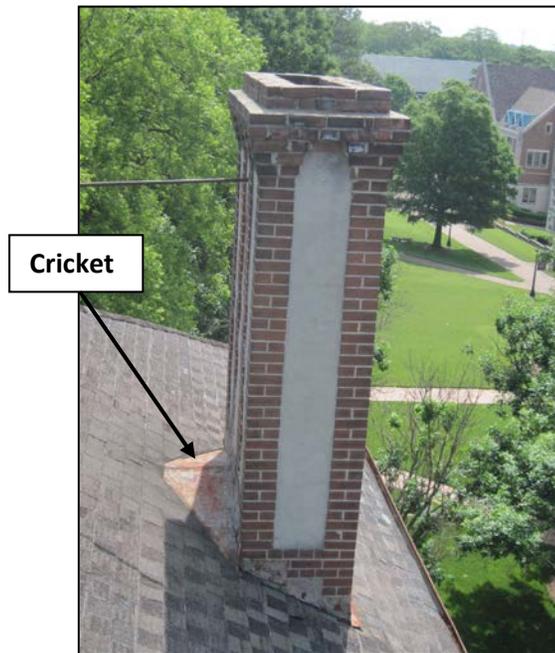
East chimney on the south ell. Note lack of chimney cap, dirty bricks, cracked stucco, and rusted flashing and cricket.

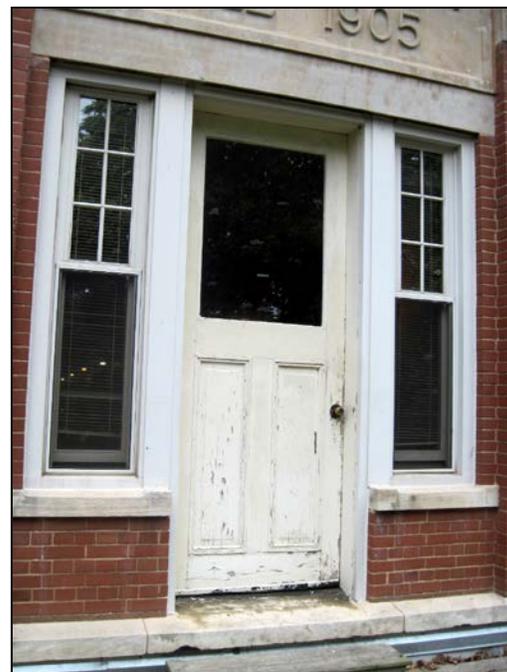
Balcony door. Note deteriorated paint.

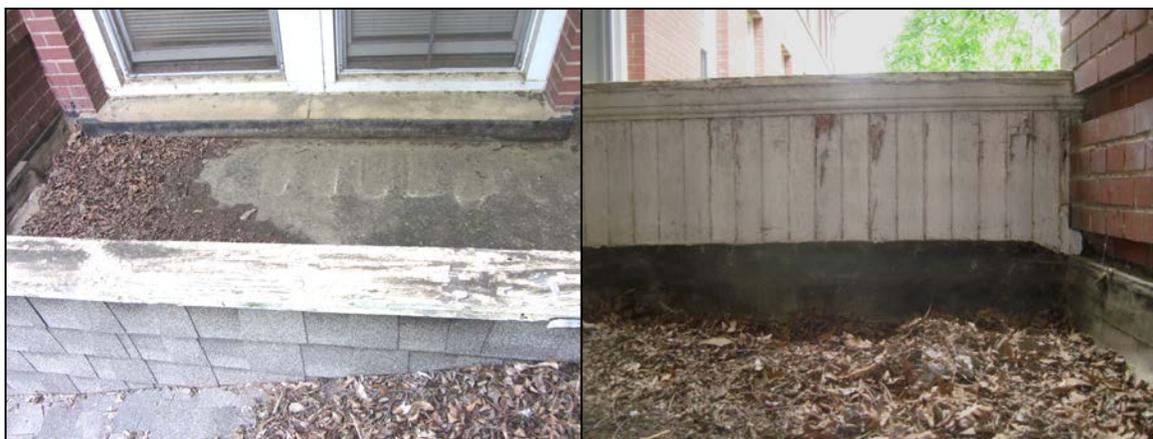
*Left: view over the parapet looking at the floor and central-stair windows. Note deteriorated wood rail and leaves accumulated on both the porch and balcony.
Right: view of the balcony from the interior stairs. Note deteriorated paint and flashing.*

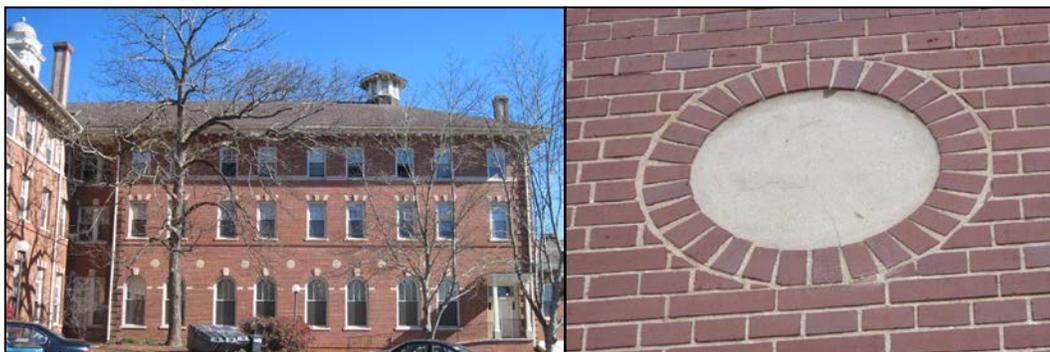
*Left: West façade of south ell showing small circles between the first floor windows.
Right: Close-up of a circular stuccoed panel. Note cracked stucco.*

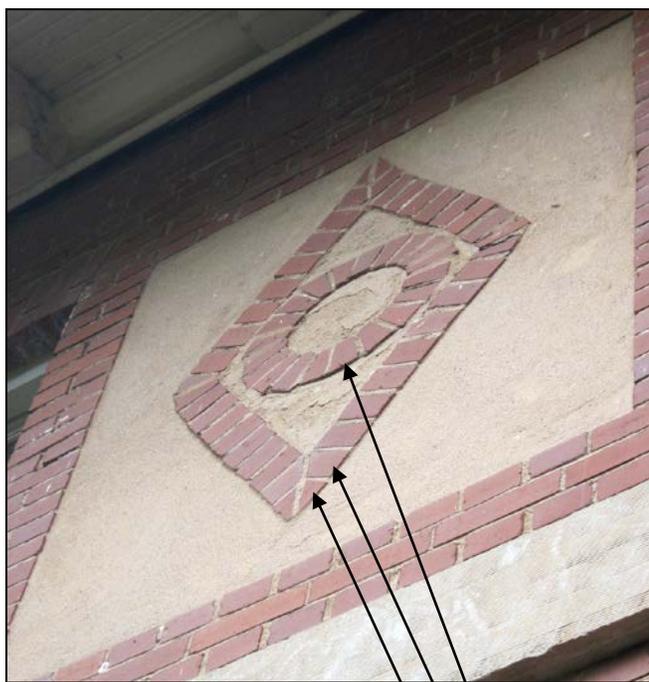
Stucco has spalled off in the interior sections of this panel. Other areas show cracks and dirt.
