# Keeping A Lid On It: Asbestos-Cement Building Materials

Amy Lamb Woods  
August 2000

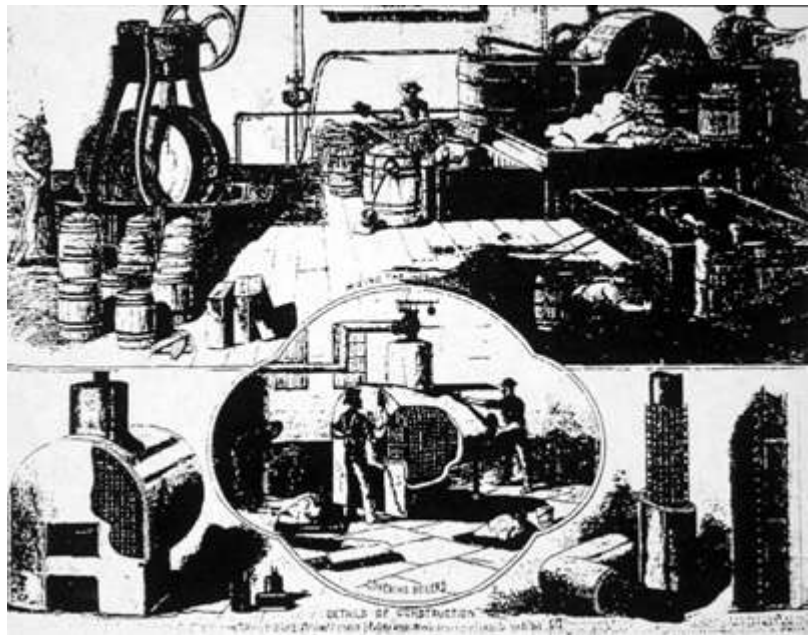
**Figure 1. Manufacture of non-conducting asbestos-cement coverings for steam-pipes and boilers (*Scientific America*, 1876).<sup>26</sup>**

Asbestos-cement was first manufactured in the United States in 1905,<sup>6</sup> introduced first in the form of a coating. It was easily installed and assumed to be indestructible when applied as a covering to boilers, steam pipes, hot blast furnaces, and stills. H. W. Johns Manufacturing Company (later Johns-Manville) became one of the leaders in the development of cement products containing asbestos.

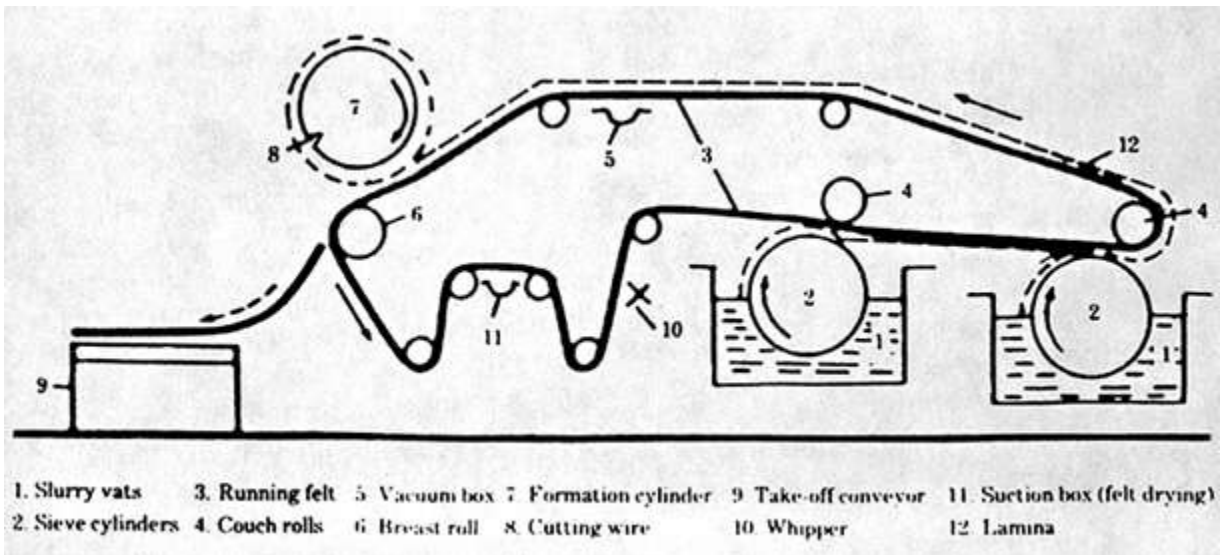
Figure 2. Simplified representation of a Hatschek machine for asbestos-cement production (Wilden, 1986).<sup>27</sup>

It was not until 1907 that the invention by an Austrian engineer, Ludwid Hatschek, made possible the manufacture of pre-formed asbestos-cement products.<sup>8</sup> The Hatschek machine, a wet transfer roller, was used to produce the initial asbestos-cement sheets (Figure 2), while two other manufacturing processes included the Mazza process for pipes, and the Magnani semi-dry process for corrugated sheets.<sup>9</sup> After being formed, most products were steam cured to achieve the optimum microstructure for strength and durability. It is these asbestos-cement building products that have many desirable material characteristics, such as being lightweight, impermeable to water, durable, tough, resistant to rot, termites, soiling, corrosion, warping, and fire, and easy to clean and maintain. Asbestos-cement also possesses low thermal conductivity and is therefore a good electrical insulator. These highly desirable material characteristics, apparent in the new found material, sparked growth in manufacture of a plethora of forms and styles to suit different needs.

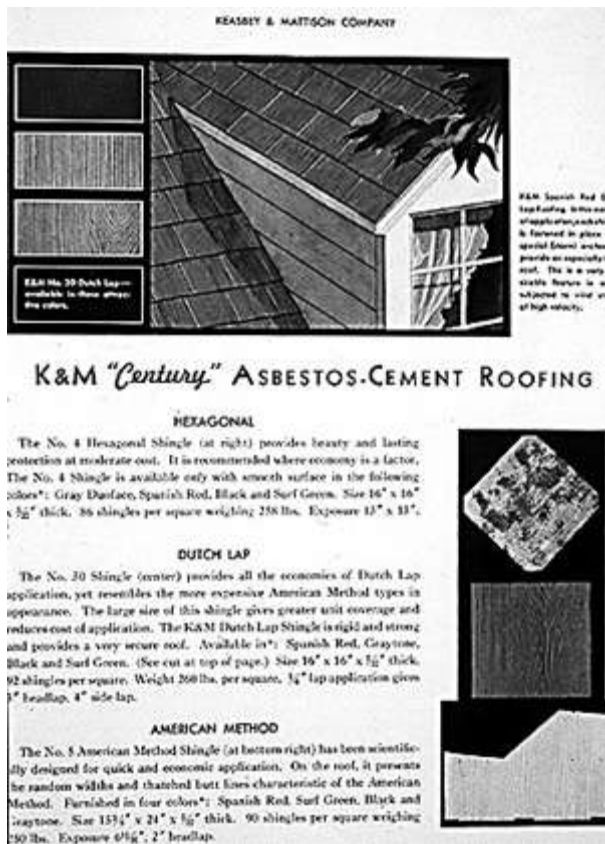
**Figure 3. Keasbey & Mattison Company advertisement showing typical asbestos-cement roofing shingles (Sweet's Catalogue of Building Construction, 1940s).**

Originally, roof shingles were manufactured in three typical colors: natural cement gray, Indian red (tile), and blue-black (slate). Two primary designs produced were Hexagonal (diamond shape) and Dutch lap (similar to wood shingles). Each shingle is held by two nails, with the addition of a storm nail at the apex of the Hexagonal pattern. They are much lighter than tile or slate and weigh only a little more than wooden shingles, allowing for a more economical substructure. Other shapes include: Poilite Straight Cover Slating (square or chamfered corners), Scalloped (three or five scales to a tile), Bell's Pan (ogee shape, or a skewed pan tile), and Endurol (wave pan tile).<sup>13</sup> When asbestos-cement roofing shingles were properly manufactured and installed, the shingles were so durable that the roof would commonly outlast the

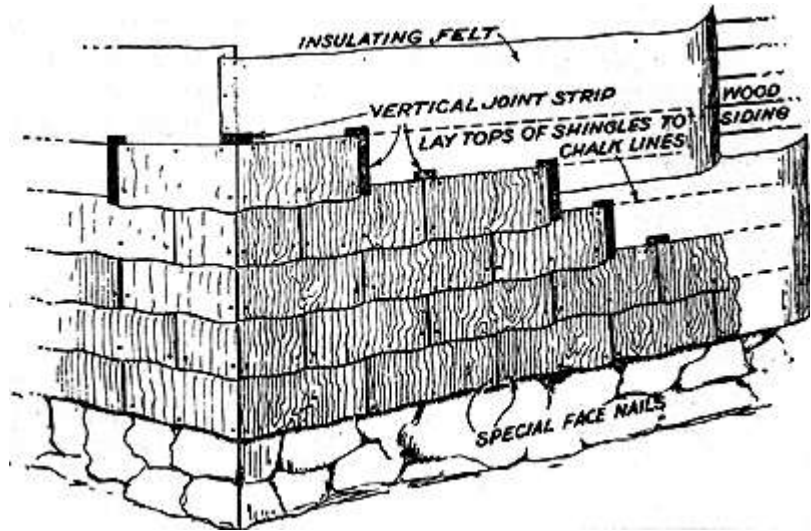
Figure 4. Asbestos-Cement siding installation specifications (McCawley, 1940).

Asbestos-cement siding shingles imitated wood siding shingles in shape and appearance, typically available in sizes of twelve by twenty-four inches. These shingles originally came in nondescript tones like gray-green, gray-pink, and Dover white. Textures such as grooved, wood-grained, or smooth were pressed into the large asbestos-cement sheets, then cut to the profile of the design, such as Tapertex (flat horizontal lines), Thatched, or Waveline. They were usually predrilled for ease of installation with two to three nails on the bottom of each shingle to secure the panels to the sheathing. Installation was executed from the bottom up. As one row of shingles was nailed, the bottom lip would secure the top of the shingle from the row below (Figure 4).<sup>14</sup> This construction technique allowed ease in replacing shingles, unlike wood or slate shingles that were secured at the top of each shingle.

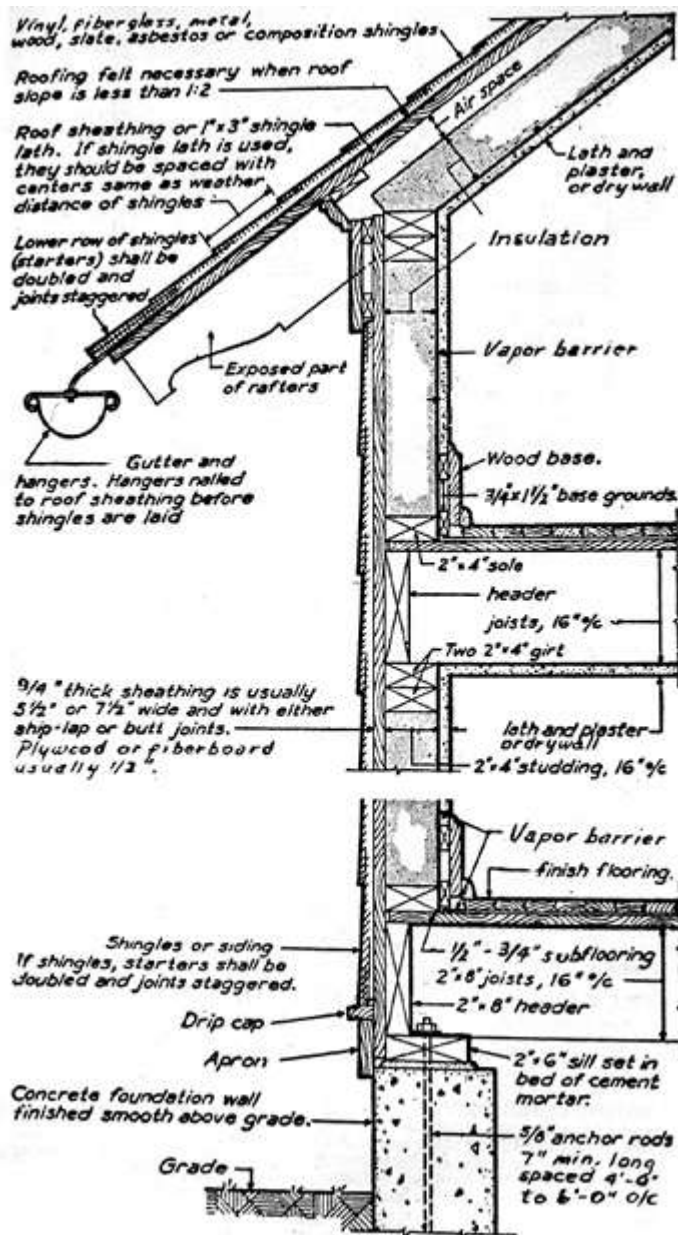
Figure 5. Partial wall section for shingle siding construction; shows a drip cap and apron in place to protect the bottom edge of siding shingles (Graf, 1985).

bumper material to the bottom row of siding to reduce vulnerability to cracking and chipping (Figure 5), and keeping branches and debris away from the roof and out of gutters.

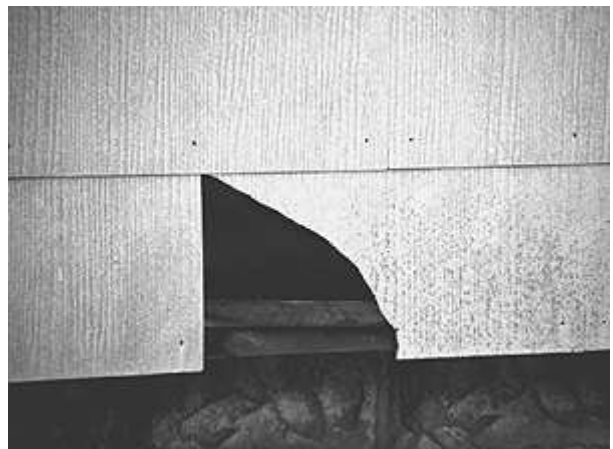
**Figure 6. Asbestos-cement products most commonly deteriorate by cracking and chipping. These kinds of deterioration are not typically feasible to repair, and therefore it is recommended that a non-asbestos fiber cement piece be used as a replacement (photo by author).**

Since asbestos-cement products were manufactured in standard sizes, shapes, colors, and textures, partial replacement is well suited for implementation. This process is acceptable when part of, or pieces of, the existing asbestos-cement building material have deteriorated to such a degree that it is much more feasible to replace than repair (Figure 6). Since the United States no longer produces asbestos-cement products, an alternative material should be selected to match the original. Some materials that have been manufactured to replicate asbestos-cement building components are non-asbestos reinforced cement, fiberboard with asphalt, fiberglass, metal, and vinyl. For the purposes of preservation, one of the non-asbestos reinforced cement products is most appropriate.

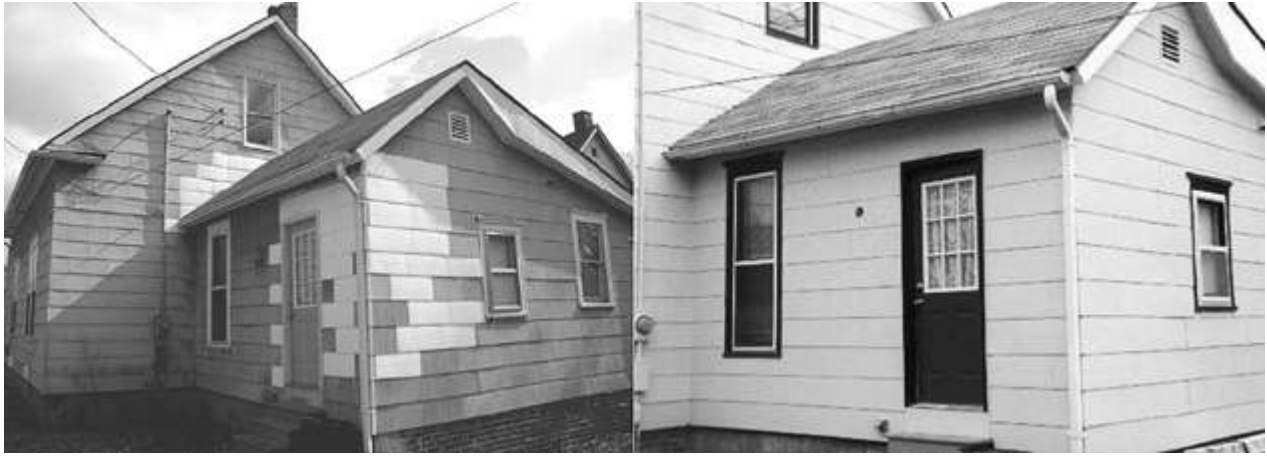
**Figure 7. Replacement non-asbestos fiber-cement shingles in place, before being painted and after (photo by author).**

Many varieties of non-asbestos reinforced cement or fiber-cement are currently available. Fibers that have been introduced with cement include: steel, glass, polypropylene, wood (these four being the most common), acrylic, akwara, alumina, carbon, cellulose, coconut, kevlar, nylon, perlon, polyethylene, rock wool, and sisal.<sup>25</sup> Combinations of fibers are currently undergoing research in order to get properties closely matching those of asbestos. Several companies manufacture products that replicate asbestos-cement roofing and siding shingles, flat sheets, and corrugated sheets. Some of these manufacturers include: Supradur Manufacturing Company, Cement Board Fabricators, U.S. Architectural Products, Inc., Re-Con Building Products, and GAF Materials Corp. The fiber-cement products replicate the size, shape, thickness, and structure, along with texture and color of many of the asbestos-cement products previously available. Where color matching is not found, an alternative is to replace in size and shape then paint over the entire structure for a uniform appearance (Figure 7). In addition, the hardware and the installation procedures for these products are similar to those for asbestos-cement products due to their similar characteristics and proportions.
