Rebekah Scott Hall

**Building Chronology
Exterior Conditions Assessment
Maintenance Recommendations**

**Agnes Scott College
Decatur, Georgia
September 2014**

Atlanta Preservation & Planning Services, LLC

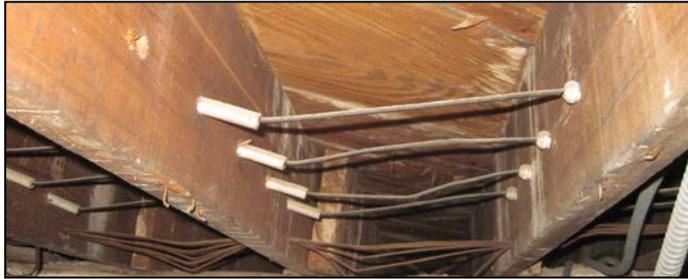
Remnants of the original knob-and-tube electrical wiring visible above the dormitory bathroom ceilings.

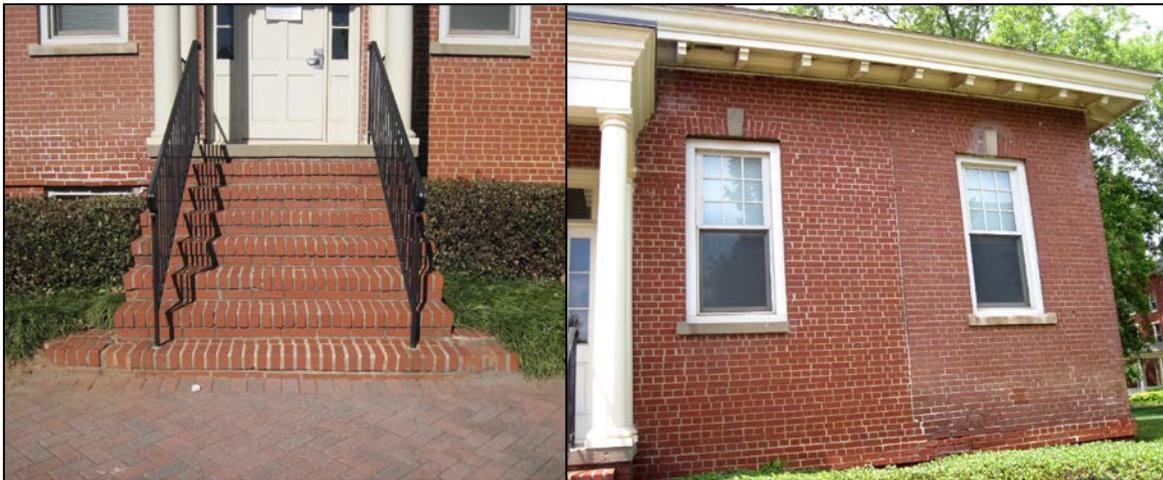
Left: The area where the stairs that today lead up to the first floor of the Annex originally led down to a door into the kitchen basement.

Right: The area just right of the columns is where the original door into the kitchen was located. The new window matches the original window (far right), except for the concrete keystone in the jack arch above the window, and the sill beneath the window. The original windows used limestone for both of these architectural features.

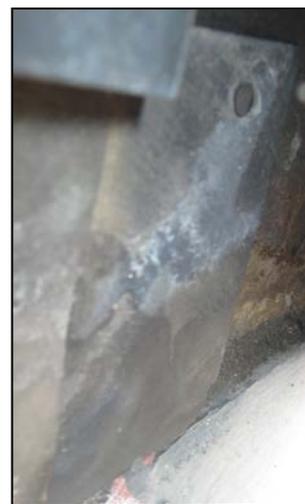
Slate tiles beneath the south cupola flashing.

The investigation did reveal the presence of slate roofing tiles on the side of the south cupola beneath the fiberglass shingles (see photo at right). The 1911 Sanborn Fire Insurance map indicates that Rebekah originally had either a tin or slate roof, while historic photographs confirm that it was slate (see photo on next page).

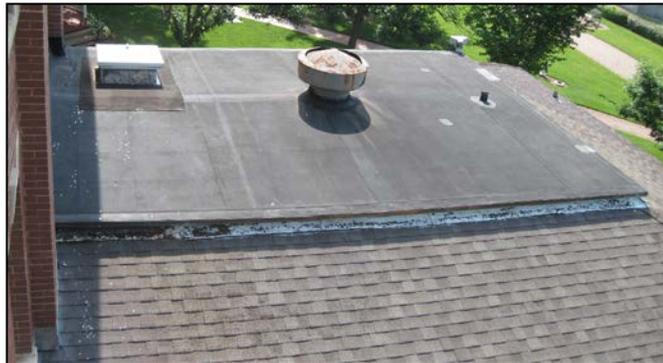
The Annex has a mansard roof (see photo at right). The bottom slope, with a steep 6/12 pitch, originally had slate tile roofing, but now has composition asphalt-fiberglass shingles. The top slope of the mansard is currently covered with rolled EPDM⁴⁷ rubber roofing, which is necessary due to its very shallow pitch. It was probably originally roofed with a type of rolled asphalt roofing, which was in widespread use by the late 1800s in the United States. The present rubber roofing is worn and patched, and should be replaced. The shingles are in fair condition, and show signs of wear. Most disturbing is the flashing between the two roof sections. The metal, once painted white, has lost much of its paint, and the exposed metal beneath is rusted. The flashing needs to be replaced (see recommendations on next page).

Mansard roof on the Annex. Top section is worn and patched; shingles are worn; flashing is rusted.

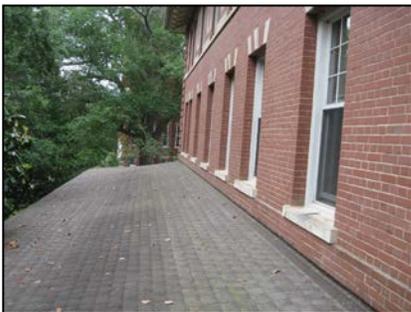
The roofing shingles on the porch and Colonnade are in good condition, and appear to be newer than the roofing on the main building. It is likely these shingles were replaced during the 1985-86 renovation.

Colonnade (right) and porch (left) roofing shingles are in good condition.

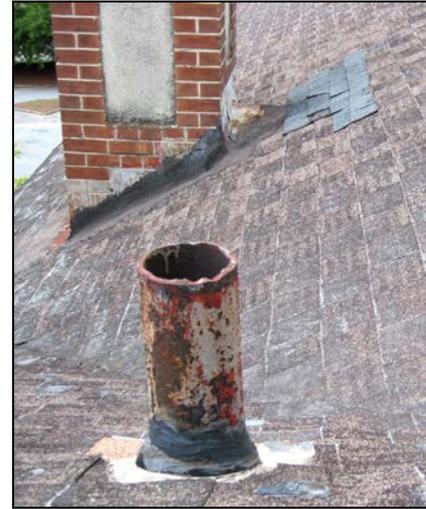
Rebekah has seven chimneys and two wood cupolas. While it was impossible to inspect them all, it was obvious that a number of them have extremely deteriorated flashing. Flashing is a key roofing component that directs the flow of water around the roof opening. In addition to the chimneys, there are hood vents, pipe stacks, and other roof fixtures also with deteriorated flashing (see photo at right and Annex roof photo on preceding page).

Deteriorated flashing on chimney and pipe stack.

All the roof penetrations need to have their flashing replaced (see more photos on pages 79, 82). The new flashing should include replacing the crickets on three chimneys: the two chimneys on the south ell, and the small chimney on the southwest side of the main building. Each of these chimneys is at the bottom of a roof slope, and their crickets deflect water from the opening in the roof at the chimney base. If composition or asphalt shingles are used to re-roof the building, they can be installed over the crickets. It is strongly recommended that a two-layer flashing be installed, with both step- and counter-flashing. Copper flashing lasts the longest and can be soldered for a watertight connection. However, it is the most expensive option, and aluminum or galvanized steel are acceptable alternatives. Plastic flashing, usually PVC-based, is less expensive than metal, but it can wear quickly in direct sunlight. Plastic flashing is not recommended for use on Rebekah. A high-quality urethane caulk should be used to seal seams. Flashing should be inspected once a year.⁴⁸

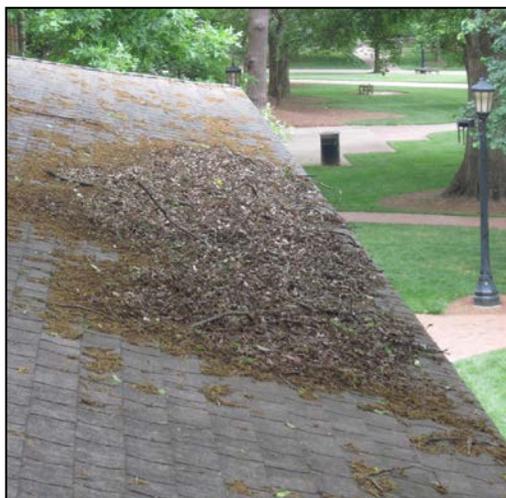
Leaves and branches on porch roof.

- Flashing at all the roof penetrations (such as cupolas, chimneys, pipe stacks, and hood vents) should be replaced.
- All limbs, leaves, and debris should be removed twice a year. These items accumulate particularly on low-slope roofs (see porch roof photo at right). They trap moisture and hold it against the roofing, accelerating the deterioration of any roofing material that is installed.

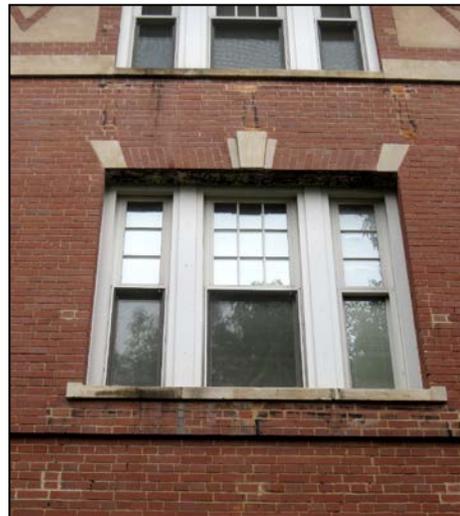
All the brick needs to be cleaned. The dirt comes from a variety of sources: splashback from the soil, wind- and rain-born debris, excessive moisture, poor drainage, and mortar loss. Human intervention has caused some of the problems, such as the “ghost” marks left behind when the fire escapes were removed from both the west and east facades (see photo at right). The structures were removed, but their black marks on the facades remain on the limestone window sills as well as the brick. While most dirt is not damaging, it is unsightly, and should be removed. The appropriate ways to clean masonry are discussed below; see also Appendix G for a technical brief on cleaning historic masonry.

Black marks left when west fire escape was removed.

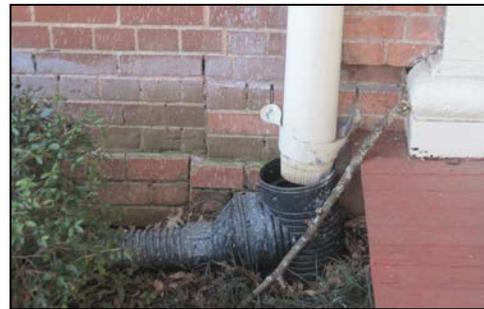
1. By the downspout on the east side of the building, immediately south of the porch (see photo #1). The deterioration in this area is due to excessive moisture caused by the open downspout connection, as well as the encroaching shrubs and the porch overhang—two features which keep the area shaded and damp. The result is loss of mortar and efflorescence from the bricks (see discussion on efflorescence below).

1. East façade by south porch; bricks showing mortar loss.

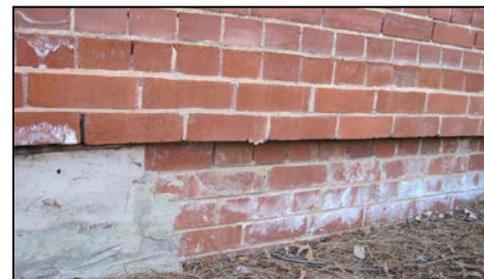
2. Along the east foundation of the south ell (see photo #2). The plastering of modern concrete over the bricks to cover some unseen problem is an egregious repair—unsightly as well as damaging to the surrounding brick. The area above it shows mortar loss, and to the right is efflorescence caused by rising damp.

2. East façade foundation with multiple brick problems.

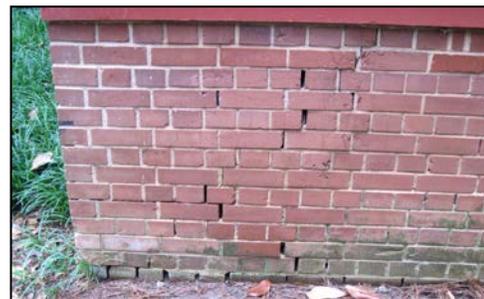
3. Along the north and northeast sections of the porch foundation. There are many areas where mortar loss is so extreme that dark voids between the bricks are visible (see photo #3). These problems do not occur on the west end of the porch, or on the south sections of the porch foundation because these areas receive direct sunlight and are not heavily shaded by trees. On the north and northeast sections, however, there is less sunlight due to the many large trees that overshadow the north facades of Rebekah and the Colonnade. The lack of proper drainage from the porch roof, coupled with the dense shade, serves to keep the north porch in a state of nearly continuous damp, a

3. Northeast porch foundation with loss of mortar, efflorescence, and dirt.

condition exacerbated by the lack of proper ventilation for the porch foundation. It is no surprise that the brick in this area shows mortar loss, efflorescence, microbial growth of various types (including mildew), and dirt accumulation. An additional problem caused by this continuously damp microclimate is the mildew on the ceiling of the north porch. This issue will be discussed in the section on the Porch below.

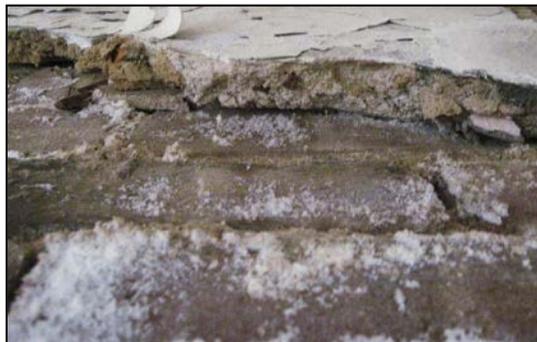
Efflorescence is the deposit of soluble salts on the surface of bricks, forming a whitish film, which is unattractive but basically harmless (see photo above right). It is, however, a sign that the area is continuously damp. **Subflorescence** is when soluble salts are deposited below the surface of a brick. Again, when the water evaporates, the salt crystallizes, but inside the brick. Salt that is crystallized is larger than when it is in solution. The large salt crystals put pressure on the brick from the inside, causing the outer surface of the brick to delaminate—a process known as **spalling** (see photo below right).

Interior east wall of the Annex. Note the salt crystals deposited on the surface of the bricks. This is an extremely wet area, and much of the plaster has already fallen off the brick wall.

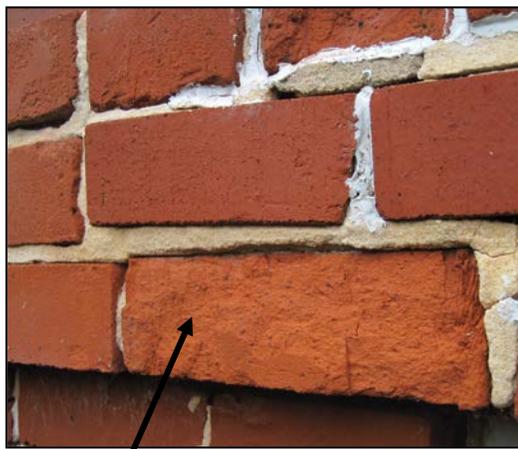
A spalled brick on the south façade of the Annex. Note other bricks, especially at the top, which are beginning to delaminate. Spalling was caused by inappropriate mortar repairs.

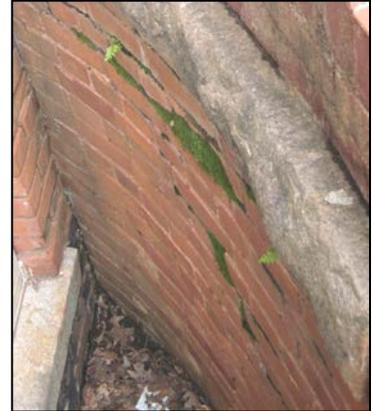
1. **Moss** (see photo #1) is a type of plant of which there are thousands of species. Moss requires a very damp environment to thrive and, like all plants, sunlight to conduct photosynthesis. Moss growing on the surface of brick or wood is an indicator of an accumulation of soil. Moss, therefore, signals a dirty and wet environment. The moss itself will also hold water against the surface of the building material, compounding the problem. It should be removed (typically an easy task), and the sources of the damp conditions eliminated; otherwise, it will regrow quickly. Moss can be removed with water and baking soda or vinegar. Certain kinds of soap and borax are also recommended.

1. Moss growing in the brick of one of the Annex's basement window wells.

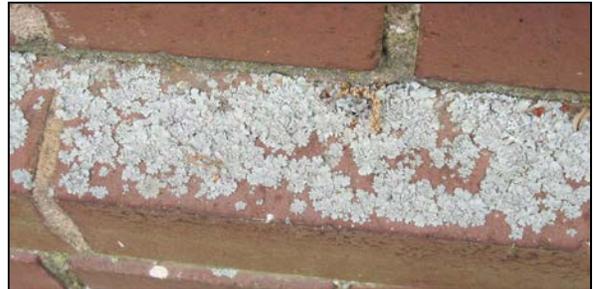
2. **Lichens** (see photo #2) are a combination plant and fungus that live in symbiosis, and can thrive in extreme environments. Unlike moss, they have a root-like structure which enables them to adhere tightly to surfaces, as they can extend their rhizines into small, shallow cracks and fissures. These "roots" make lichens extremely difficult to remove, and, when they are dislodged from a surface, often part of that surface comes off with them. This can happen on brick, wood, roofing, and painted surfaces. Removal of lichens is difficult, and can be more harmful to the surface of the building material than just leaving them in place. A biocide is the only chemical way to eradicate lichens completely, but is toxic to the environment, many building materials, and the human operator. Physical removal seldom extracts the lichens entirely, and usually peels off building surfaces with it.

2. Lichens growing on top of the brick shelf above the porch roof.

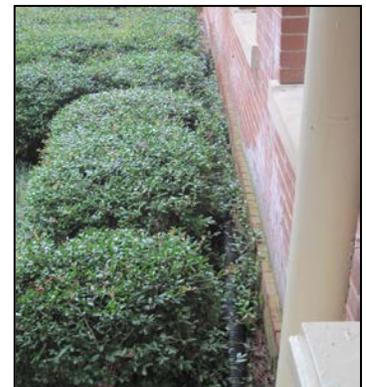
3. **Trees, shrubbery, climbing plants and vines** which come in contact with a building can be harmful. A plant growing on or against a building's surface attracts and holds moisture (see photo #3). The roots can damage the surface on which it is growing. Plants also provide access

3. Shrubs crowd the east foundation.

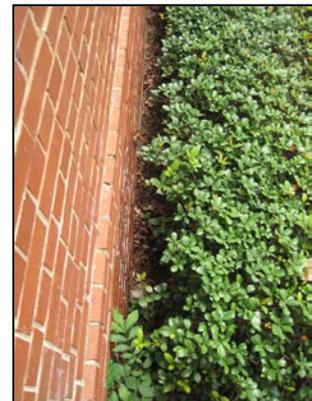
- This south ell has no gutters, downspouts, or splashblocks to direct stormwater away from the building’s foundation. Rain flows over the eaves and drops down onto the ground or onto the brick edges of the window wells (see the Drainage section below).
- The building has very dense shrubbery at the perimeter of its south foundation (see photo at right). The closely-packed bushes are difficult to walk through, and are very close to the building’s surface. The plants create shaded areas that retain moisture.

Dense shrubbery crowds the Annex’s south foundation.

- The combination of rain water pooling near the foundation (because there are no gutters) AND the dense shrubs growing at the foundation absolutely guarantees that these areas stay moist much of the time. This one-two punch is delivering a knock-out blow to the historic brick on the south Annex.

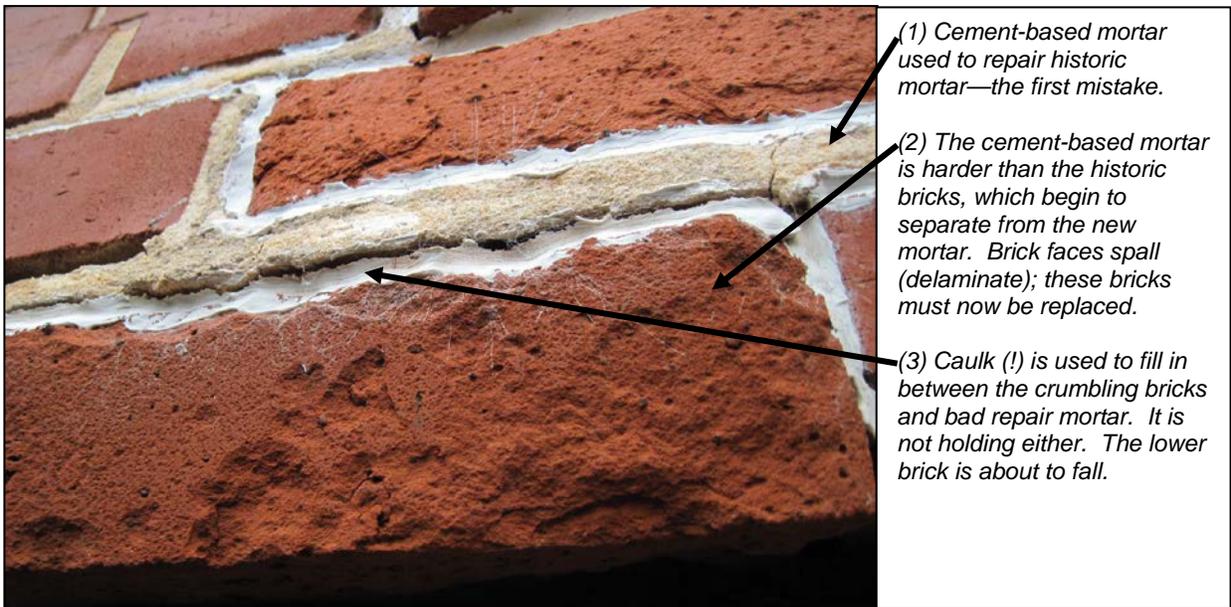
Original mortar failed due to continuously moist environment caused by lack of gutters and dense shrubbery. Incorrect repairs made with cement-based mortar. Use of caulk to "repair the repairs."

The result of these unmitigated issues (moist environment and improper repairs) is the ruinous condition of the wall, which continues to crumble. Historic mortar has been lost. Some historic bricks are so deteriorated they must be replaced (see photo below and photos on the following page), and others have been displaced or soon will be. It is imperative first that the moist microclimate be eliminated. When that has been achieved, then correct repairs must be made, using custom mortar and bricks to make the repairs.

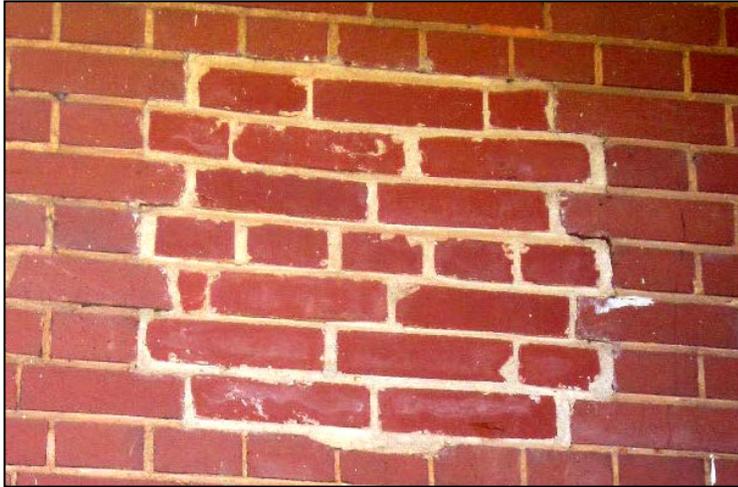
Not only does the mortar not match in color, composition, or texture, but the mortar joints are sloppy, of irregular sizes, and are simply finished flush with the brick without any attempt at a matching joint profile. The bricks also do not match the originals.

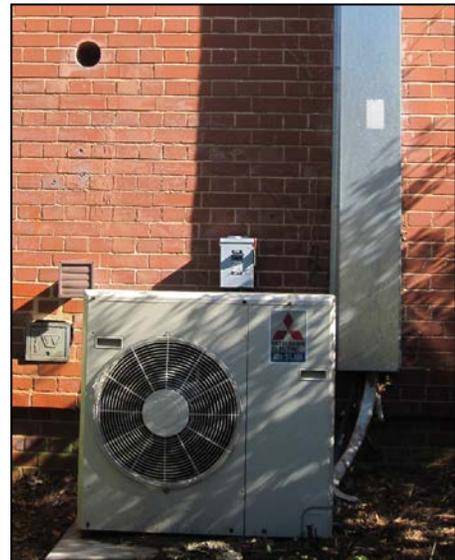
West façade. Note top left open hole through to the interior.

There are a number of places in Rebekah's brick facades where holes or openings have been made for various reasons. In the west façade near the air-cooled chiller is a hole core-drilled through the entire wall thickness that needs to be repaired (see photo at right). In the east foundation of the Annex is another opening that should be covered (see photo below). Venting for the clothes dryers on west façade (one is visible in photo at right) should to be done in a more sensitive manner; for example, the vent could be painted to match the brick.

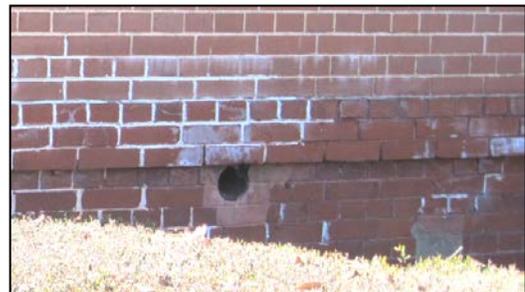
Opening in the east foundation of the Annex.

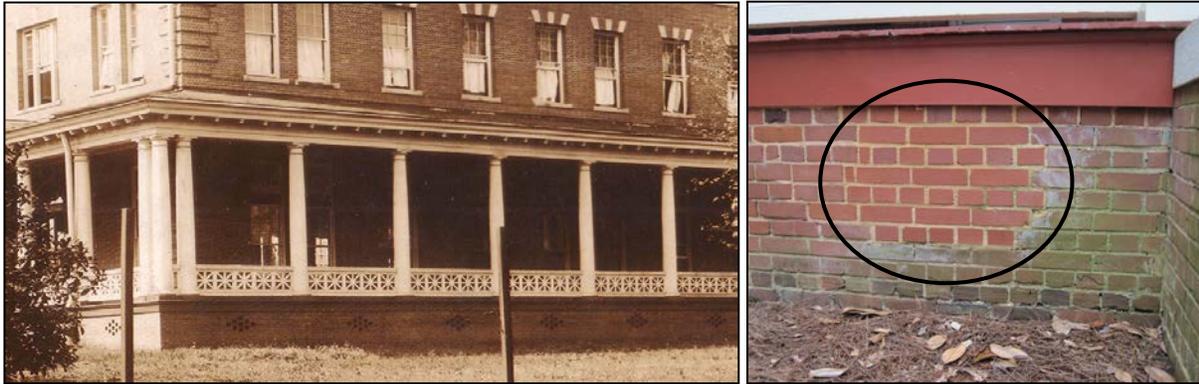
Historically the foundation walls of the porch were vented at each bay with a nine-hole diamond design in the brickwork (see top left photo on next page). As part of the 1985-86 renovation, the vent areas were filled in. Alternating bays were infilled with new bricks and mortar. While the English bond pattern was maintained during the infill and repairs, the brick color was not an exact match, nor did the

mortar match in color, composition, texture, or joint profile (see top right photo).

Left: section from pre-1926 photo of Rebekah. Note nine-hole diamond-shaped vents in foundation between each column.

Right: north porch foundation where a nine-hole diamond shaped vent was replaced with bricks and mortar that do not match the original.

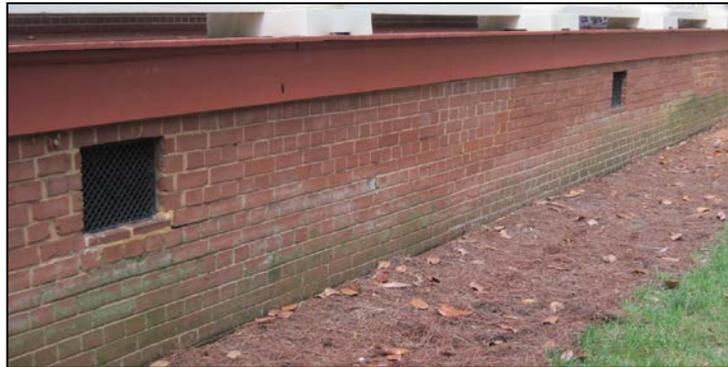
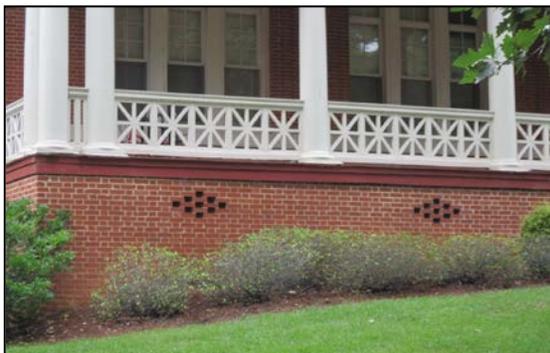
In place of the original vents, new rectangular metal mesh vents were installed in every other bay (see photo below right). The new vents are not providing adequate ventilation to the crawlspace under the porch. It is constantly damp, which is causing mildew and even rot on some of the wood structural members. It is recommended that vents be installed in every bay of the porch foundation, and a vapor barrier be placed on the ground in the porch crawlspace.

Metal mesh vents now installed in Rebekah's porch foundation between every other column.

The nine-hole diamond-shaped vents were left intact on Inman Hall, built in 1911. Why were Rebekah's removed?

8. Establish positive grade away from the perimeter of the building to ensure that stormwater drains away from the brick foundation and footers.
9. Install additional metal mesh vents in the porch foundation.

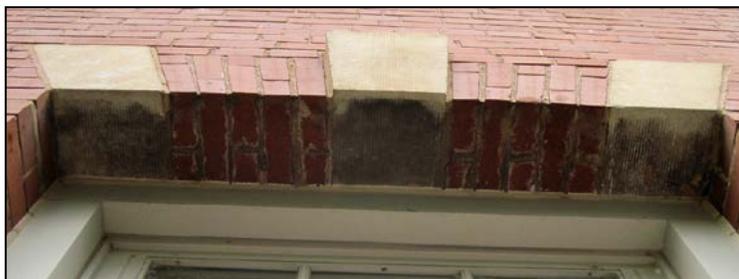
All of Rebekah's brick and limestone surfaces need to be cleaned (see Appendix G for a technical brief on cleaning historic masonry). Do not overlook the underside of the window lintels (see photo below). Water washing with low-pressure is the first recommended cleaning method for masonry. Start with a very low pressure of 100 psi,⁷¹ and increasing as needed, but generally no higher than 300-400 psi. Scrubbing with natural bristle or synthetic bristle brushes may be needed; however, metal bristle brushes should never be used as they can abrade the brick and mortar.

The undersides of the window lintels—both brick and limestone—need to be cleaned.

1. Clean all of the brick surfaces. See discussion above for the various conditions found on Rebekah's brick. Consideration should be given to leaving the lichens growing on brick shelves above the balcony. No water repellent should be applied, as this will accelerate deterioration of the historic brick. See Appendix G for a technical brief on cleaning and water-repellant treatments for historic masonry buildings.

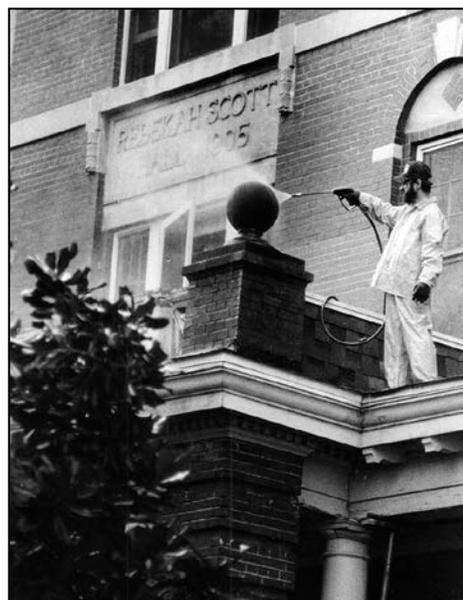
This investigator learned from various staff that many of ASC's building exteriors are cleaned by pressure-washing at very high psi. Investigators also personally observed damage to the stonework at the entrance to McClain Library caused by pressure-washing at a psi too high for the stones. It is strongly recommended that the College use only an operator experienced with historic building materials to perform any pressure-washing, and that all pressure-washing be done at a low pressure. If water alone does not clean the surface, then a non-ionic detergent should be utilized. Increasing the water pressure may clean the masonry, but can also irreparably damage it.

Pressure washing the balcony during the 1985-86 renovation of Rebekah.

2. Under no circumstances should moderate to high pressure-washing be used. Recommended pressure washing is 100 psi at a range of 3 to 12 inches. Any psi beyond those limits should be carefully tested first to ensure no damage occurs to the bricks or mortar. Any pressure-washing should be closely supervised. See Appendix G for a technical brief on cleaning and water-repellant treatments for historic masonry buildings.

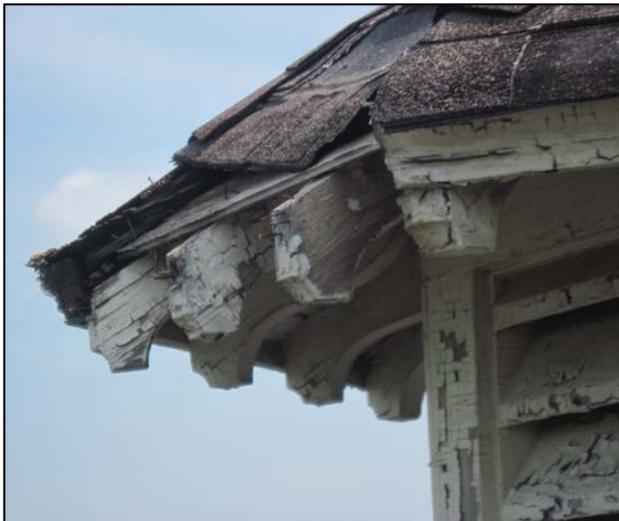
West eave of south cupola with missing shingles and cornice, deteriorating brackets, paint loss.

The south cupola's roof is in ruinous condition. The roofing shingles show the same wear and loss of granules as the main roof, and need to be replaced. At the southwest side, a section of the shingles is missing, and the bracket ends and exposed decking have lost paint and are rotting. Worse is the loss of a section of the molded cornice at the eave (see photo at left). The paint has completely failed, and exposed elements are beginning to rot.

range of colors; generally, the darker the rot, the more damage is occurring to the wood. White and brown rots were observed on Rebekah. The presence of rot indicates a damp environment, and often occurs on wood when paint has failed, as the paint protects the wood from moisture. The rotted sections need to be cut out, and replacement parts manufactured to match the existing cornice in wood type, size, and molding profile. All wood elements need to be repaired or replaced, sanded, primed, and re-painted. Missing shingles must be replaced. See sections below on wood repair/replacement and paint recommendations.

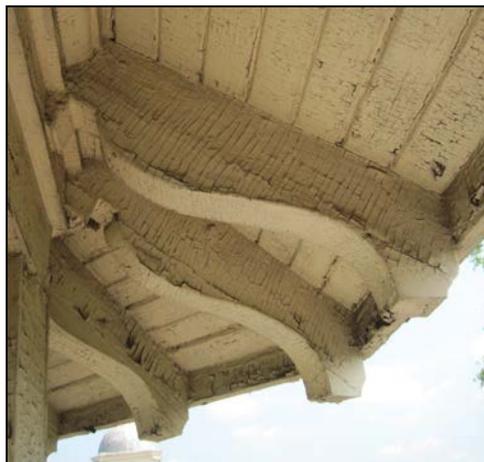
Brackets supporting the south cupola roof show alligatored paint.

Much of the paint on the south cupola is alligatored (see photo above right), a failure of the paint film where deep fissures form a relief pattern resembling the scales on a reptile. On some surfaces there is checking, which is less severe than alligatoring, but does represent a failure of the paint and the consequent loss of protection to the wood beneath. To solve both problems, the wood surface must be sanded, primed, and re-painted. Details on repair and painting of historic wood elements are discussed below. Also, a technical brief on exterior paint problems on historic woodwork is in Appendix I. Paint samples were taken from the south cupola and examined. The first paint layer was white. The cupola was then painted silver, and then back to white, as it is now. It is recommended that the south cupola be repainted the original yellowish white (see Appendices B and C for paint analysis reports and original color documentation).

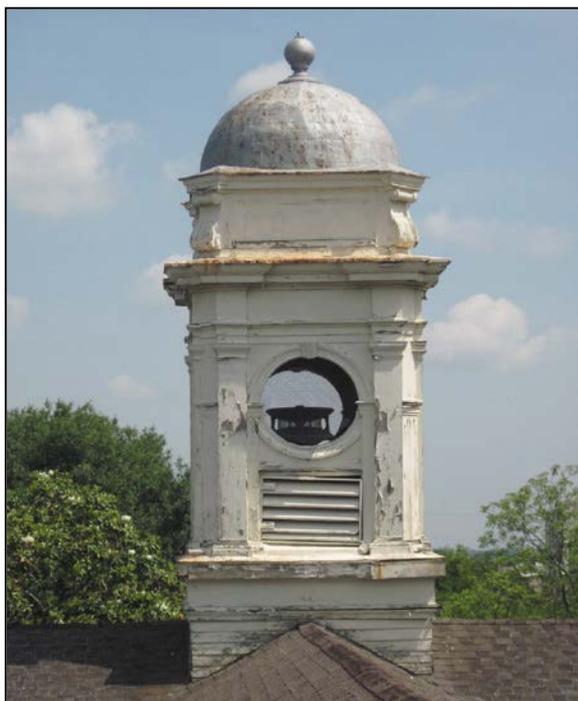
North cupola as viewed from the south.

through the windows. Access to the north cupola will be necessary to properly investigate its current conditions, and to make appropriate recommendations for much-needed repairs and maintenance.

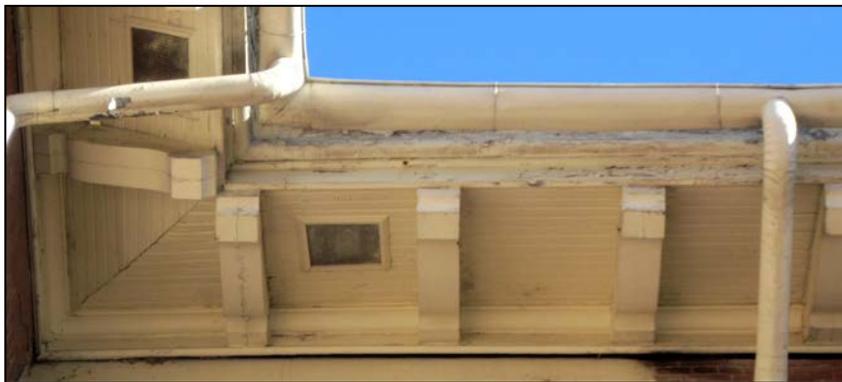
Like many of the wood elements on Rebekah's exterior, the cornice paint is in ruinous condition in places (see photo below). With the protective paint coating gone, sections of the cornice have rotted, and will need to be replaced. The areas with peeling, flaking, checking, or alligatored paint film must have all the deteriorated paint scraped, the underlying wood repaired or replaced as necessary, then sanded, primed, and re-painted.

Wood details at the west corner where the main building (left) adjoins the south ell (right). Note the deteriorated paint and damage to cornice and fascia.

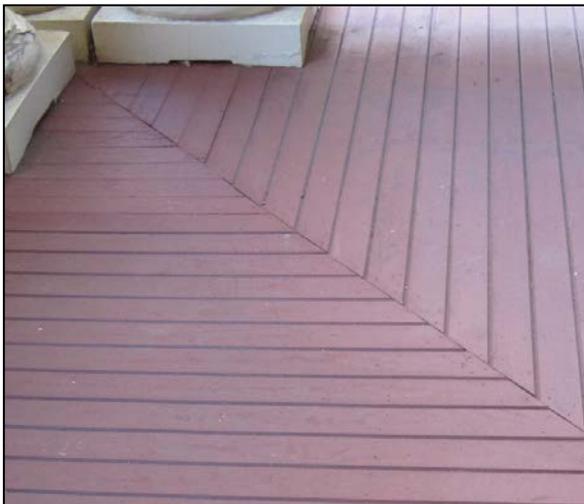
The historic flooring was tongue-and-groove laid north-south. The wood flooring and its underlying structural system were slated to be replaced in the 1985-86 renovation according to architectural drawings, but it apparently was not done. The present flooring is part 5" tongue-and-groove (perhaps original) interspersed with sections of 5" V-joint (see photos below). It is strongly recommended that any flooring replacements be 5" tongue-and-groove.

*At left: Replacement, 5" wide V-joint flooring.
Below: Historic (possibly original) 5" wide tongue-and-groove flooring.*

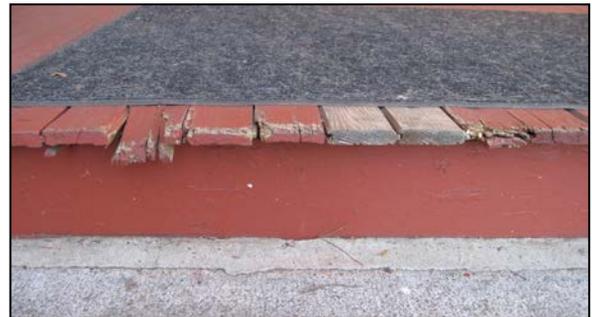
In general the flooring is in stable condition, although its paint needs to be maintained uniformly. Some sections are very damaged, especially at the exterior edges (see photo at right and photos on next page). These deteriorated floor boards will need to be replaced.

Deteriorated floor board ends at the step from the quad to the south porch—a high traffic area.

The major cause of deterioration of the porch flooring is its high moisture environment, the result of the absence of gutters for the porch roof (see section on Drainage below), and the presence of large trees overshadowing the front facade (see page 39 above). Installation of a gutter system and trimming back the trees is strongly recommended. Proper maintenance of the flooring, including regular painting, will extend the life of the porch. If the gutters are installed and the paint properly maintained, it will not be necessary to cap the board ends.

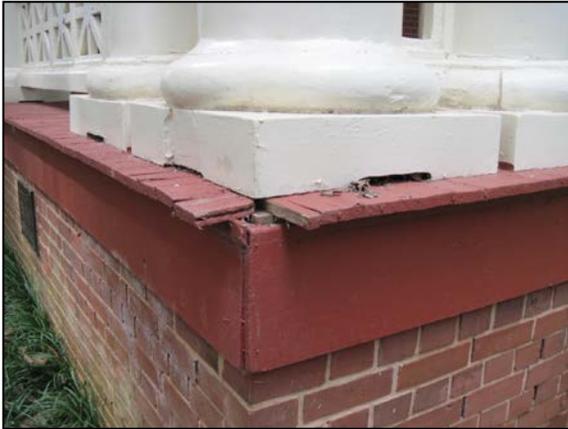
Northwest corner of the front porch has missing flooring edges, and missing trim sections from beneath the flooring.

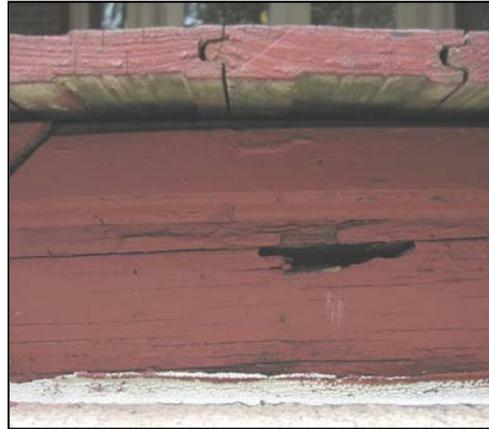
Trim piece under the flooring above the front steps is displaced. Fascia board above the front step has rotted and should be replaced.

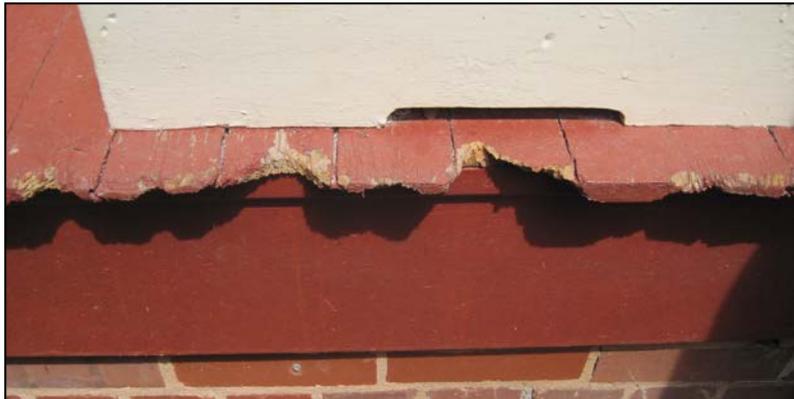
Animals have been gnawing at the edges of the floor boards on the porch's west end. These areas can be repaired rather than replaced as they are in an obscure area with no foot traffic.

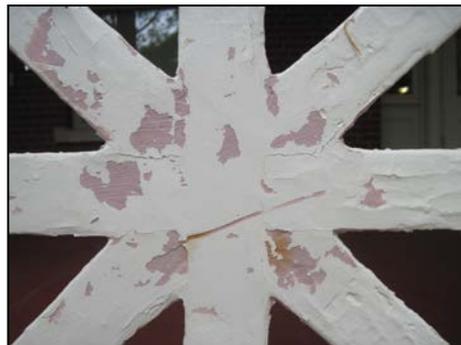
The balustrade is the original star-pattern with top and bottom molded rails (see photos on next page). It is in fair condition, although sections, especially on the north side which is in continuous shade, have deteriorated. Bondo® wood filler has been used to make some repairs; the repaired elements need to be re-painted (see photo at right). The balustrade has many layers of paint, which ideally should be removed completely. The deteriorated sections should be replaced in kind, and all the wood sanded, primed,

Bondo® repaired balustrade section needs to be re-painted.

and re-painted. See pages 56-60 for information on repair/replacement, cleaning, and painting historic woodwork, as well as lead-based paint.

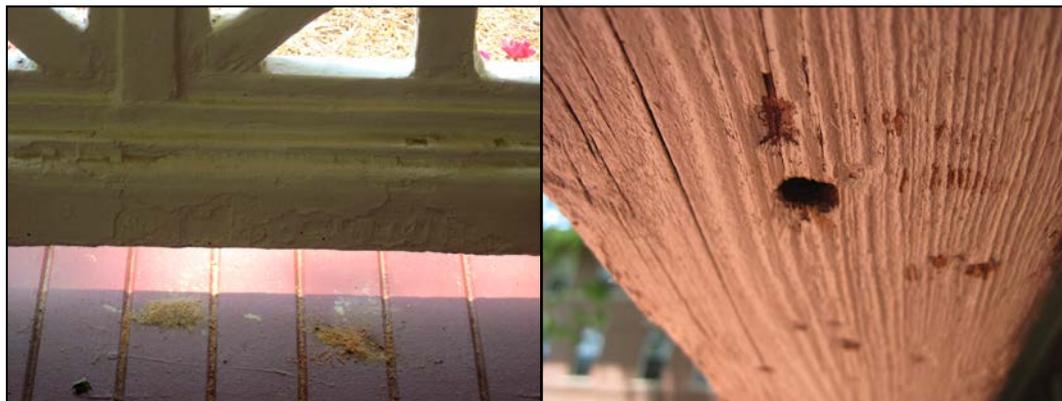
The underside of the bottom rail of the balustrade on the south side of the porch has been attacked by carpenter bees. There are multiple entrance holes to the tunnels, excavated into the unpainted section of the balustrade, where the bees have burrowed to build their nests and lay their eggs (photo below right). The piles of frass (sawdust) on the porch floor beneath the holes are a noticeable sign of infestation (photo below left). Carpenter bees are distinguished from bumble bees by several characteristics: they are generally larger, have shiny abdomens, and are less hairy. Bumble bees nest in the ground, while carpenter bees drill holes into wood surfaces. While male carpenter bees act aggressively towards people,

Left image shows frass on the porch floor beneath the area where carpenter bees have drilled holes. Right image shows one of the circular entrance holes on the underside of the bottom balustrade rail.

Carpenter bees are especially attracted to unfinished or untreated wood and weathered finished wood, which is why they are attacking the underside of the balustrade. To prevent the carpenter bees from drilling holes, the wood surface must be treated. The underside of the balustrade could be primed and painted, which will provide protection against the bees.

Rebekah's carpenter bee nests occur only on the south porch, which is airy and gets plenty of sunlight—an attractive environment for the bees. There are no carpenter bee nests on the front (north) porch, which is continually damp and heavily shaded.

Treat carpenter bee nests with dust insecticide that can be sprayed into the drill holes, then cork the holes so the larvae will be killed. Drione® is a dust which works as a desiccant on insects. It is an organic pyrethrin, and is safe to mammals when properly applied. It will last a minimum of six months when placed in the voids. Carbaryl (Sevin™) is another dust insecticide that is effective, yet also toxic to humans, is outlawed in several countries, and not recommended for use on Rebekah.

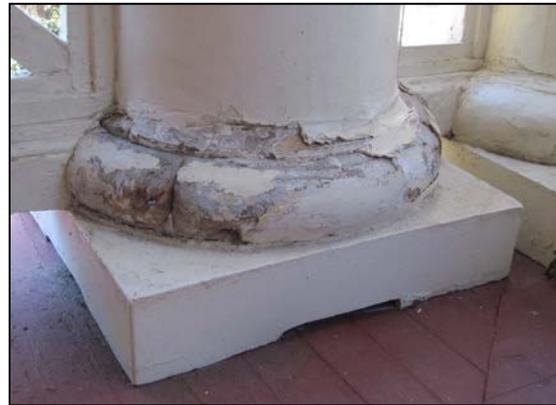
Deteriorated column at porch's northwest corner.

The 12'-tall Tuscan⁹⁰ columns that support the porch roof are in good condition, with some exceptions. One column on the northwest side has cracked wood and peeling paint at its base (photo above right), while another by the front stairs has been repaired with Bondo® (photo below right). All the columns need to have their paint properly maintained, and those with damaged wood sections should be repaired immediately before expensive replacements are required. Most of the columns need to be scraped and repainted.

- Repair deteriorated column elements. Remove paint to the next sound layer, then repaint.
- Address the carpenter bee problem on the south wing of the porch.

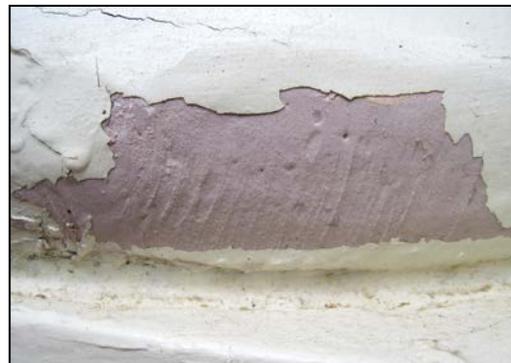
Close-up view of column by the front porch with Bondo® wood filler repair on the base. The paint has flaked off the repair, or was never applied.

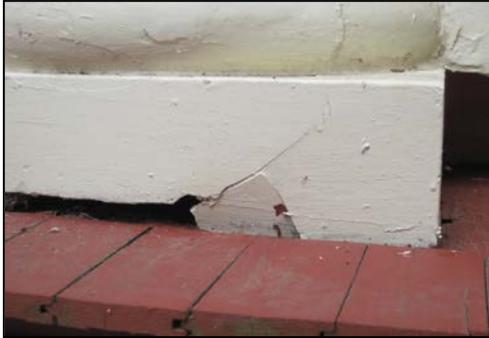
porch flooring (see photo top right). It is not known when the current plinths were installed, but it was likely during the 1985-86 renovation. They are the same size as the column bases, are probably made of PVC or fiberglass, and have been painted to match the columns (see photo below left). These are ventilator plinths and have openings at the base on all four sides so water can drain through. Some of the plinths are cracked or broken, and most are clogged with leaves and other trash. Damaged plinths should be repaired or replaced, and their openings should be cleared of debris.

Current ventilator plinth painted to match the column. Note crack and broken section.

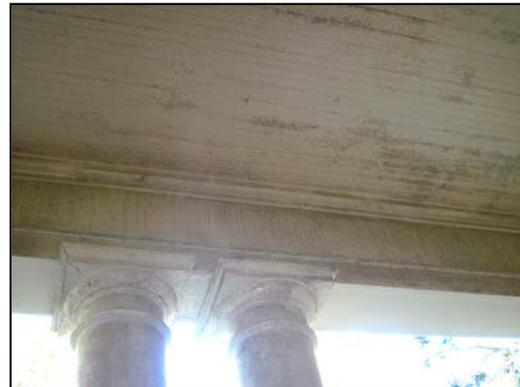
The beadboard ceiling has mildew because of the continuously moist environment (see photo at right). This damp microclimate is primarily a result of the large, overhanging trees which flank the front stairs and the southwest porch, creating the dark, humid conditions so detrimental to both the wood and brick building materials. An additional cause of the damp conditions is the fact that the porch has no gutter system. Rain water pools by the building foundation, and the dense shade ensures that it does not evaporate rapidly.

View of mildew on porch ceiling and entablature.

The ceiling should be cleaned, after which it should be evaluated to determine if it needs to be re-painted. See pages 58-60 for information on cleaning and painting historic woodwork.

- Paint the porch ceiling, if the post-cleaning inspection determines it is necessary.
- Missing trim pieces beneath floorboards must be replaced with matching trim, primed, and painted. Rotted fascia boards beneath the trim must be replaced, primed, and painted.

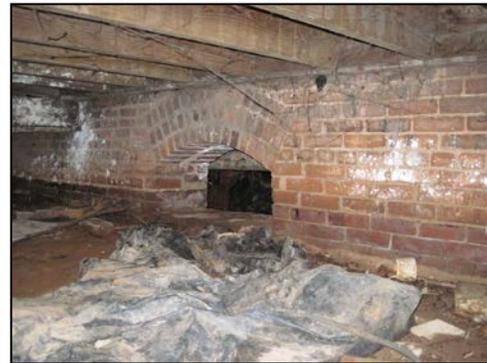
On Monday, May 19, 2014, Glenn Johnson, Project Manager of Jenkins•Peer Architects, went under the west side of the porch crawlspace. At the southwest corner of the crawlspace was a brick arch through the building’s foundation opening. It leads into the crawlspace under the main building (see photo at right). Water was discovered in the northwest corner of the main building crawlspace. Other team members, including this investigator, went under the porch crawlspace and observed the situation.

View from the west end of the porch crawlspace looking southeast toward the foundation arch leading to the main building crawlspace.

The source of leak was not detected, but the sound of running water could be clearly heard, as if a faucet was left on with water flowing out at rapid rate. “Leak” is too unsubstantial a term for the rate of water currently discharging beneath the building. The water and the very shallow height of the crawlspace made access difficult.

- ***Immediately*** locate the source of the running water in the northwest corner of the main building's crawlspace and ***shut it off***. Install fans to dry out the affected crawlspaces. Clean the rot off the wood elements in the crawlspaces (see Appendix I). Dry out both crawlspaces. Make repairs as necessary to crawlspace elements. Install plastic vapor barriers on the ground in both crawlspaces.

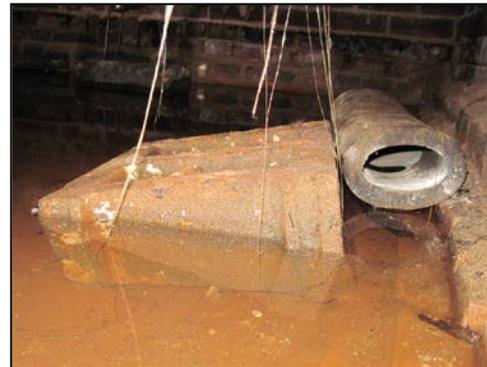
Water was accumulating to a depth of 3”-5” in the main building crawlspace. A cinder block was half-submerged in the flow (see photo at right). Mold was accumulating on many surfaces in the crawlspace and pipes were rusting (see top photo on next page).

View of the water in the crawlspace of the main building. Cinder block is partially submerged.

The water was been running for over two months. How long it had been running before it was discovered on May 19th is not known. However, Bill Dean of Newcomb and Boyd, at the January 2014 presentation, reported that Rebekah used more water than any other dormitory on campus. Perhaps the present unrestrained outflow is a contributing factor.

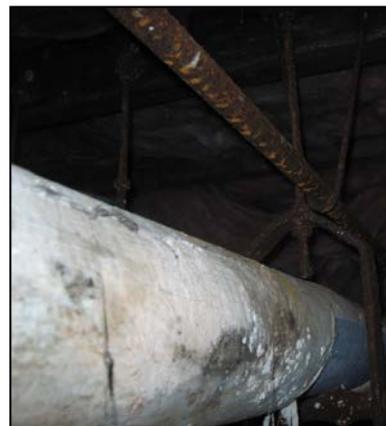
The moisture from the main building's crawlspace has penetrated the porch crawlspace. All of the wood elements near the arched opening are seriously affected by white rot (see photos below), including the porch floor boards, the floor joists, and the wood porch piers. The water outflow will also cause erosion, settlement of the building, and masonry deterioration.

Mold and rust in the crawlspace—results of the extremely moist environment.

It is imperative for the structural integrity of the building and its below-floor systems that the source of this outflow be located and stopped. It will then be necessary to install fans to dry out the crawlspaces. Repair or replacement of pipes, ductwork, wood elements, or other systems located in the area may be necessary. It is strongly recommended that, once the crawlspace has been dried out, a plastic barrier be installed on the ground.

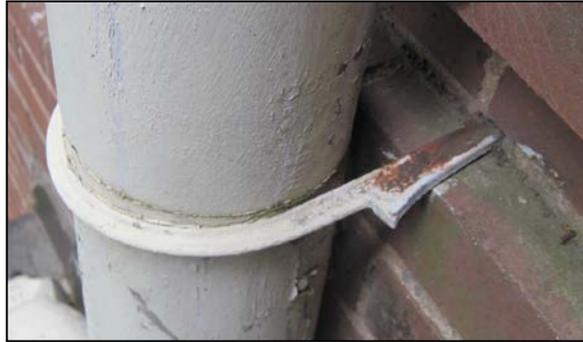
One of the few remaining historic downspout brackets, east façade above the porch.

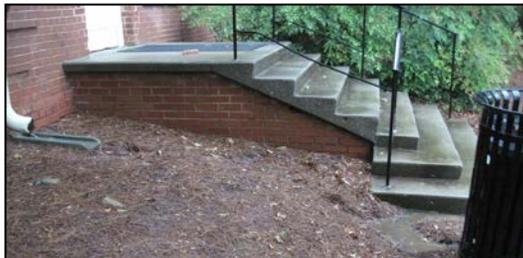
Southwest door to parking lot off north wing. Splashblock is correctly placed, but mulch still washes onto the sidewalk, and soil is eroding.

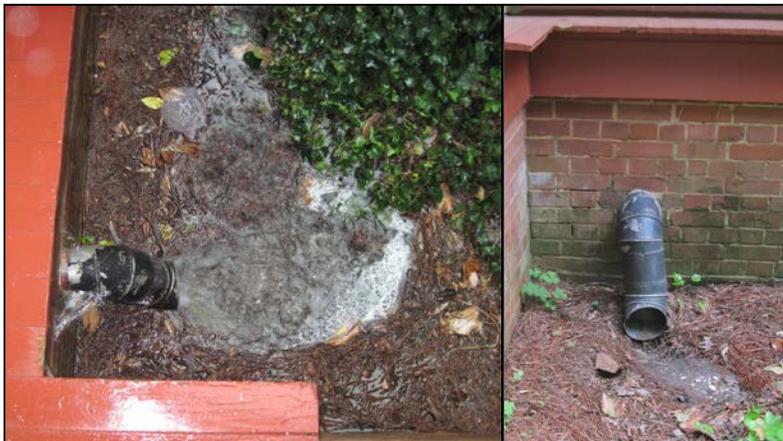
#2

There is one splashblock on the north side of the building (#1 below), but it is incorrectly placed and is totally ineffective when it rains. Most of the downspouts simply pour stormwater onto the ground where it pools by the foundations and erodes the soil (#2 below). On the west side, the downspout does not empty directly into the standpipe, so rainwater pools around the foundation (#3 below). The runoff from that same downspout and another one nearby is washing the mulch and the soil in the area (see #4 on next page).

West of the front stairs. Same downspout, two views, no splashblock. Left: during a rainstorm showing amount and force of water. Right: mulch and soil have washed away. Algae and mildew on bricks indicate constant dampness.

- Install splashblocks or downspout extenders beneath or connecting to every downspout (excluding those that lead into standpipes), and in such a way as to direct water away from the foundation of the building. Ideally, all downspouts would lead into a campus-wide water reclamation system.

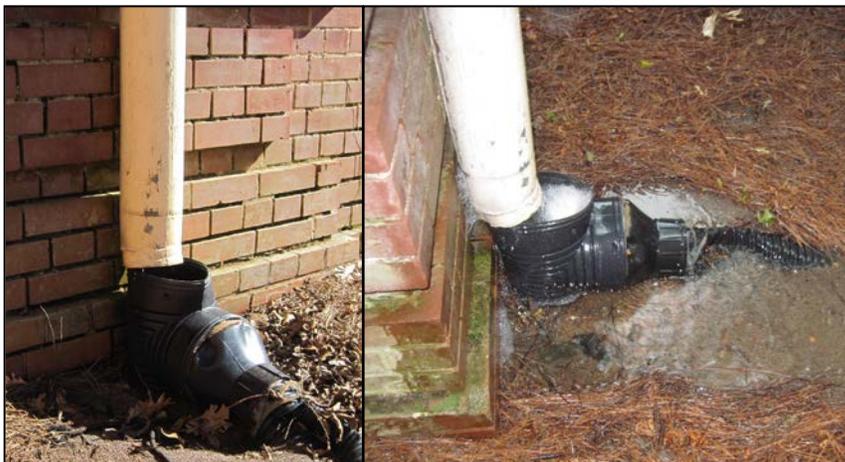
#3

Northwest corner of south ell. Same downspout, four views, unattached and crushed downspout extender. Left: downspout does not empty directly into the extender. Right: during a rainstorm, water pours over the extender, flooding the area.

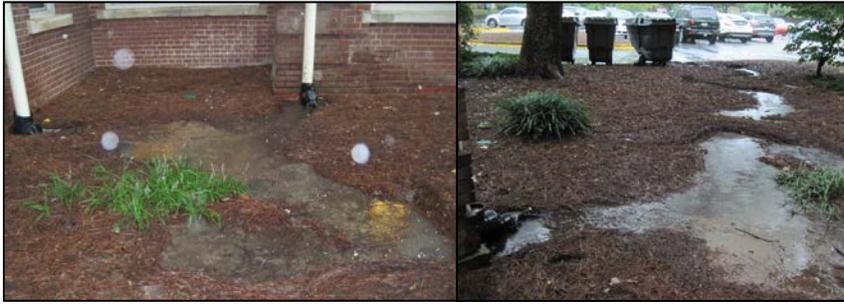
#4

Same area as #3 above during a rainstorm with water washing away soil and mulch. Left: view looking northeast. Right: view looking south-west to the parking lot.

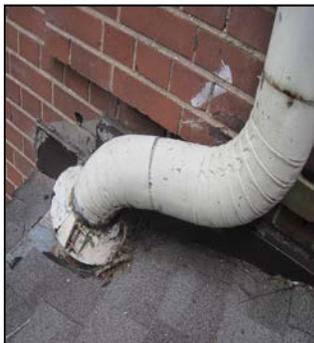
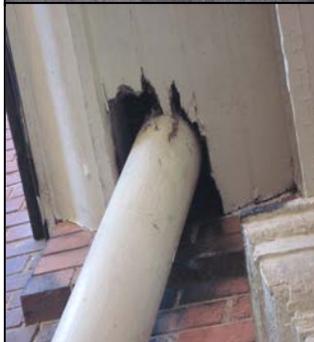
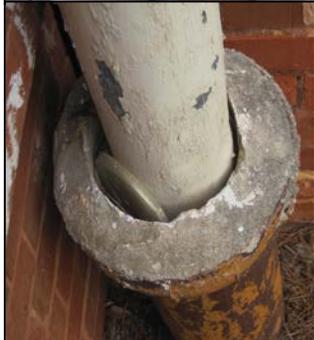
Deteriorating downspout at east junction of south porch and south ell. Top: above the porch roof, flashing needs to be replaced. Middle: below the porch roof, decaying soffit, black on brick indicates heavy moisture. Bottom: entering a standpipe, coping needs to be replaced,

The series of photos at left indicate the systemic problems in one of the downspouts, this at the east junction of the south porch with the south ell. Above the porch roof, the flashing around the downspout leading from the main building is incorrectly installed (top image). Where the downspout emerges below the porch roof, the wood soffit is rotting. Note darkened bricks in this area as well (middle image). The lower image shows the blistered paint on the downspout and the deteriorated concrete coping on the standpipe. A downspout replacement is recommended, in addition to new flashing, repair of the soffit and coping, and removal of the trash from the standpipe.

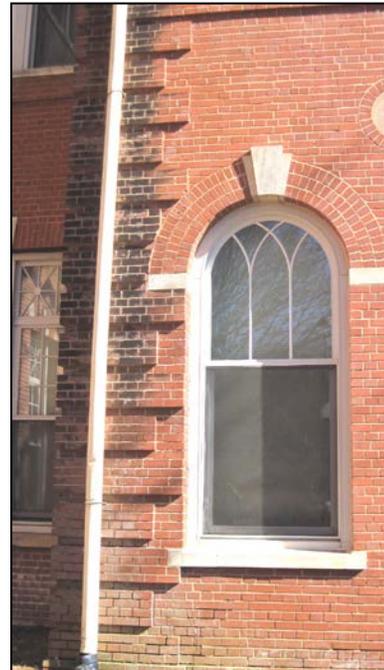
Downspout view at northwest corner of the south ell (same as #3 & #4 above). The blackened bricks indicate excessive moisture.
