Rebekah Scott Hall

**Building Chronology
Exterior Conditions Assessment
Maintenance Recommendations**

**Agnes Scott College
Decatur, Georgia
September 2014**

Atlanta Preservation & Planning Services, LLC

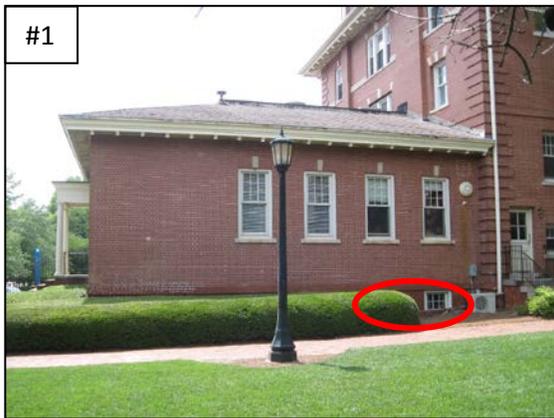
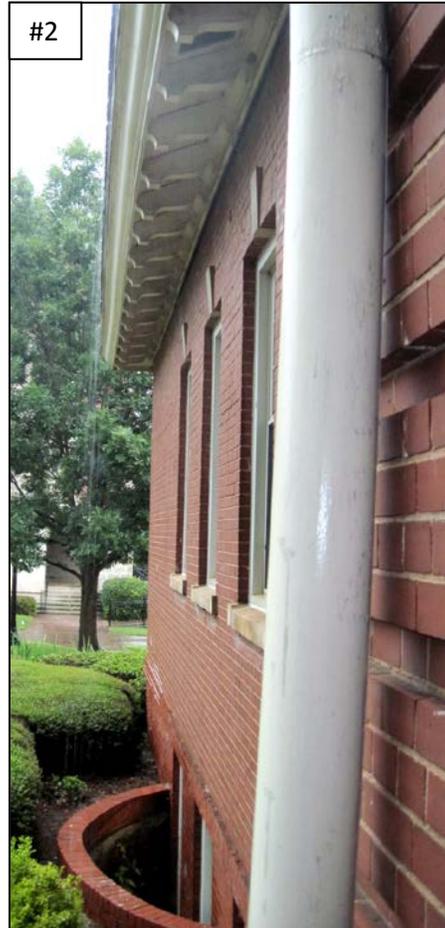
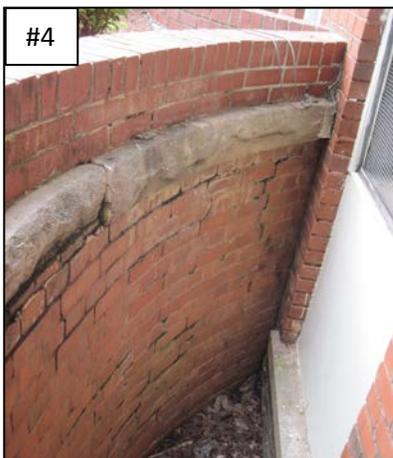
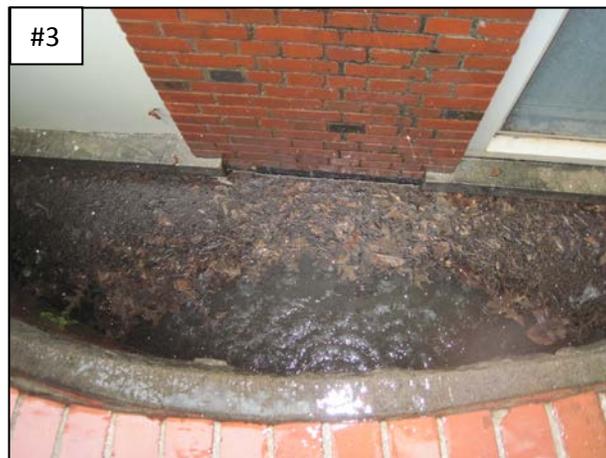
The deterioration of the brick caused by the wet conditions from the stormwater runoff on the Annex south well has been well documented on pages 43-45. The lack of gutters also allows stormwater to fall onto the bricks edging the below-grade window wells, causing water to collect in the wells. The series of photos below were all taken near the north window well on the east side of the Annex (see circled area in #1). Photo #2 (top right) was taken during a storm, and it shows rain running off the roof onto the window well bricks. Photo #3 (lower right) shows the water collecting inside that window well, moments after the photo #2 was taken.

Photo #4 (lower left) shows the interior of the same window well, but on a dry day. The granite layer at ground level serves as a damp course. Bricks, mortar, and the granite show signs of deterioration from the moisture-laden conditions. Once again, the lack of a gutter system to remove stormwater from the roof and direct it away from the building has caused more problems for the historic structural brick walls.

- This recommendation has the highest priority: install gutters, downspouts, and splashblocks or downspout extenders on the entire porch and Annex. Ideally, downspout extenders would lead into a campus-wide water reclamation system. If that is not possible, then extenders or splashblocks should be placed so they direct water away from the building's foundation.

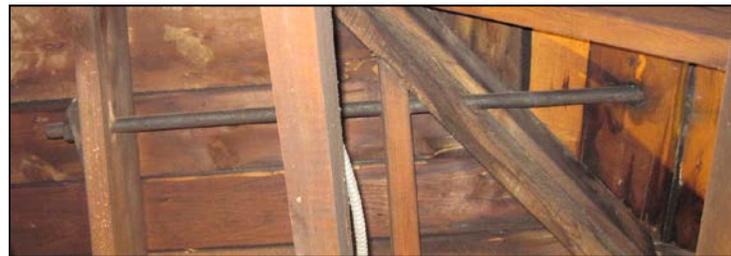
Due to the limited roof access, the only chimney scrutinized closely was the west chimney on the south ell (see top photo preceding page). That chimney has two flues, indicating it connected originally to two fireplaces (neither of which has been located inside the south ell, and have probably been filled in). The chimney is lined with brick on the interior, and the crown is completely open, with no cap or covering of any kind. Like the east chimney on the south ell, there is an iron brace on the north side of the chimney. The braces on the two south ell chimneys are not original, and do not show up in historic photographs until 1935. The iron braces, which extend into the interior of the attic and are bolted to rafters, provide support (see middle photo above).

View of the iron brace supporting the south ell's east chimney coming through the roof and bolted to a rafter.

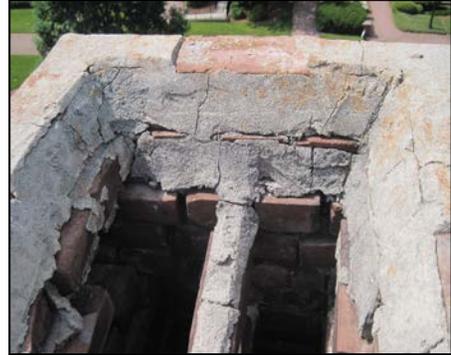
The crown of the chimney is extremely deteriorated, and in some places completely missing, coping (see top photo at right). Coping, sometimes called a wall cap, is a layer of impervious stone or mortar laid on the top of a brick wall or, in this case, on the brick sides of the chimneys. It serves to protect the brick from water intrusion, which can quickly deteriorate the bricks and mortar, compromising the structural integrity of the wall or chimney. In this instance, the coping is cracked and missing in places.

Interior of the west chimney on the south ell showing two flues and deteriorated coping. Note complete lack of covering on the chimney top.

Loose bricks were visible on the crown and inside the chimney flues (see photo middle right). The bricks should be repositioned and securely attached. It is absolutely imperative that the coping be renewed so that it completely covers the exposed tops of the chimneys. Without this repair, the chimneys will become structurally unstable.

- Remove deteriorated coping and replace with custom stucco such as was used on the chimney walls (see Appendices D and E for cement stucco analysis).
- Flashing around all the chimneys needs to be replaced. See page 28 for recommendations on materials and methods.

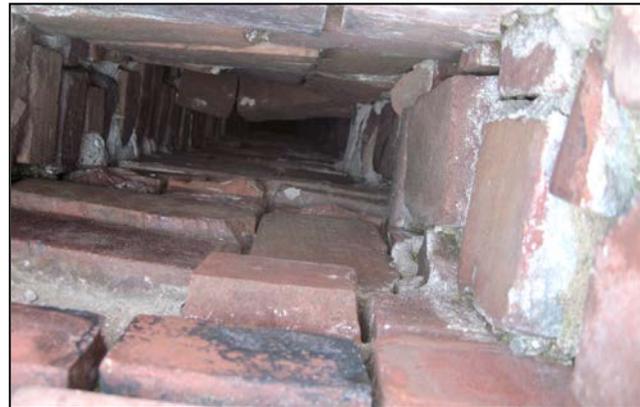
View down the west flue of the west chimney on the south ell. Note mortar loss and loosened bricks resulting from complete exposure to the weather.

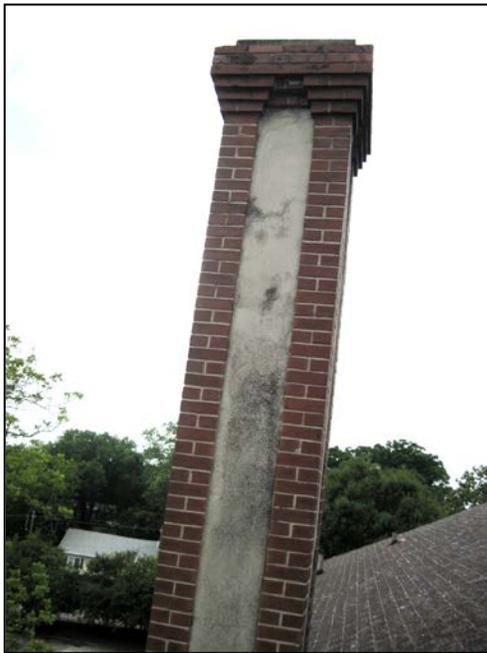
All the chimneys need to be cleaned (see photos below). The appropriate way to clean masonry is discussed on page 49 and in Appendix G. All chimneys need to have their flashing replaced (see photo at right, also photo on page 79). See page 28 for a discussion of appropriate flashing materials and methods.

Chimney for the parlor fireplace. Note dirty condition of the brick and concrete stucco.

- All chimneys need to be cleaned appropriately (see Appendix G). It is recommended that the chimneys be cleaned prior to undertaking any repairs, and certainly before the installation of new flashing and roofing.

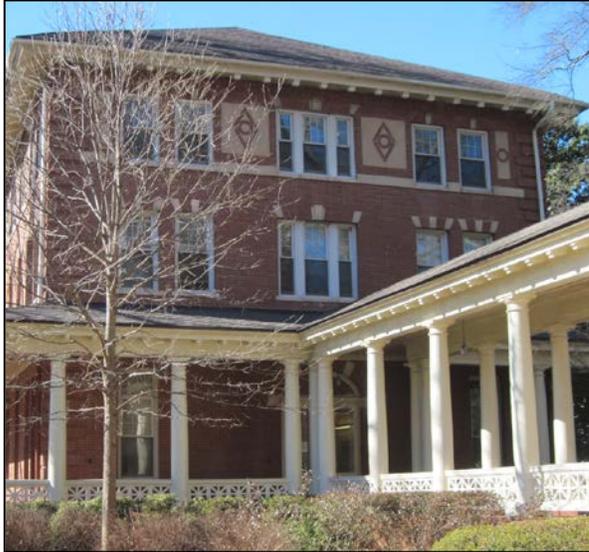
View of the east end of the main building. The central windows in the east and west wings have been altered. At one time they were doors leading onto the fire escapes.

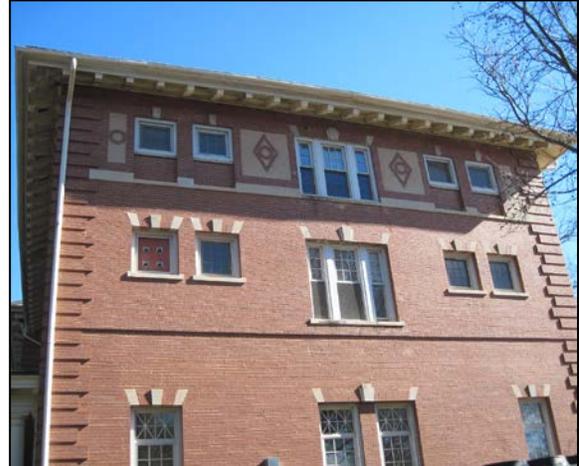
The west façade of the main building. The windows on the top floor and both upstairs central windows have been altered. The small, 9-light casement windows on the second floor do not appear to have been changed, except the insertion of dryer vents in the far left window. The first floor windows match those on the porch, except the jack arches have limestone keystones and voussoirs.

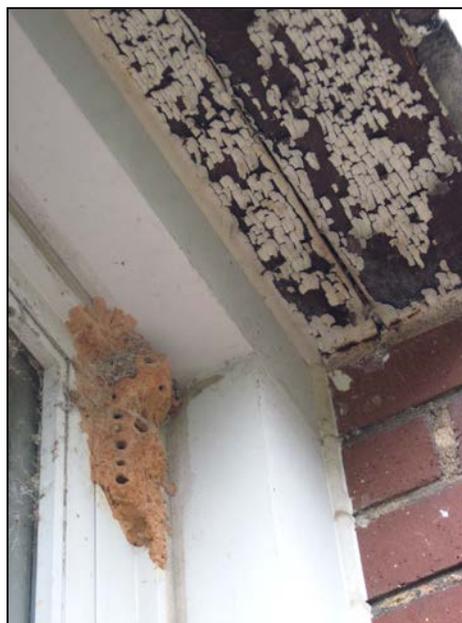
Second floor window with steel lintel. Paint is badly deteriorated, and the steel is rusted. The mud dauber's nest should be removed.

- Retain functioning, double-hung windows (windows that open and shut). Do not install fixed sash windows
- The main problem is with the windows that have steel lintels (see photo at right). The paint on the lintels is peeling badly and the steel beneath has rusted. The lintels should be cleaned, and any loose paint removed. The steel needs to be primed and repainted.
- All of the windows need to be cleaned. Some of the brick arches, and the combination brick and limestone arches are very dirty. See page 49 and Appendix G for recommendations on cleaning masonry.
- Replace all exterior sealants around the window perimeters.

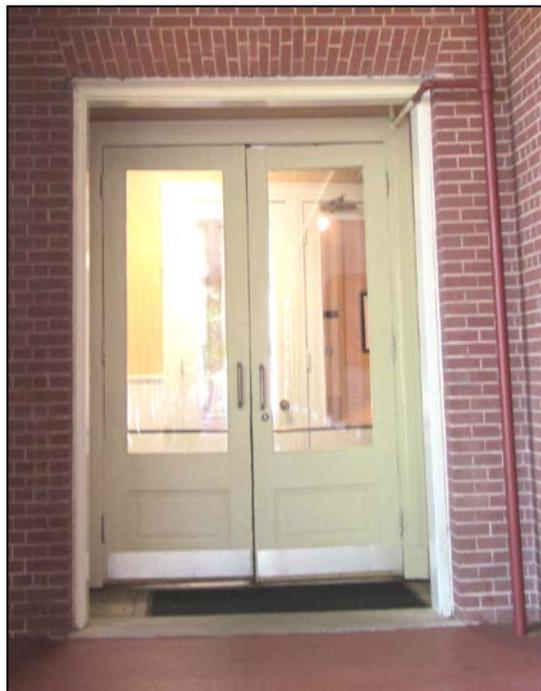
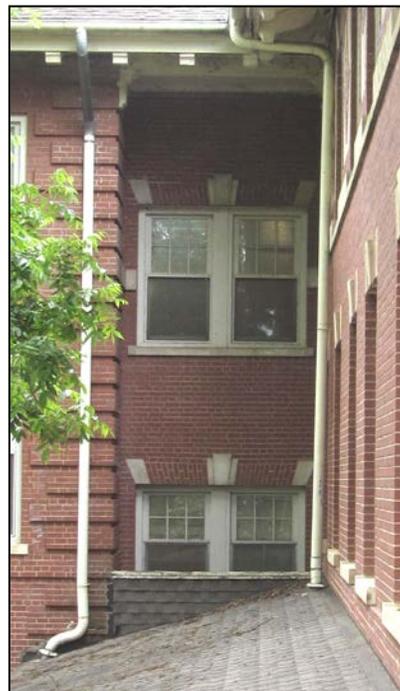
*Left: east door at the recessed junction of south ell with the main building. It leads from the south porch into the central stair enclosure.
Right: the short parapet behind which is a small balcony that forms the roof of the recess.*

The flooring of the balcony is actually rolled rubber roofing, showing that the structure also functions as a portico above the entrance. In any case, the roofing is worn, and the junctures with the walls have been inexpertly repaired. It is recommended that the roofing be replaced and correctly flashed. Finally, the top of the parapet is a wood rail, while the interior wall is wood V-board. The paint on these elements is in terrible condition. It should be scraped, sanded, primed, and painted.

Above entrance to these doors is a small balcony, which has a short parapet wall separating it from the porch (see right photo below). This balcony is accessible from either the porch roof or the double windows on the second floor of the central stair. As the balcony has not been rated for load-carrying capacity and the parapet wall does not meet code, it is recommended that the double windows be kept locked.

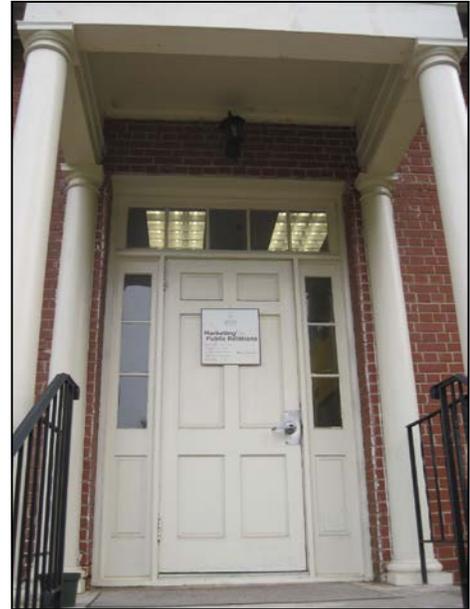
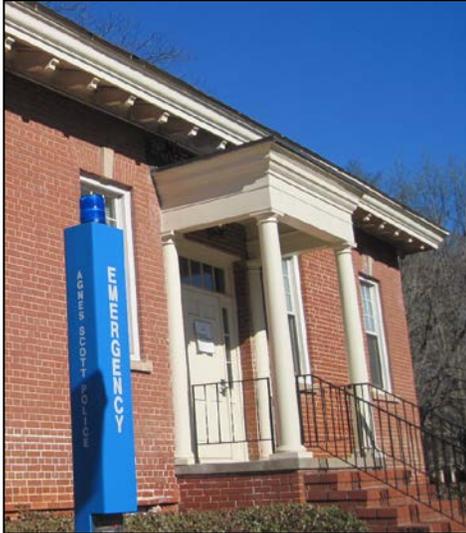
The portico roof above this door was not accessed during this study (photos below left). However, the lower photo shows repairs made with tar at the juncture of the portico roof with the brick façade. It is strongly recommended that the portico roof be inspected, and roofing and flashing be replaced or repaired as needed.

The south door of the Annex. This door opening was created during the 1959 renovation of the kitchen into offices. The two original south kitchen doors were removed and bricked over.

South portico roof views.

- The roof to the south Annex entrance should be inspected, with special attention to the wall juncture. Replace roofing and flashing as necessary.
- The roof above the recessed double door leading into the Lobby from the south portico is in poor condition. The rolled asphalt roofing should be replaced and new flashing installed. In addition, the wood elements of the parapet wall should be scraped, primed, and repainted.
- A corner of the granite stoop at the southeast door into the south ell is cracked and broken. It should be repaired.
- Re-attach loose bricks in the stairs leading to the south Annex door.
- All stairs need to be cleaned.
- All exterior sealants around the door openings should be replaced.

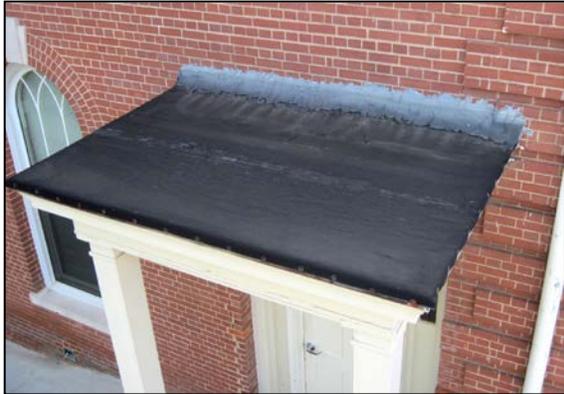
The roof of the portico above this door appears to be covered with rolled EPDM rubber roofing (see photo top left on next page). The roofing is in good condition, but the sealant between the roof and the brick façade is deteriorating. It is recommended that the existing sealant be removed, and new metal flashing be correctly installed.

Portico roof above the southwest door (with accessibility ramp).

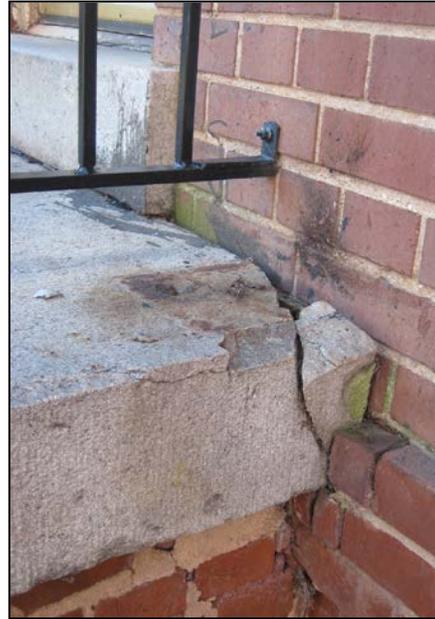
Original granite stoop at the southeast entrance to the south ell. The north corner is broken and is also cracked. It appears that an earlier handrail that attached into the granite had rusted and was removed.

The doors are in generally good condition as most are protected from the elements by porticos or the porch. One exception is the unprotected southeast door leading to the main quad (see photo on page 89). Its concrete stoop is cracked at one corner (see photo above right), and should be repaired.

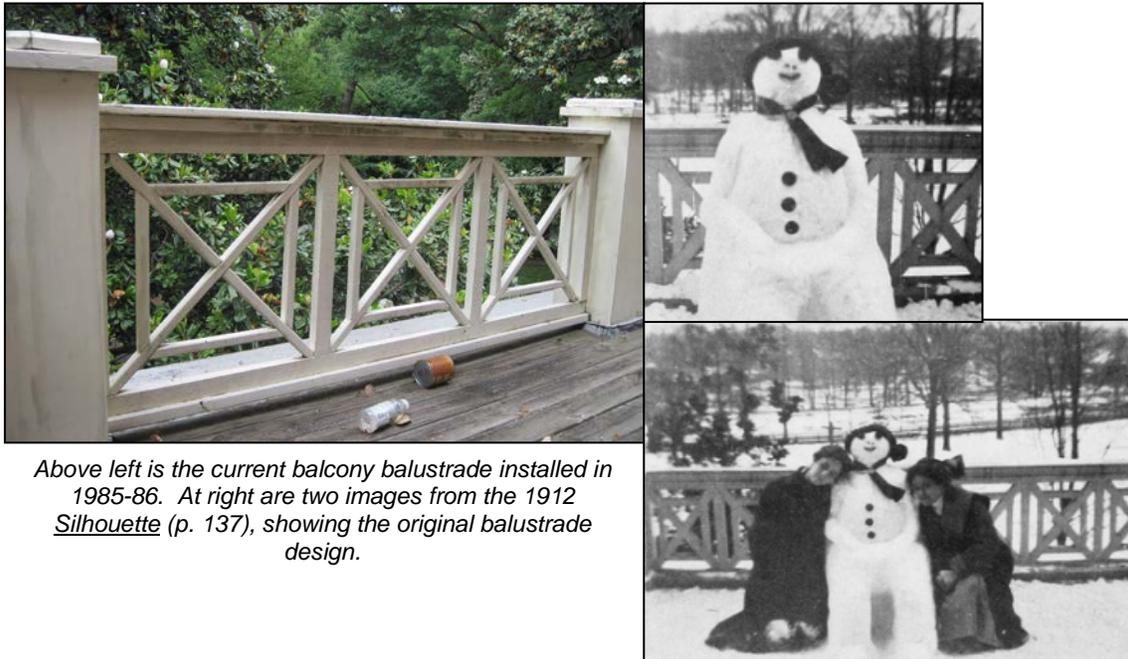
The balcony floor and balustrade were replaced during the 1985-86 renovation. The balustrade was supposed to match the existing one, but it differed in materials, size, and design. The new balustrade was wood, but was made of thin trim pieces rather than what appear in historic photographs below to be 2" wide boards (see modern and historic photos below). The new design is generally correct, except the boxed **X** design element is square, while the original was a narrower vertical rectangle. The new balustrade approximates the historic balustrade, but it does not meet the standard of "replace in kind".

Above left is the current balcony balustrade installed in 1985-86. At right are two images from the 1912 Silhouette (p. 137), showing the original balustrade design.

The balustrade appears to be in good condition, but it is extremely dirty. The wood needs to be cleaned, and if any deteriorated wood sections are discovered, they should be replaced. After cleaning, it may be determined that the balustrade needs to be repainted.

- At all times use only certified renovators to ensure they follow lead-safe work practices when repairing, replacing, cleaning, and painting window elements. Use only lead-free primers and paint.
- Clean all the balcony surfaces: floor, balustrade, piers, finials, and side walls.
- Repair or replace any deteriorated wood elements.
- Repaint the balustrade.
- Seal the floor.

- Repoint the brick piers where necessary, using custom mortar manufactured to match the historic mortar.
- If the balustrade ever needs to be replaced, it is recommended that historic photographs, as well as Inman Hall's balcony, be used in the manufacture of a replacement balustrade so that the historic design and dimensions can be restored.

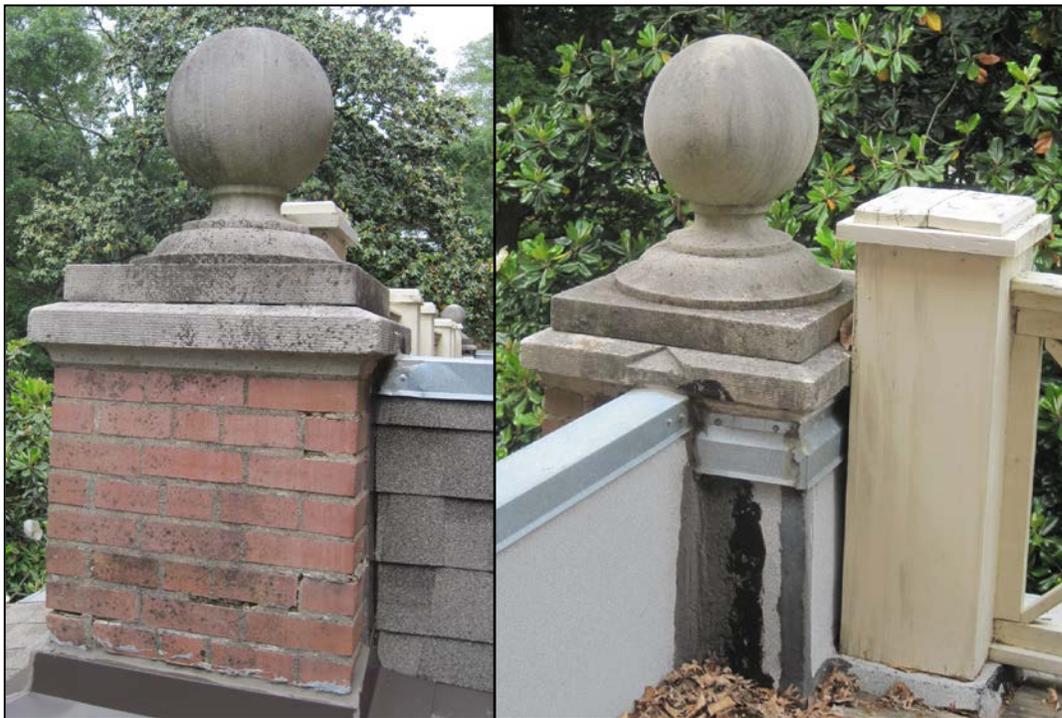
Limestone finials top the brick piers set at the front corners of the balcony.

At the corners of the balustrade are brick piers topped with round limestone finials (see photos above). The bricks are dirty, and there is some mortar missing. The limestone finials and tooled bases are also dirty. See page 49 for information on cleaning masonry, and pages 46-47 for information on repointing.

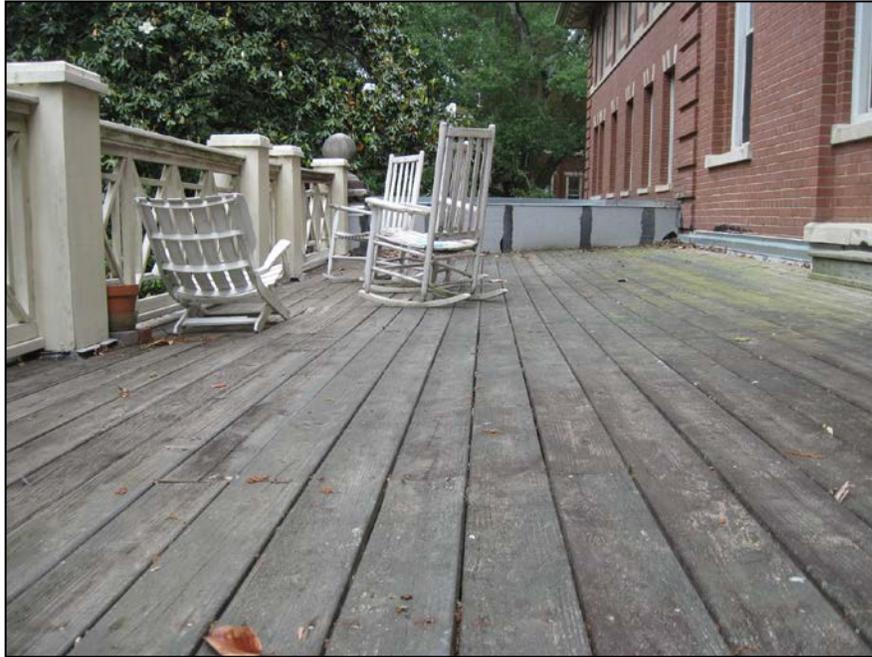
The balcony flooring has accumulated dirt and mildew (see photo below). Some boards are cracked and may be rotted. It is completely devoid of any paint or sealant. It is strongly recommended that it be cleaned, damaged floor boards replaced, and the entire wood floor sealed.

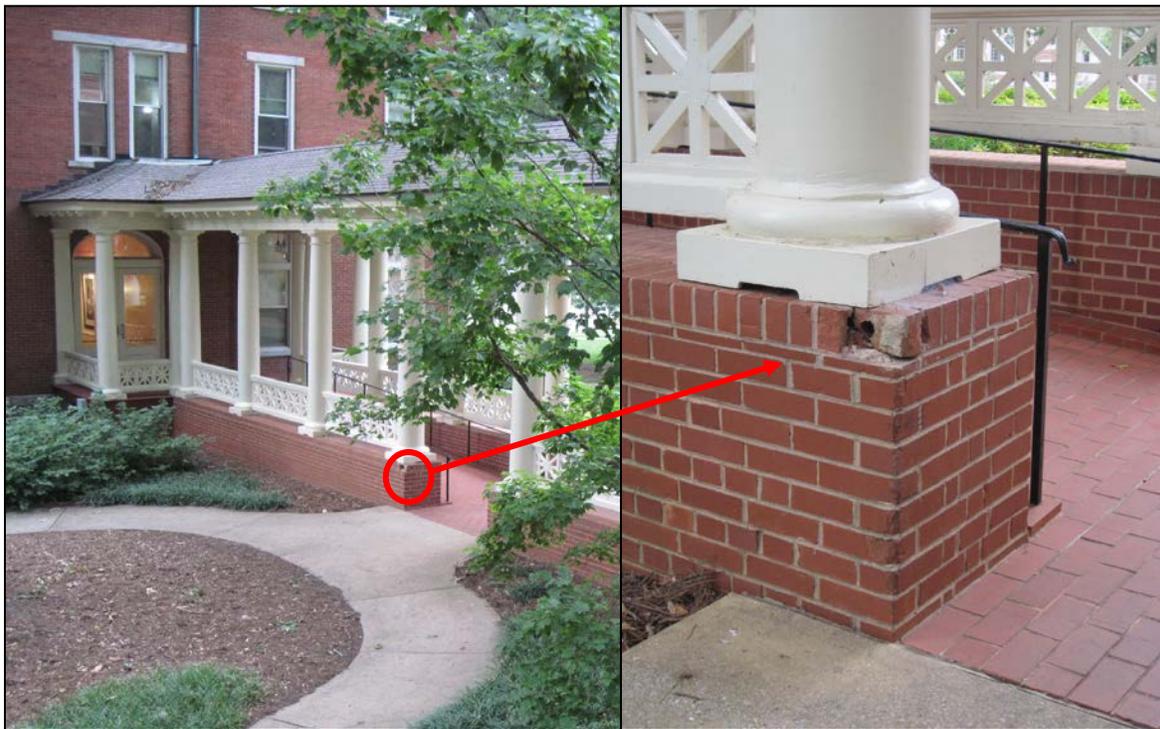
The Colonnade is in very good condition, with the exception of the west brick wall at the north entrance (see photos below). The edges of the bricks at this corner are broken and scraped, and present a poor appearance to anyone, especially in a wheelchair, entering the quad from the north.

- Replace scraped, chipped, and broken bricks at the corners of the at-grade entrances with shaped bricks that have rounded edges.

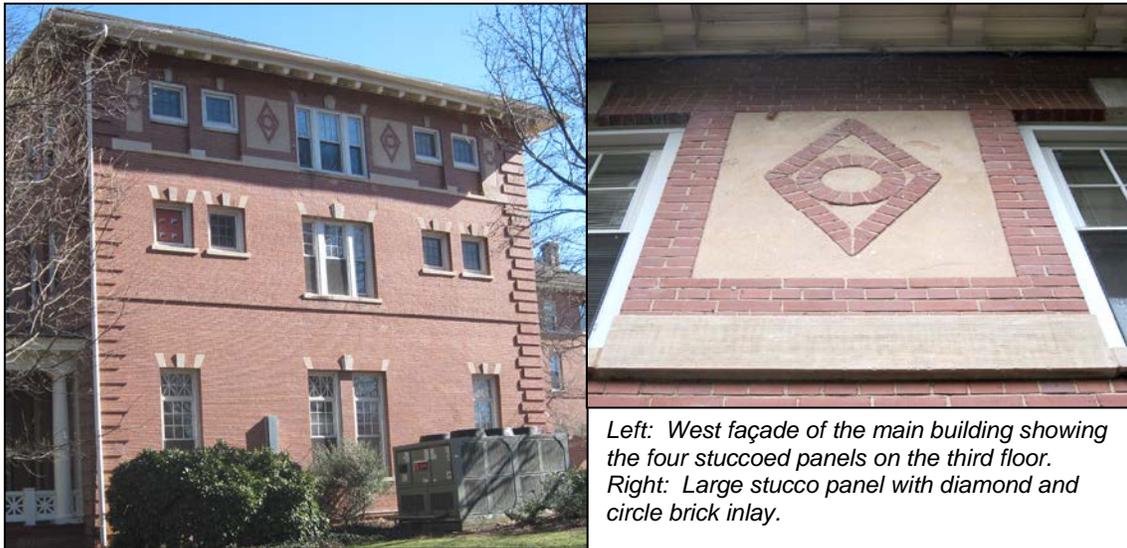
*Left: West façade of the main building showing the four stuccoed panels on the third floor.
Right: Large stucco panel with diamond and circle brick inlay.*

Most of the stucco panels appear to be in fair condition. Some have sections of stucco where the surface has spalled off (see photo below). Other panels have surface cracks, and some of the stucco is chipped. The bricks are in good condition. It is not known if these panels have ever been maintained.

- Clean all of the panels, but with the gentlest means possible. Refer to Appendix J for a technical brief on the care of historic stucco.
- Repairs to the stucco should be made only with replacement stucco custom manufactured to match the historic stucco. See Appendices D and E for the results of the stucco analysis.

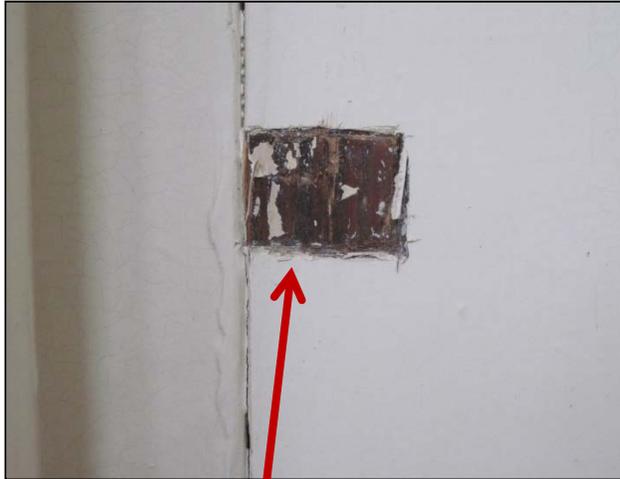
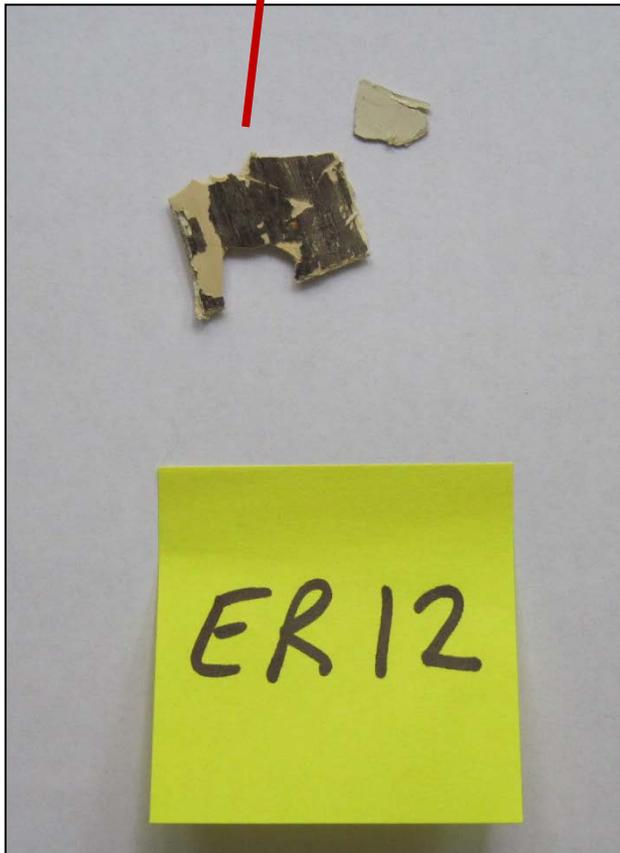
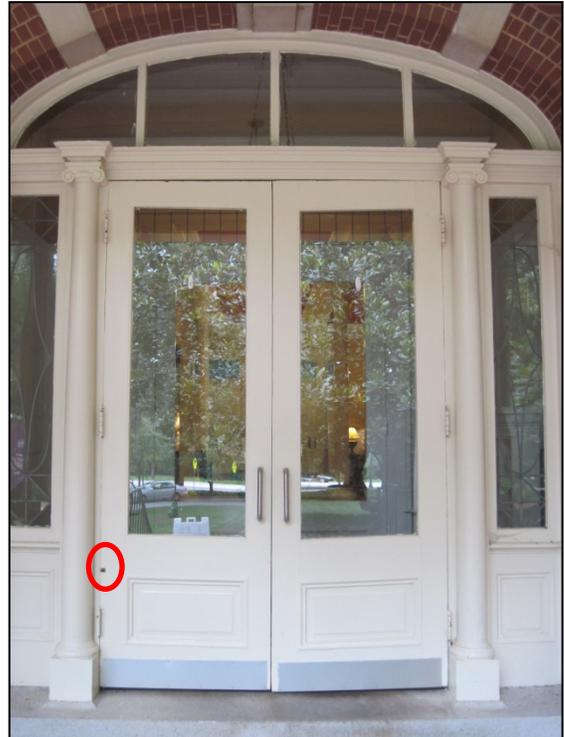
ER12

- Collected 07-31-2014 from the front (north) entrance; from the left (east) door of the double doors.
- Under the hand lens, it appears that the front doors were originally stained dark, then painted shades of cream and white.

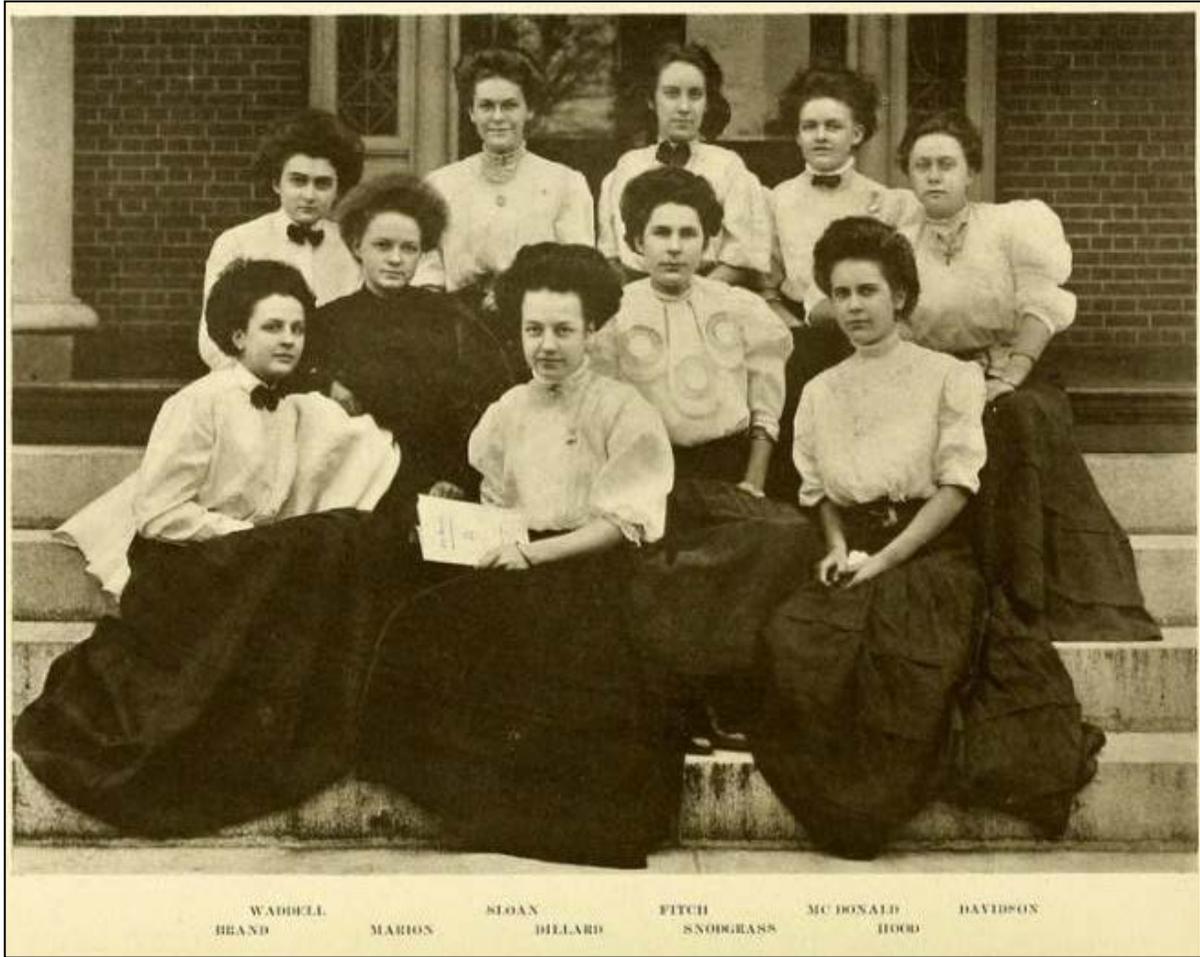
From the 1908 *Silhouette* (the Agnes Scott College yearbook), p. 50. Taken on the front steps of Rebekah Scott Hall. Note dark stained/painted front doors with light-colored columns and sidelights.

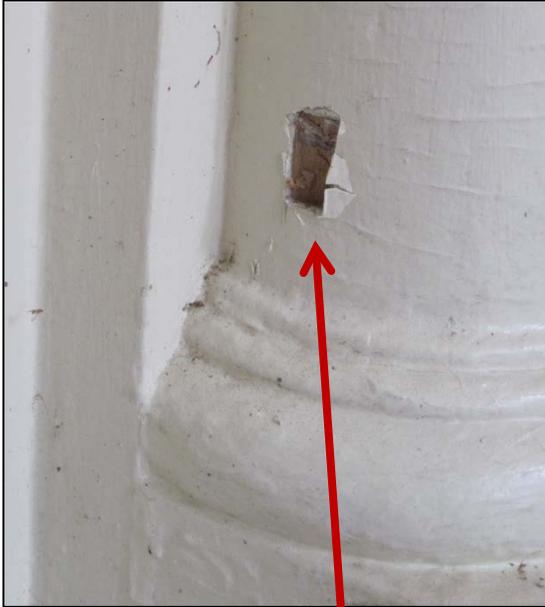
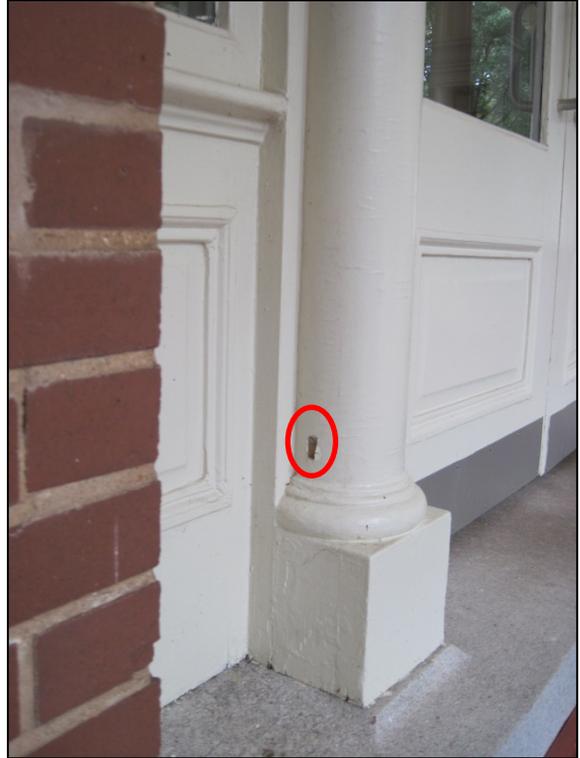
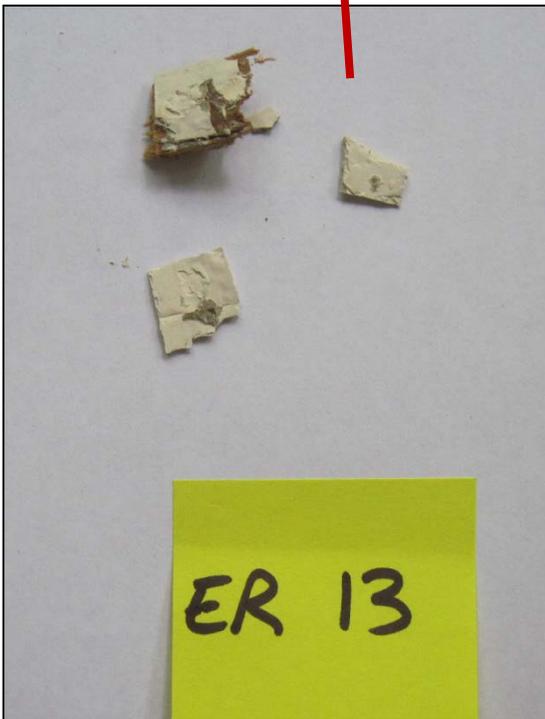
ER13

- Collected 07-31-2014 from the front (north) entrance; from the small Ionic column to the left (east) of the double doors.
- Under the hand lens, it appears that the column was originally white, then gray/silver, and then several shades of white paint.

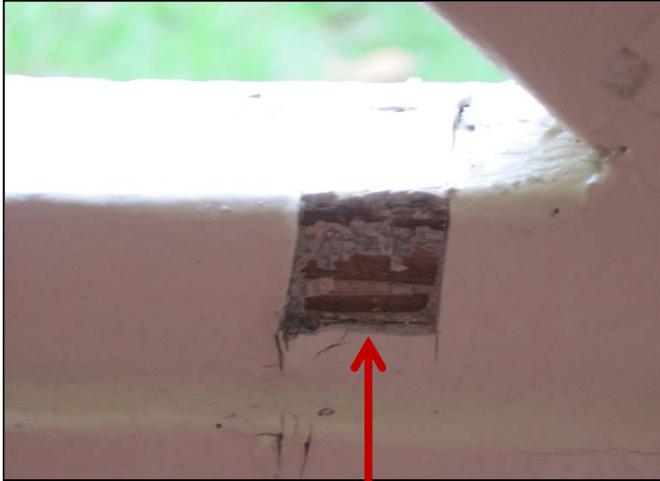
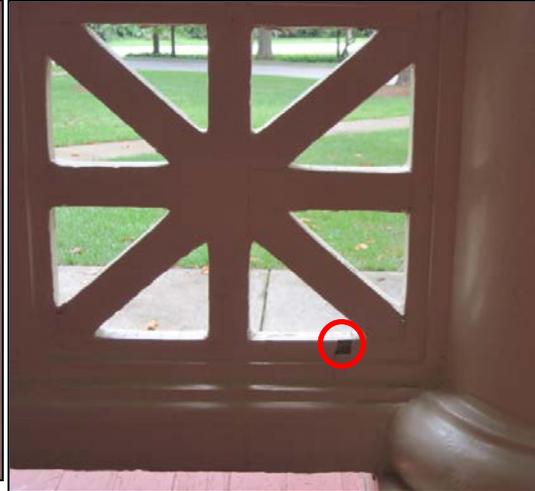
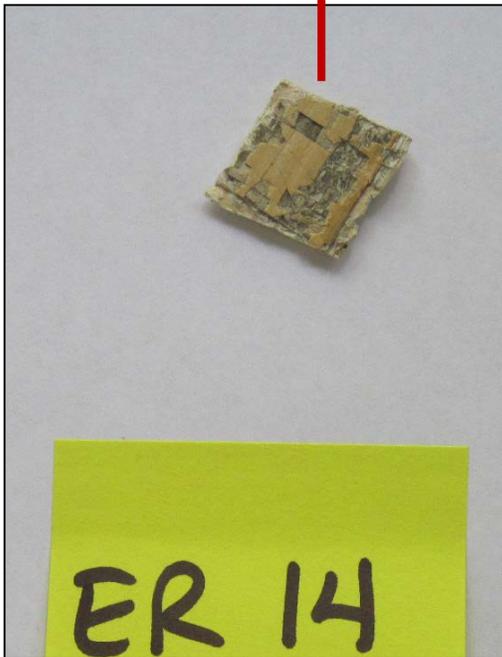
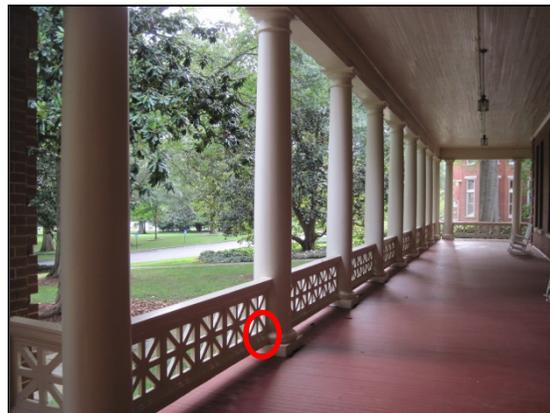
ER14

- Collected 07-31-2014 from the front (north) verandah, east of the front door. The sample was taken from the porch-side horizontal framing below the first star pattern left (west) of the second column of the east colonnade.
- Under the hand lens, it appears that the balustrade section has been painted several shades of white. The layer closest to the wood appears greyish, which could be discoloration from the wood, primer, dirt, etc.

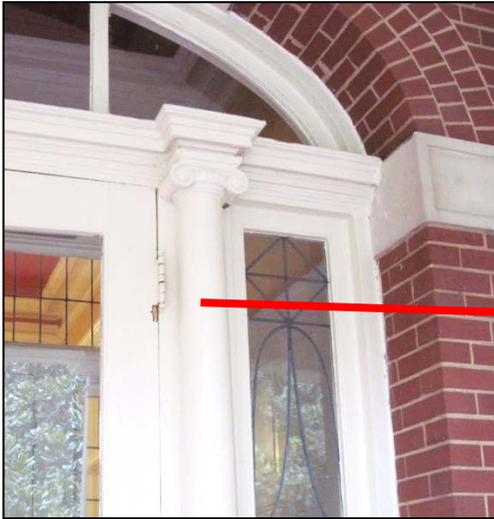
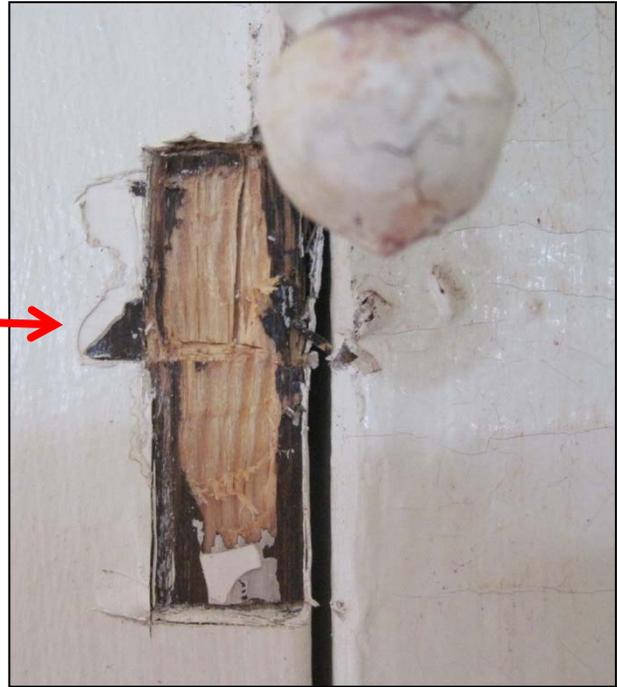
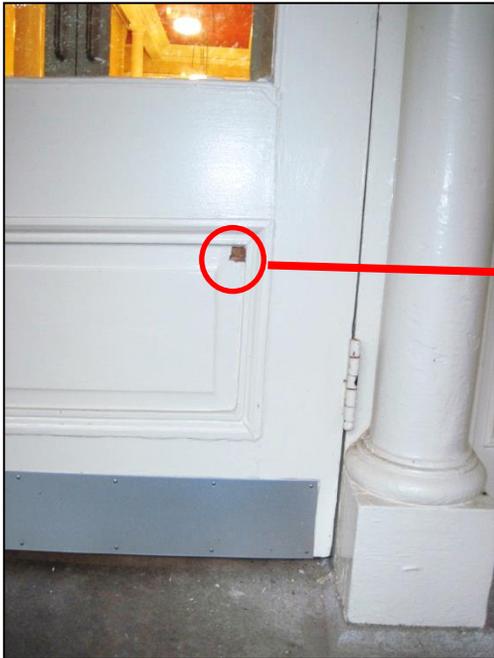
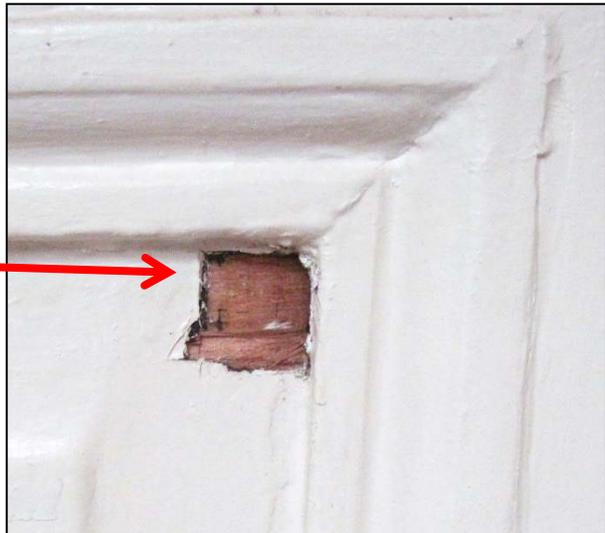
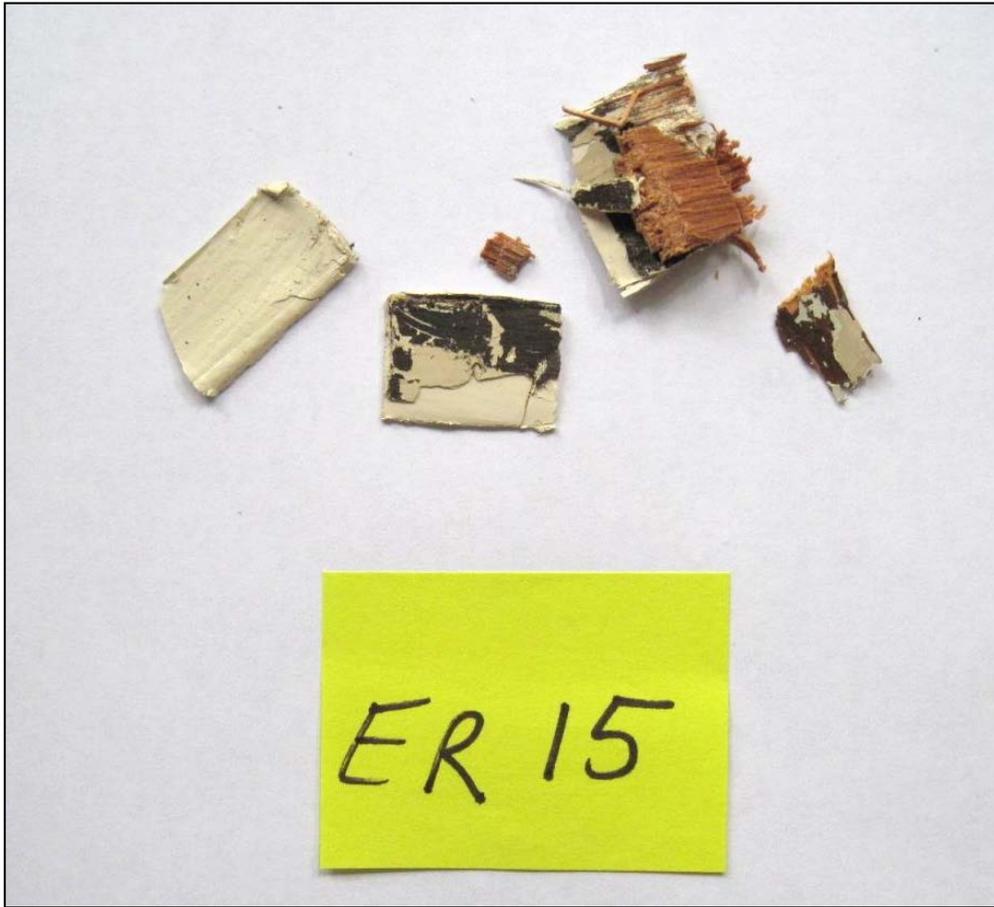
ER15

- Collected 08-08-2014 from the front (north) entrance; from the right (west) door of the double doors. One sample was taken from beneath the upper door hinge; the second sample was taken from the top left corner of the door's lower panel.
- Under the hand lens, it appears that the front doors were originally stained dark, then painted shades of cream and white.

On the exterior, the samples from the front door exhibit poor evidence of a black stain similar to that seen on the interior staircase. Evidence of the top finish on those samples is missing, but I suspect that it was varnished originally.

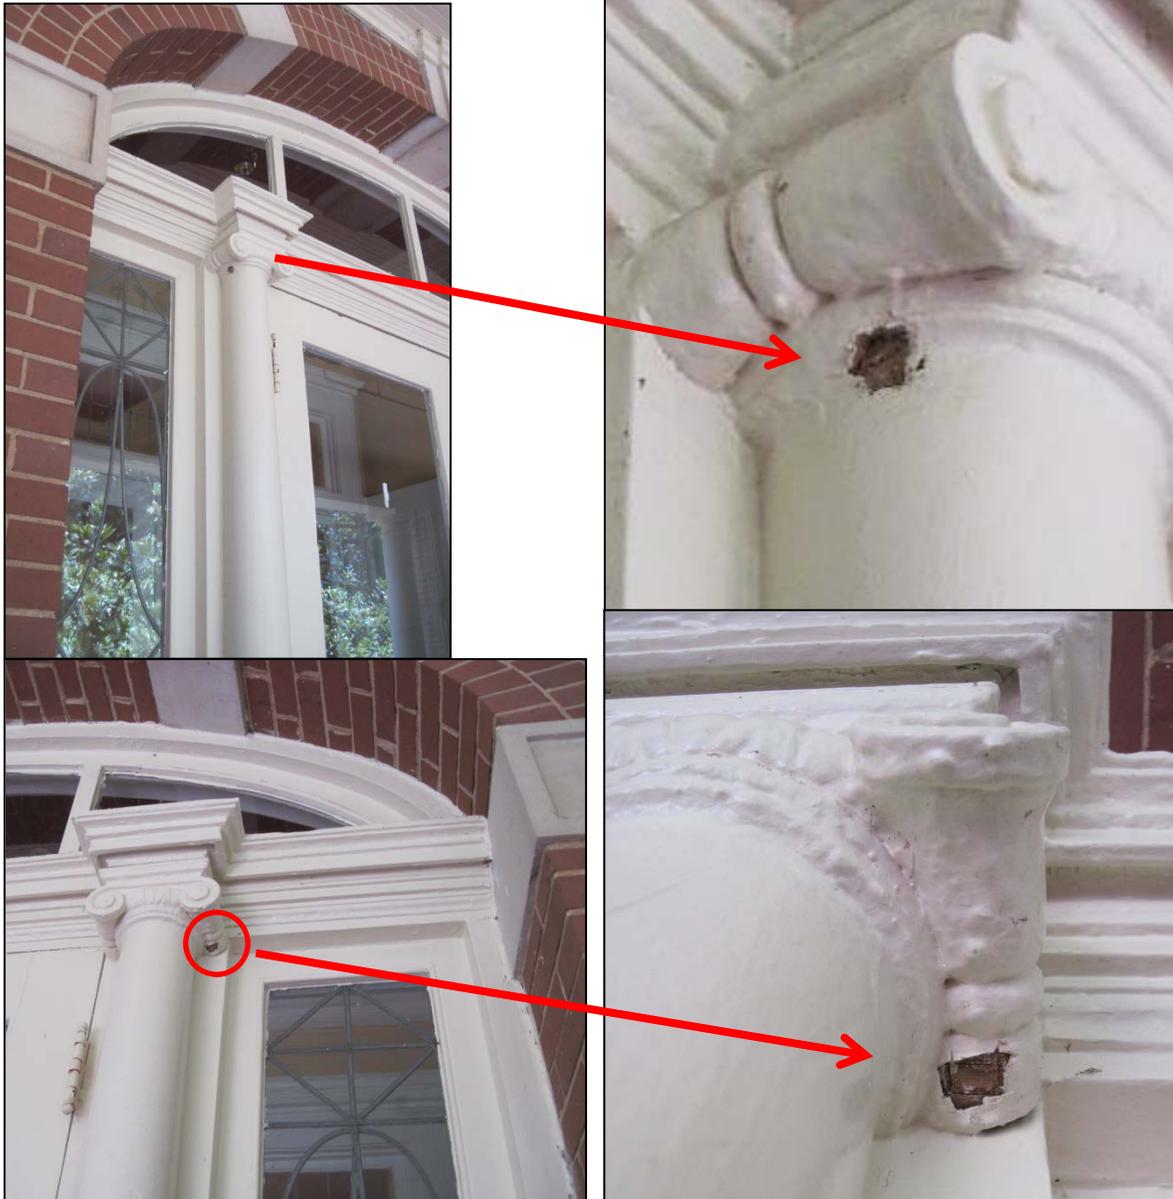
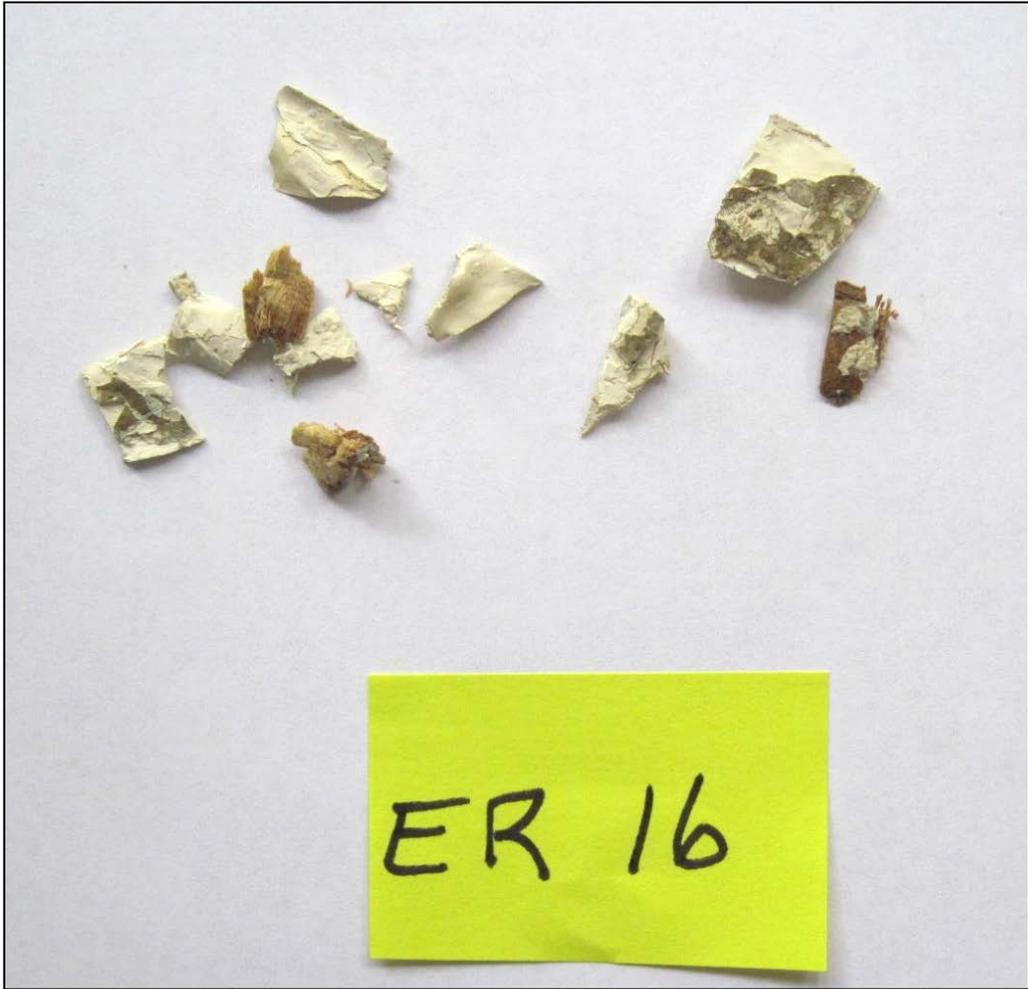
ER16

- Collected 08-08-2014 from the front (north) entrance, from the Ionic columns flanking the double doors. One sample was taken from the left (east) column just beneath the volute of the capital. The second sample was taken from the underside of a curve of the volute of the right (west) column.
- Under the hand lens, it appears that the columns were originally white or cream color, then a grey layer of dirt, followed by several layers of white or cream colored paint.
