Rebekah Scott Hall

**Building Chronology
Exterior Conditions Assessment
Maintenance Recommendations**

**Agnes Scott College
Decatur, Georgia
September 2014**

Atlanta Preservation & Planning Services, LLC

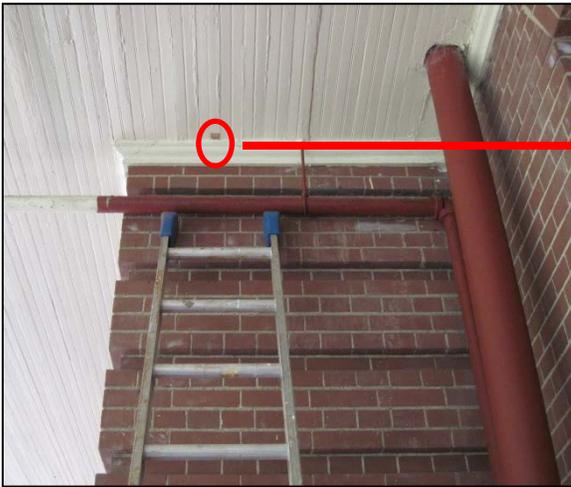
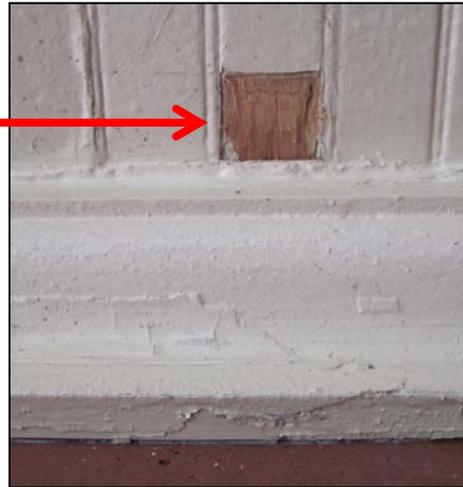
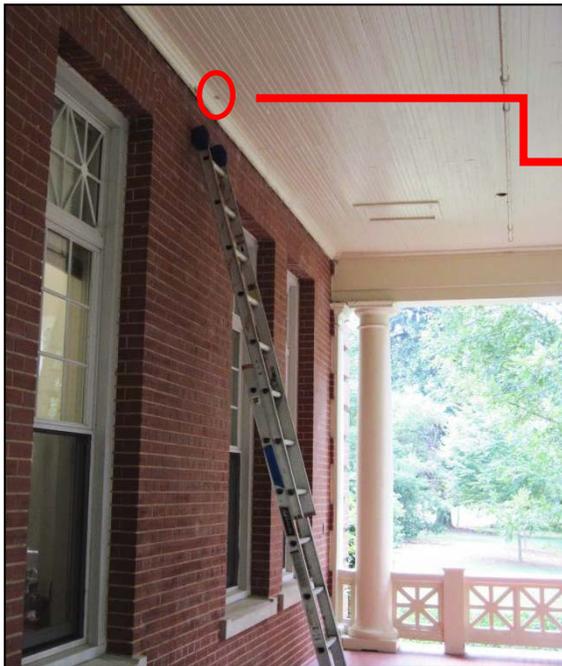
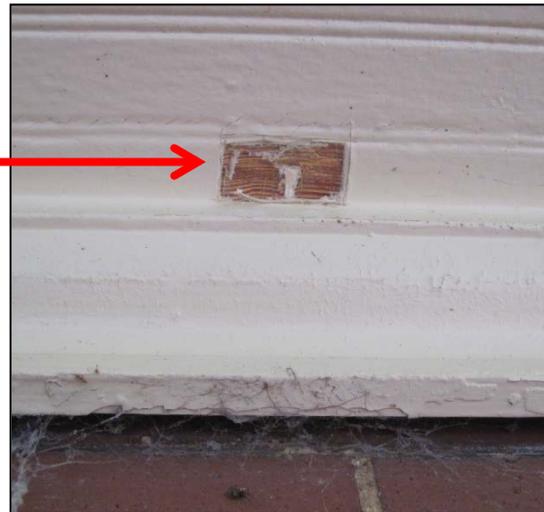
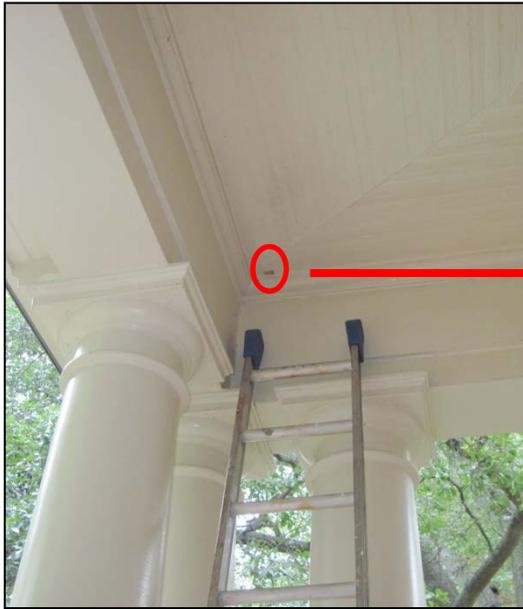
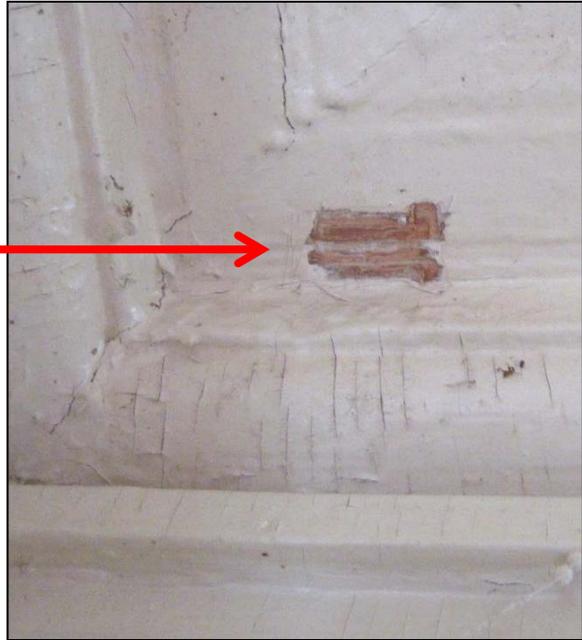
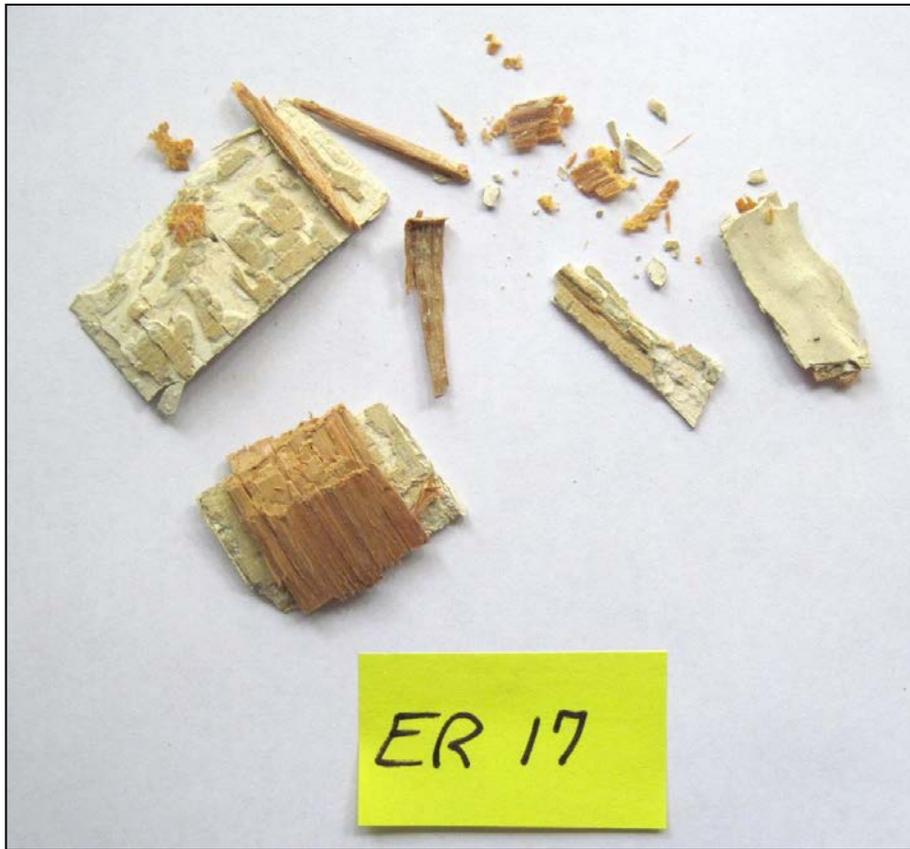
ER17

- Collected 08-08-2014 from the ceiling of the front (north) porch. One sample was taken from the west side of the front entrance projection. One sample was taken from the building side of the west colonnade. One sample was taken from the northeast corner of the east colonnade.
- Under the hand lens, it appears that the ceiling has been painted several shades of white or cream. The grey layer is probably dirt. There was no evidence of the sea-green color seen on Sample ER2 from the previous sample set submitted to Welsh Color and Conservation, Inc.

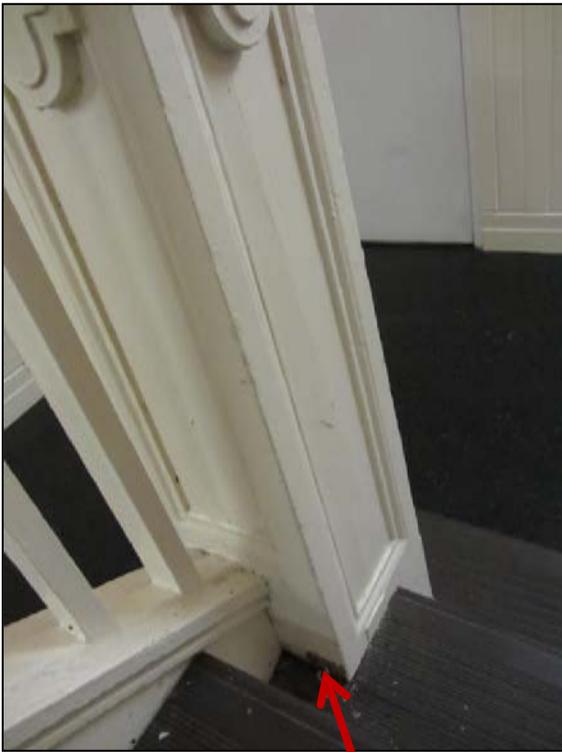
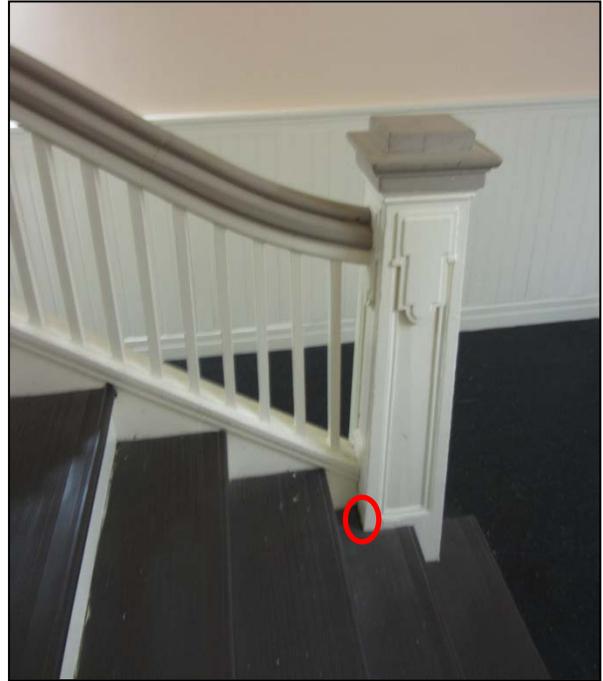
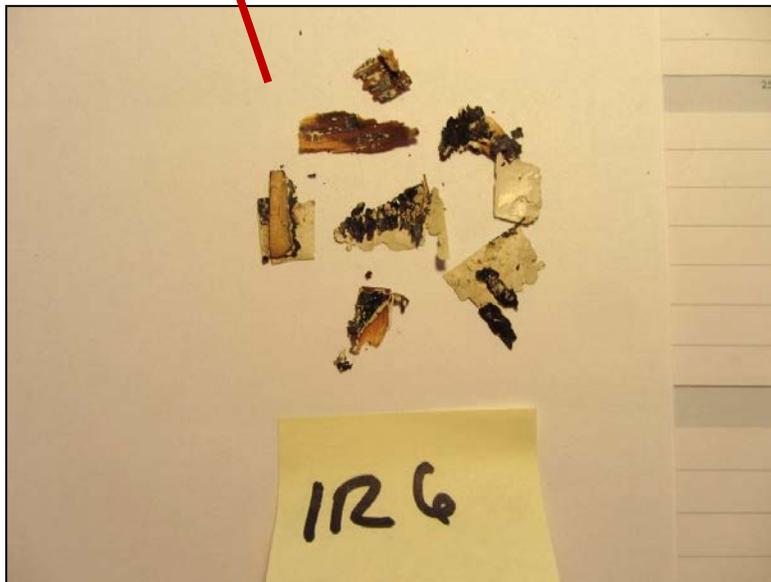
IR6

- Collected 06-16-2014 from the base of the shaft of the first floor central stair newel post.
- Under the hand lens, it appears that the newel post was originally stained dark, then painted white. In between white layers is another dark layer that may have come from coating the stair tread, as the sample is from next to the tread.

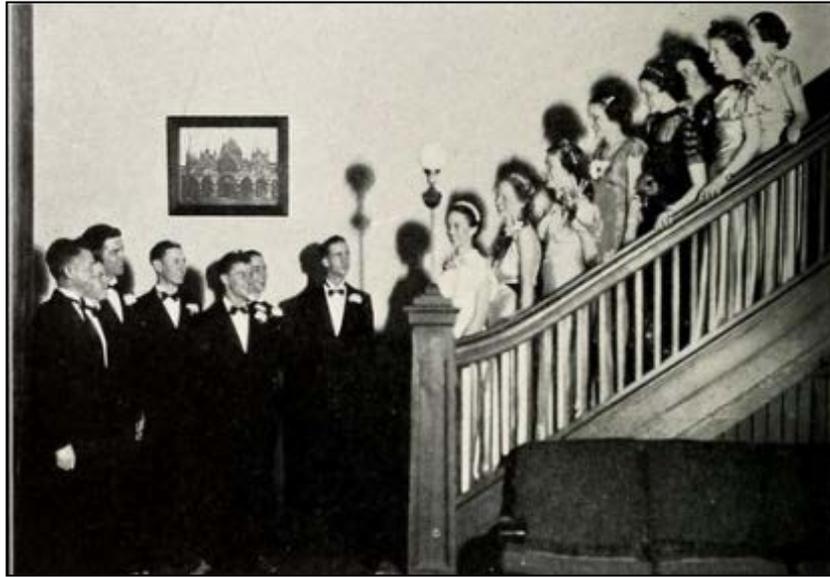
From the 1937 *Silhouette*, p. 196. The central stair of Rebekah Scott Hall. Note dark stained/painted newel post (with tall lamp/light fixture), rail, runner, and spandrel. Note the lighter colored balusters.

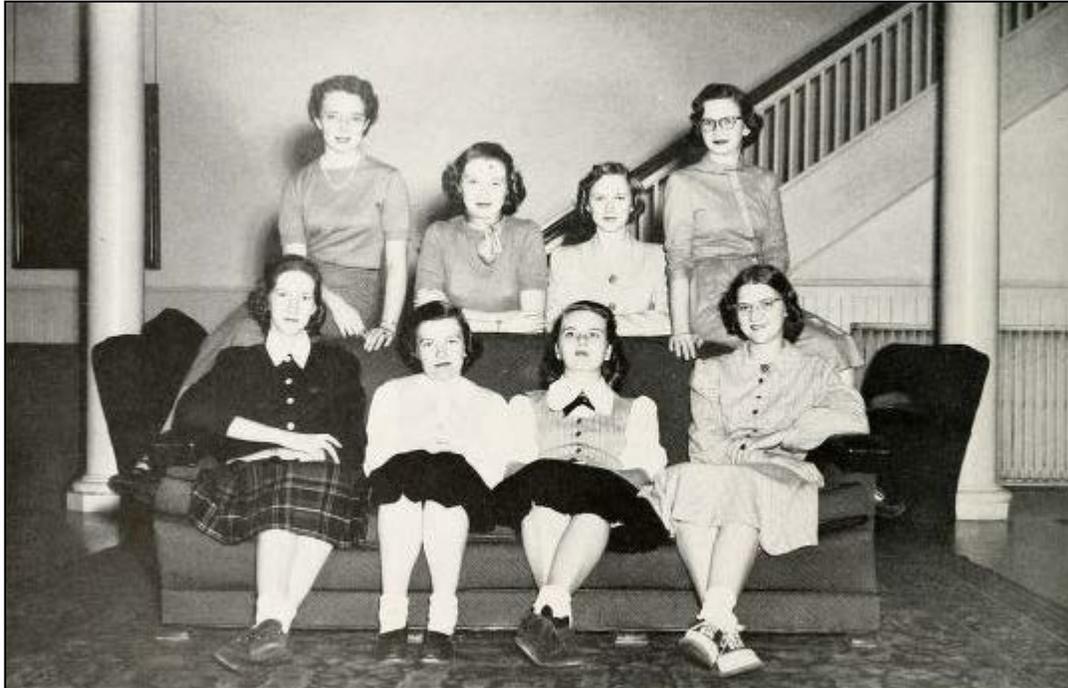
From the 1951 *Silhouette*, p. 124. From the lobby looking east toward the central stair of Rebekah Scott Hall. Note dark stained/painted handrail. Note the lighter colored balusters, runner, and spandrel. Newel post is not visible.

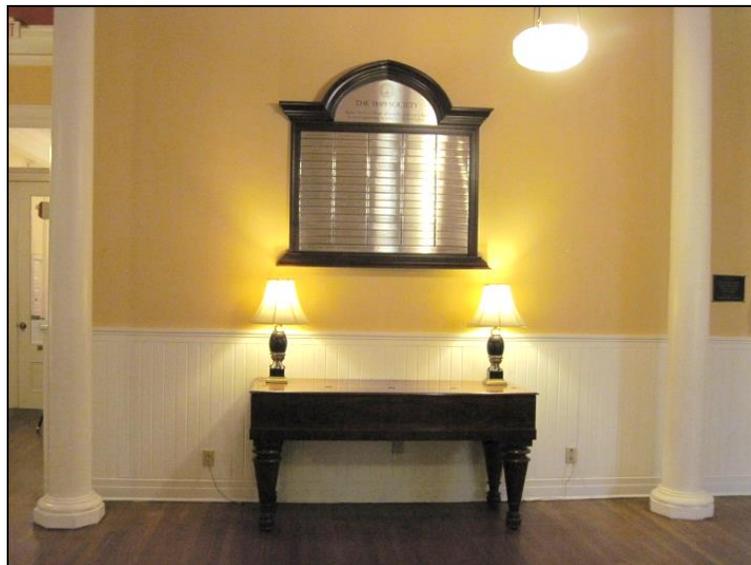
Cannot replicate angle in 1937 or 1951 photos as the stairway was enclosed in 1956. Above is 07/31/2014 view showing, behind the columns, the modern wall that now encloses the stair.

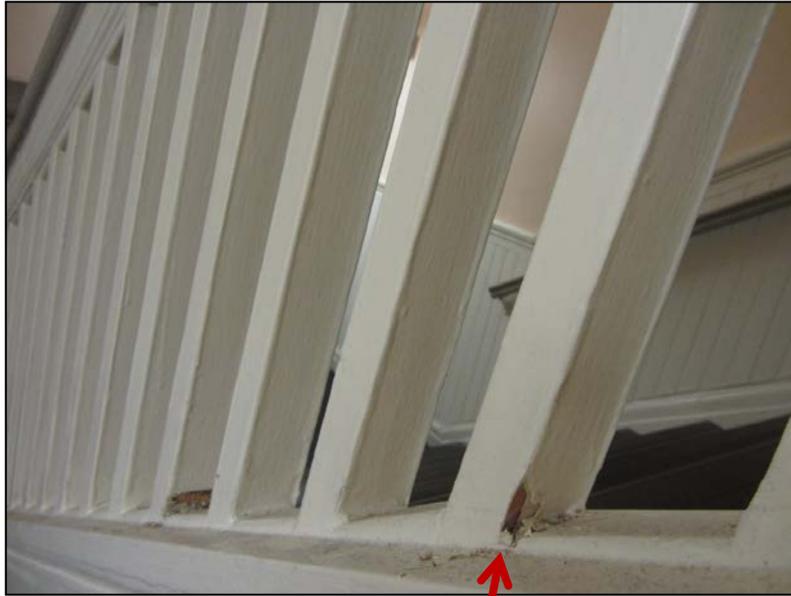
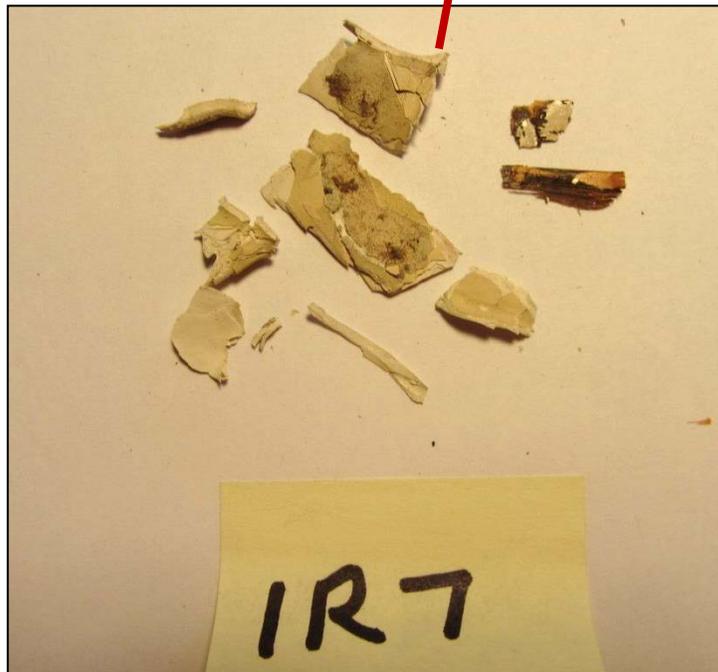
IR7

- Collected 06-16-2014 from the baluster of the first floor central stair.
- Under the hand lens it appears that the balusters were originally dark stained, followed by various shades of white.

Our analyses and color evaluation disclose that two of the samples (#'s 7 & 8) from the interior oak staircase exhibit reasonably good evidence of an original finish. There is a black stain that appears to have been applied and then wiped off so that only the open grain of the wood retained the stain. The finish on the wood over the stain appears to be a wax. Above this original finish there are approximately 15 layers of white paint.

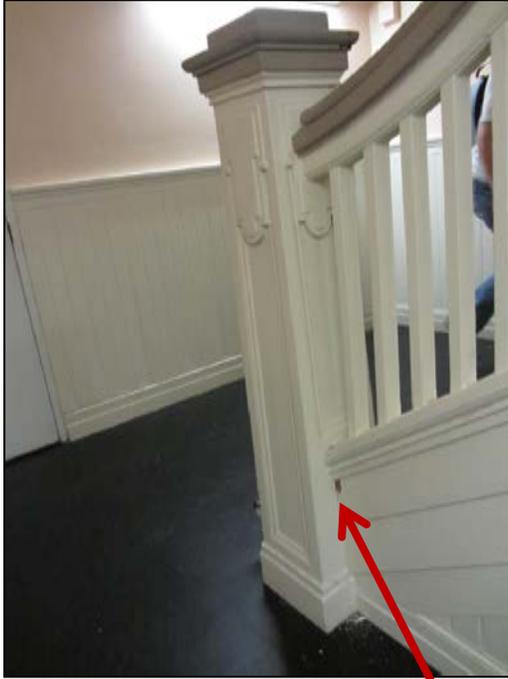
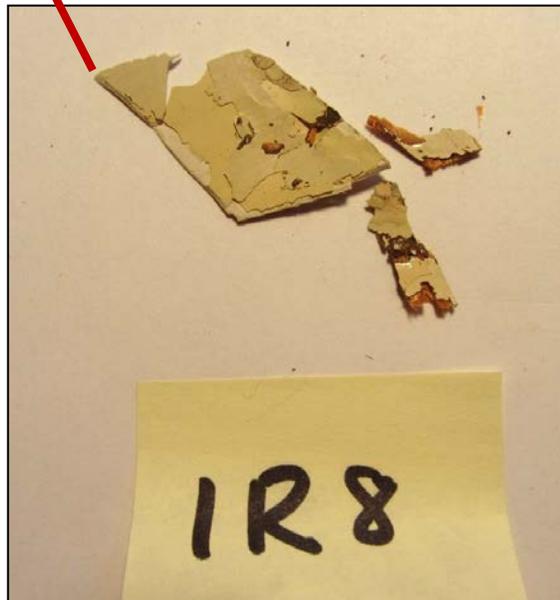
IR8

- Collected 06-16-2014 from the runner by the newel post of the first floor central stair.
- Under the hand lens it appears that the stair runner was originally dark stained, followed by various shades of white.

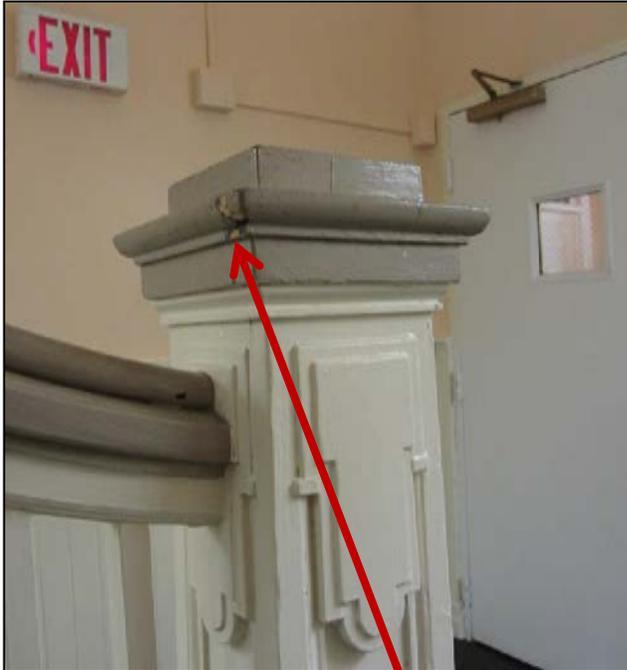
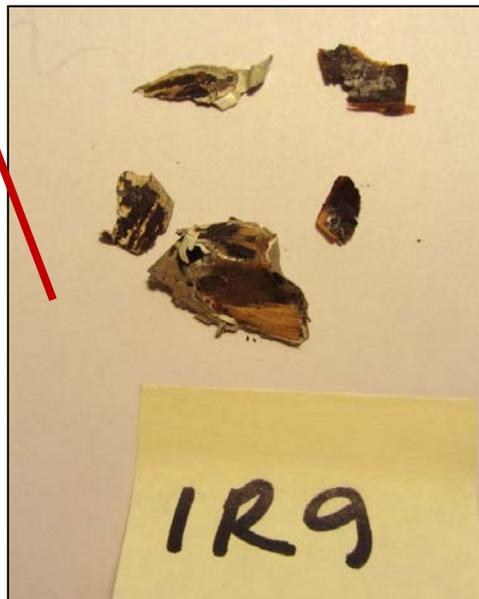
IR9

- Collected 06-16-2014 from the underside of the cap of the first floor central stair newel post.
- Under the hand lens it appears that the newel cap was originally dark stained, followed by white and the present gray.

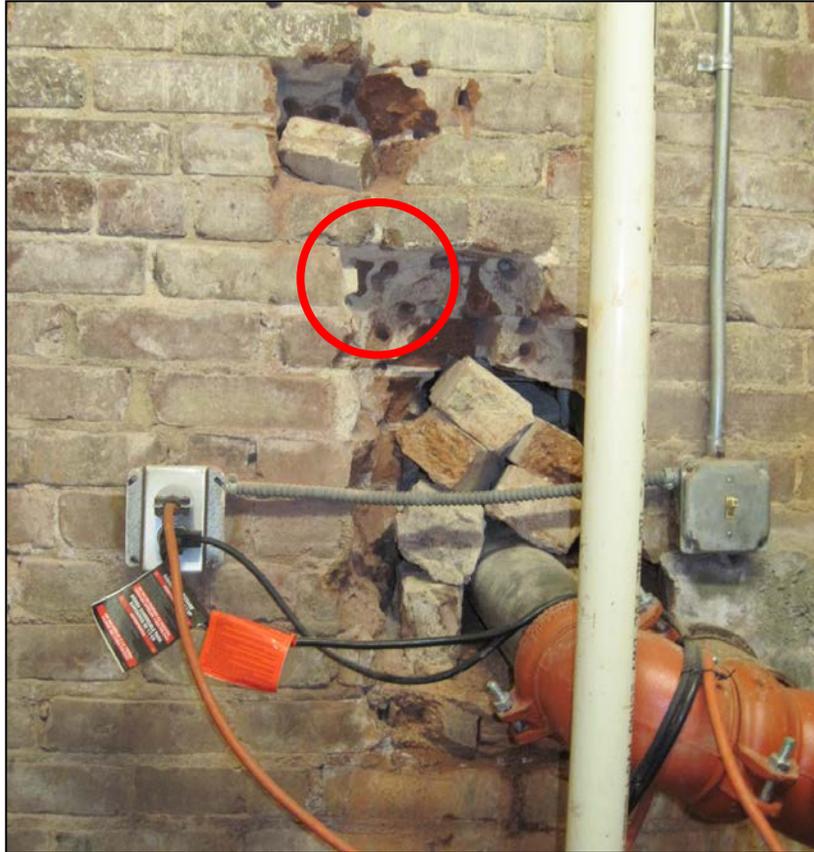
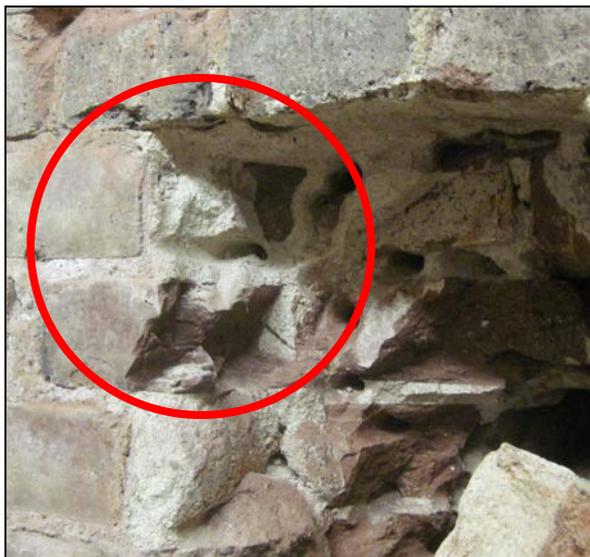
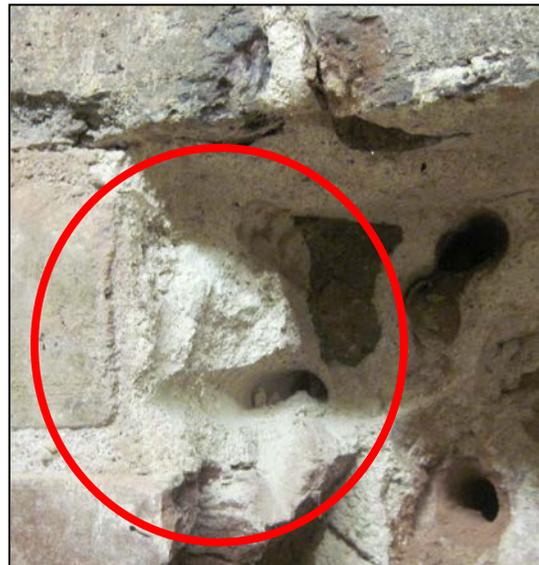
Mortar taken from interior east wall of the historic kitchen basement, in the northeast corner of the basement under the building's southeast stair. Red circles indicate area where sample was taken.

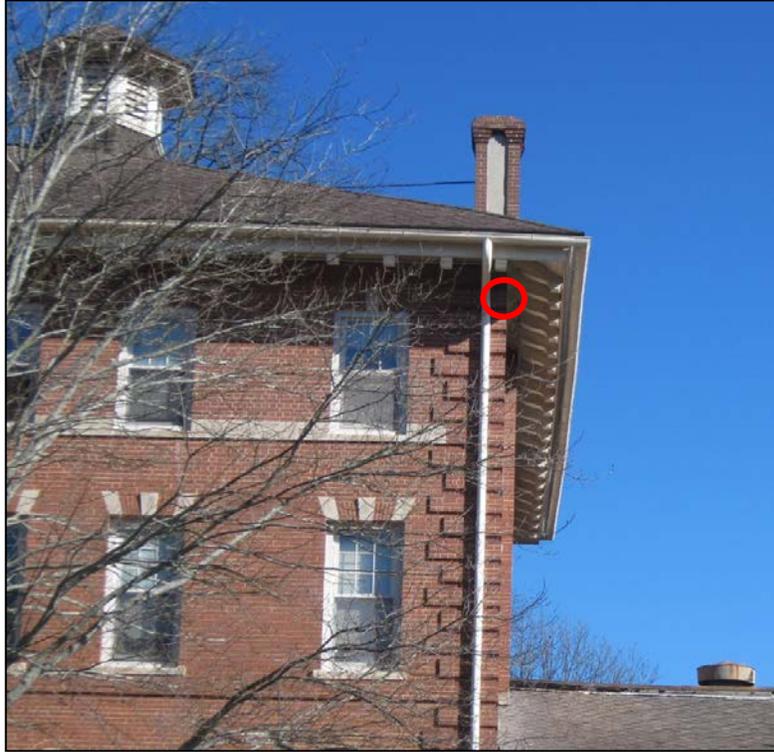
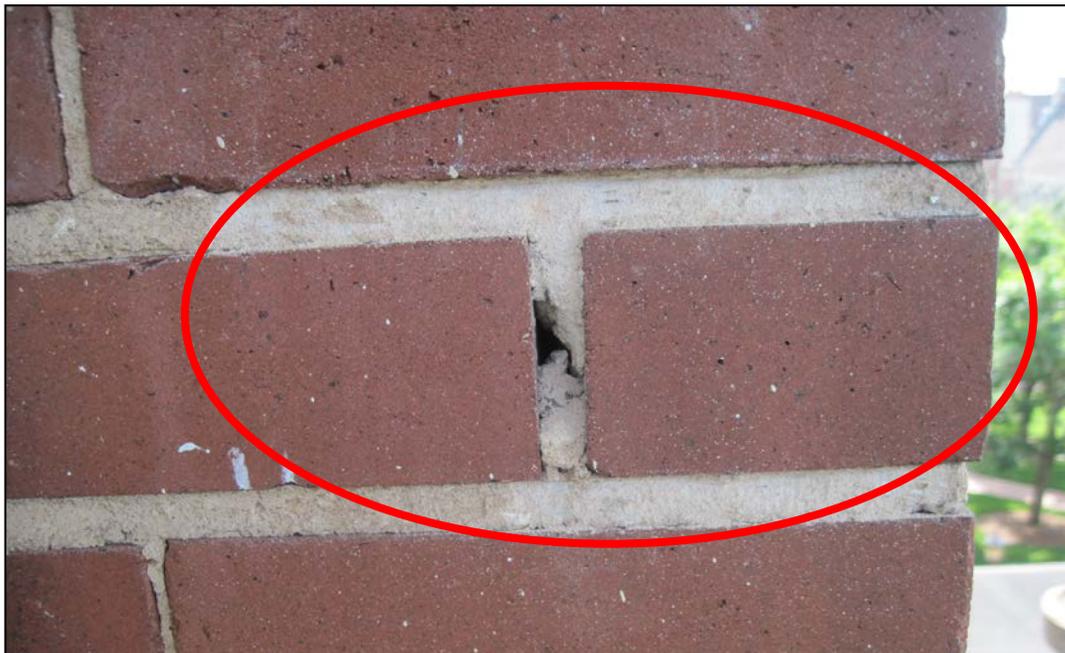
Sample 2. Pointing Mortar

Mortar taken from exterior west wall of the south ell, in the southwest corner under the eaves on a corner quoin. Red circles indicate area where sample was taken.

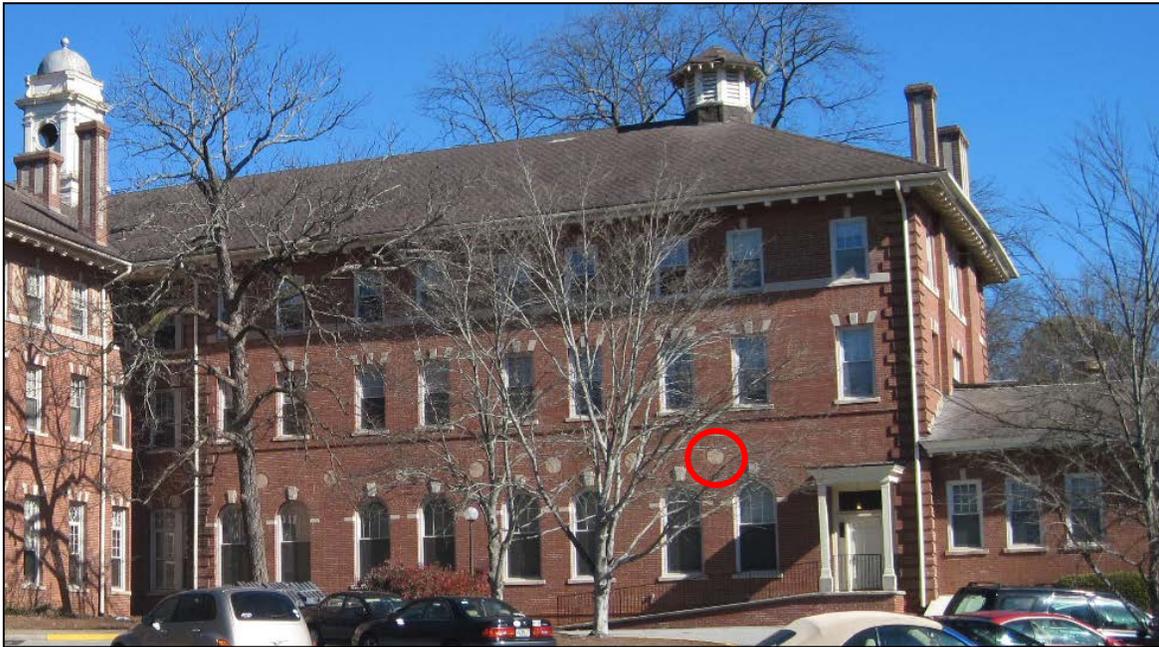
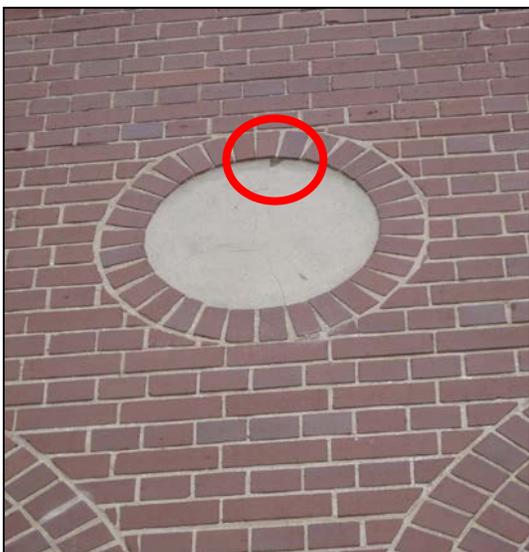
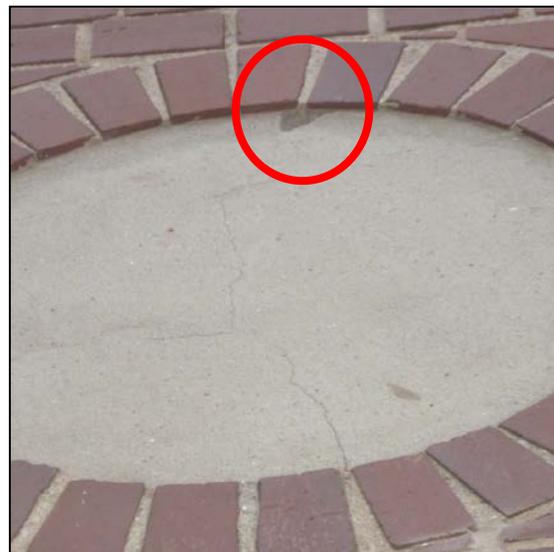
Sample 3. Exterior Stucco
Rebekah Scott Hall, Agnes Scott College, Decatur, GA; May 23, 2014

Stucco taken from west facade of the south ell, in the circular panel between the two southernmost first floor windows of the Katherine Woltz Reception Room (original dining hall). Red circles indicate area where sample was taken.

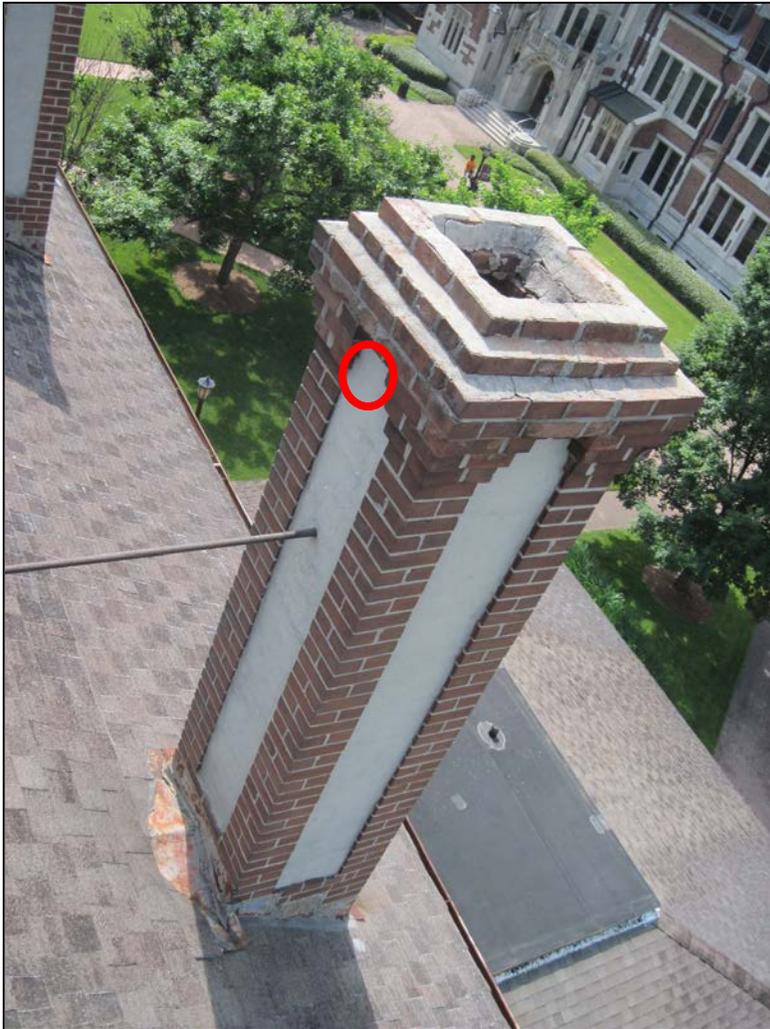
Sample 4. Chimney "Stucco"

"Stucco" taken from exterior north side of the southwest chimney, under the corbeling. Red circles indicate area where sample was taken.
